REGULAR MEETING OF COUNCIL
Monday, October 23, 2023 @ 4:00 PM
Ucluelet Community Centre
500 Matterson Drive, Ucluelet

| 7.3 | <p>Fire Hall Replacement

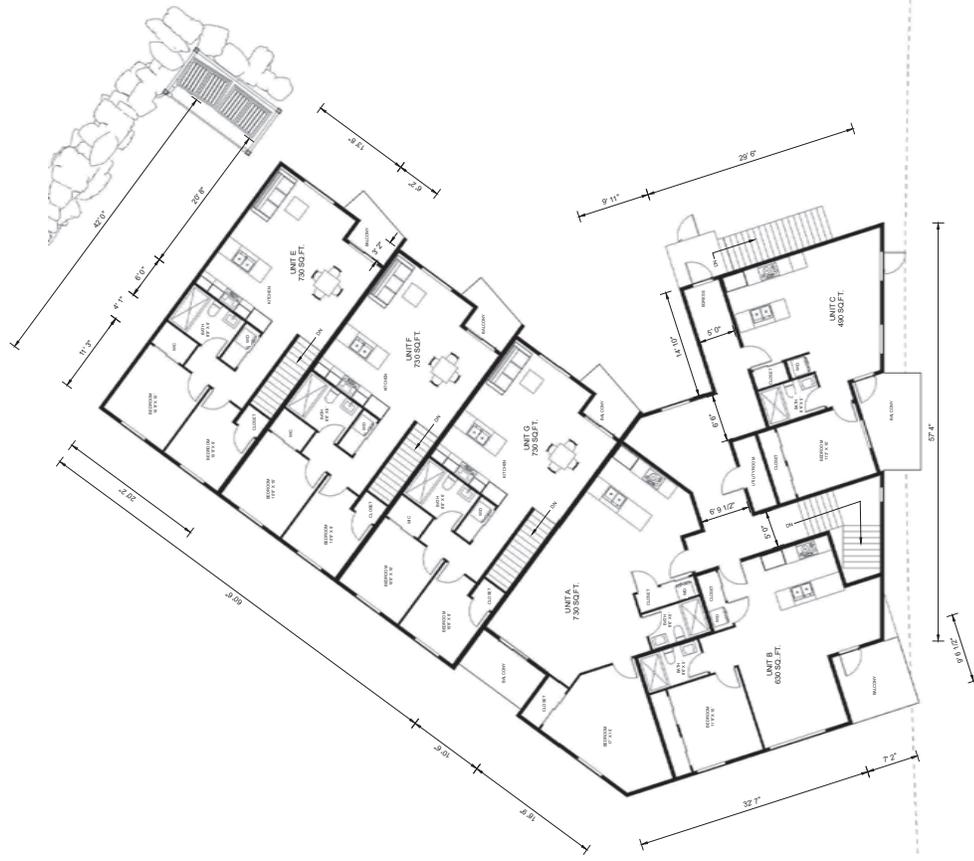
NOTES:
 DIMENSIONS TO OUTSIDE OF 13.25" WALL THICKNESS

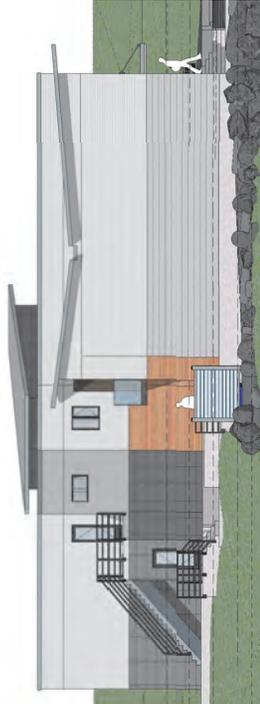
3 NORTHEAST ELEVATION
 A.04 / Scale: 1/8" = 1'-0"

0.00m a.f.f.
 ROOF PEAK (15.00m)
 FINISHED FLOOR (15.00m)
 FINISHED FLOOR (15.00m)
 0.00m a.f.f.
 FINISHED FLOOR 2 (10.00m)
 0.00m a.f.f.
 FINISHED FLOOR 1 (7.00m)
 0.00m a.f.f.
 FINISHED FLOOR 0 (0.00m)

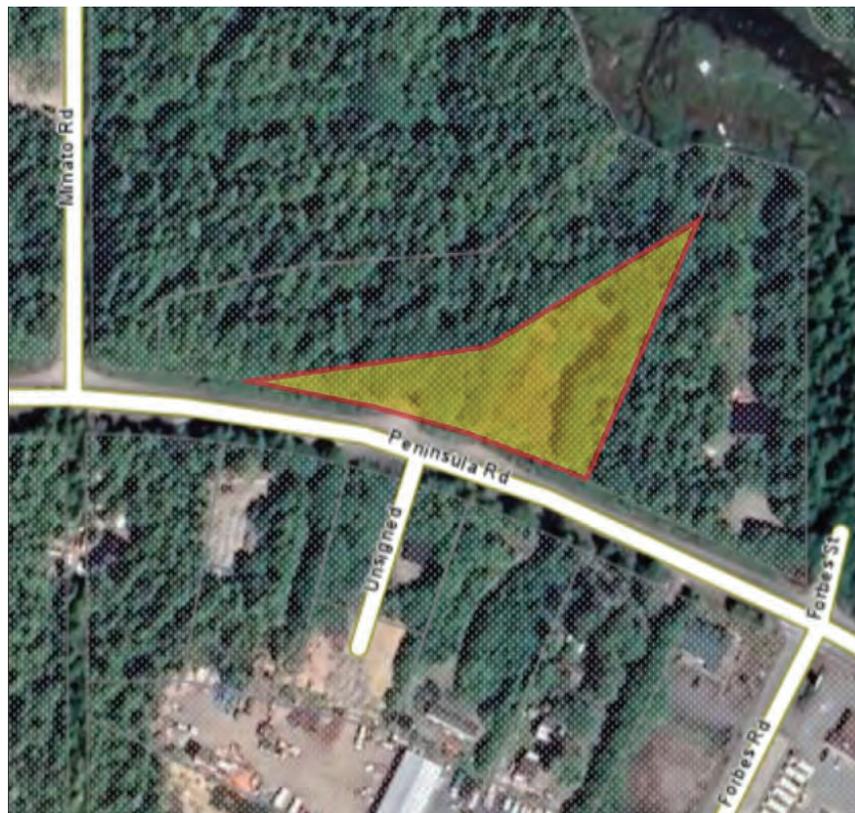
The intent of this report is to identify possible issues related to accessing and servicing this site and to suggest appropriate approaches for the civil engineering design of this development. The project is located at 2091 Peninsula Road within the District of Ucluelet (DoU). The site is currently zoned CS-2 (Service Commercial) and consists of a vacant lot with previously excavated depressions (Figure 1).

Figure 1: Existing Site – 2091 Peninsula Road (Ukeemap)

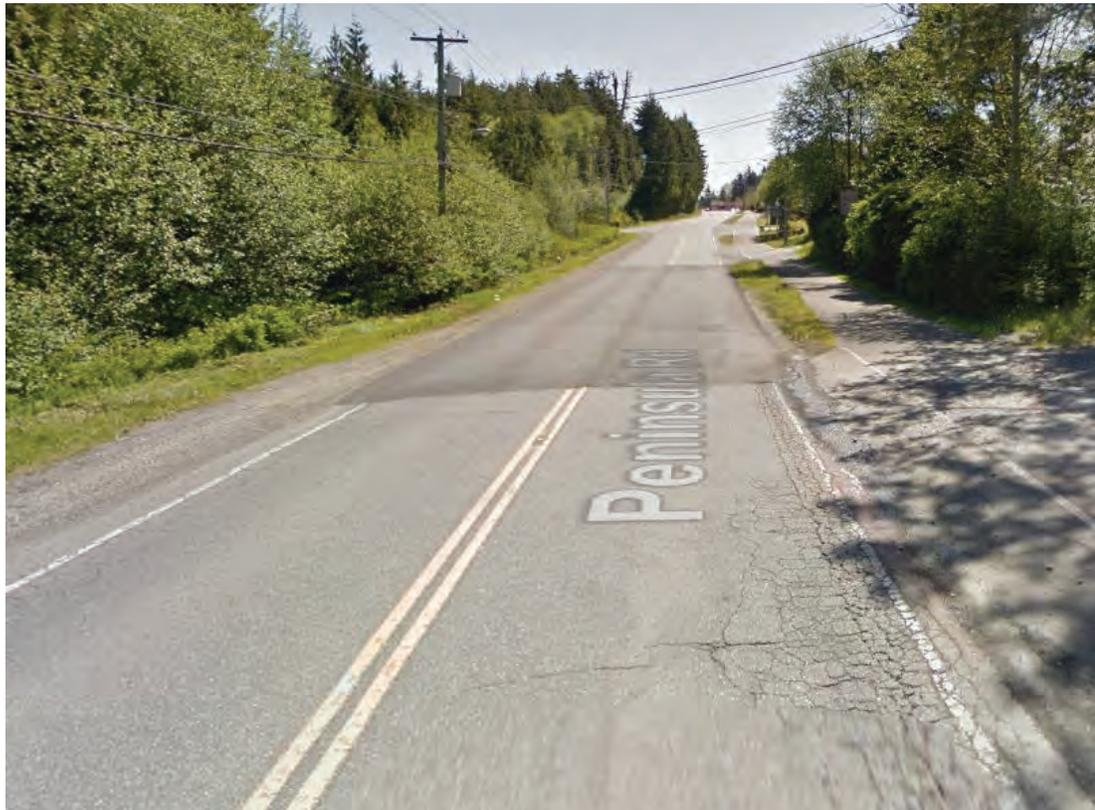
Discussions with DoU staff and the DoU 2011 Transportation Plan indicate that offsite frontage works on Peninsula Road are anticipated to include resurfacing Peninsula Road with new asphalt up to the existing centerline along the property frontage.

Figure 2: Peninsula Road - Looking East (Google Maps)

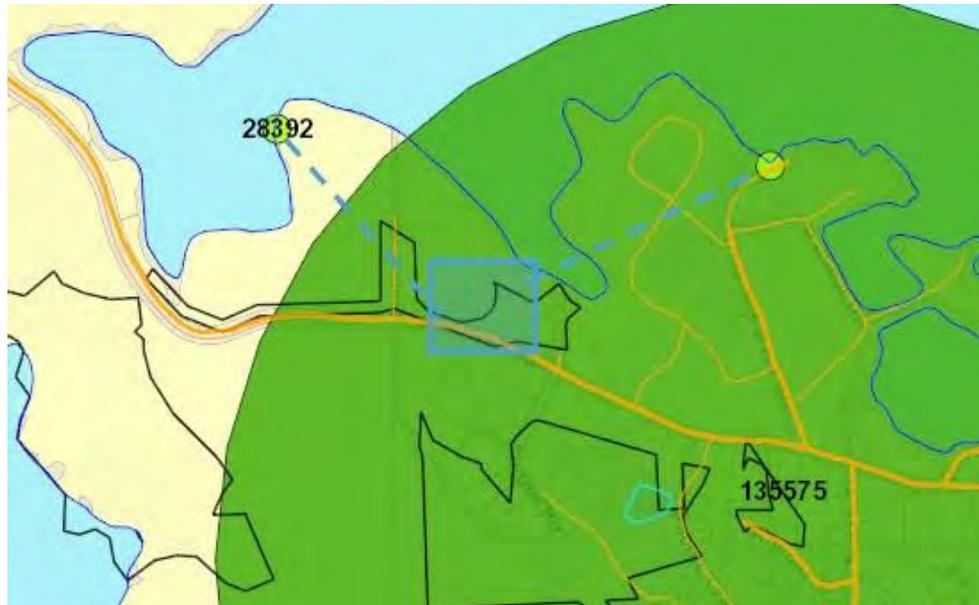
Figure 1. Element Occurrence 135575 tall woolly-heads (dark green) and element occurrence 28392 seaside centipede (2 light green polygons) along with Critical Habitat for Marbled Murrelet (black outline) occur on or near the Property (approximate location outlined in blue).

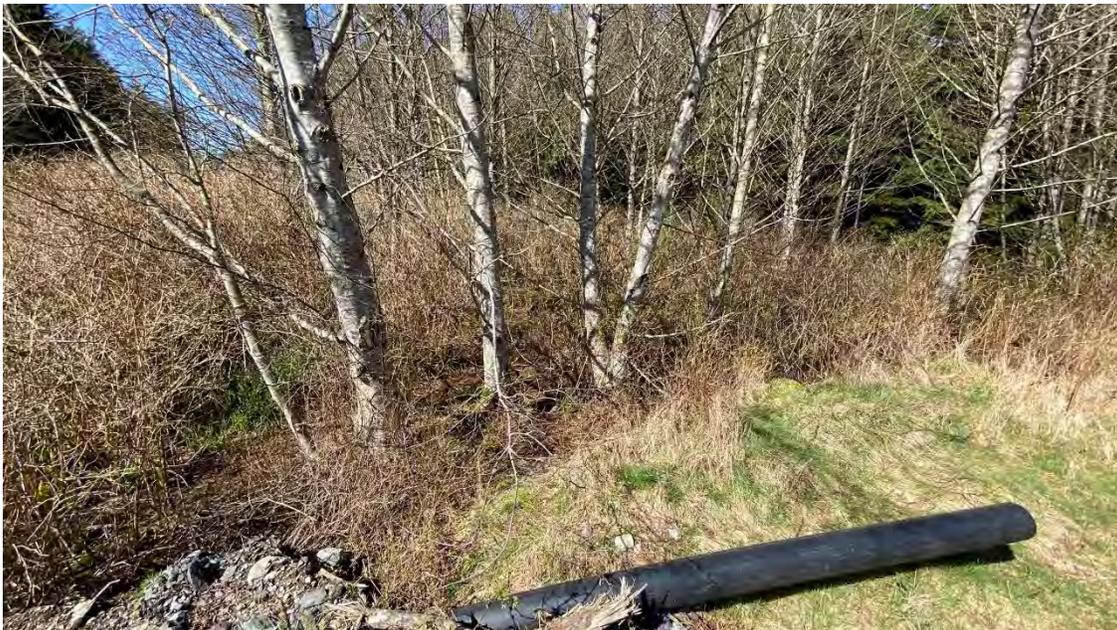
Appendix Photo 2. View looking west towards Wetland 1 from the edge of the disturbed area.

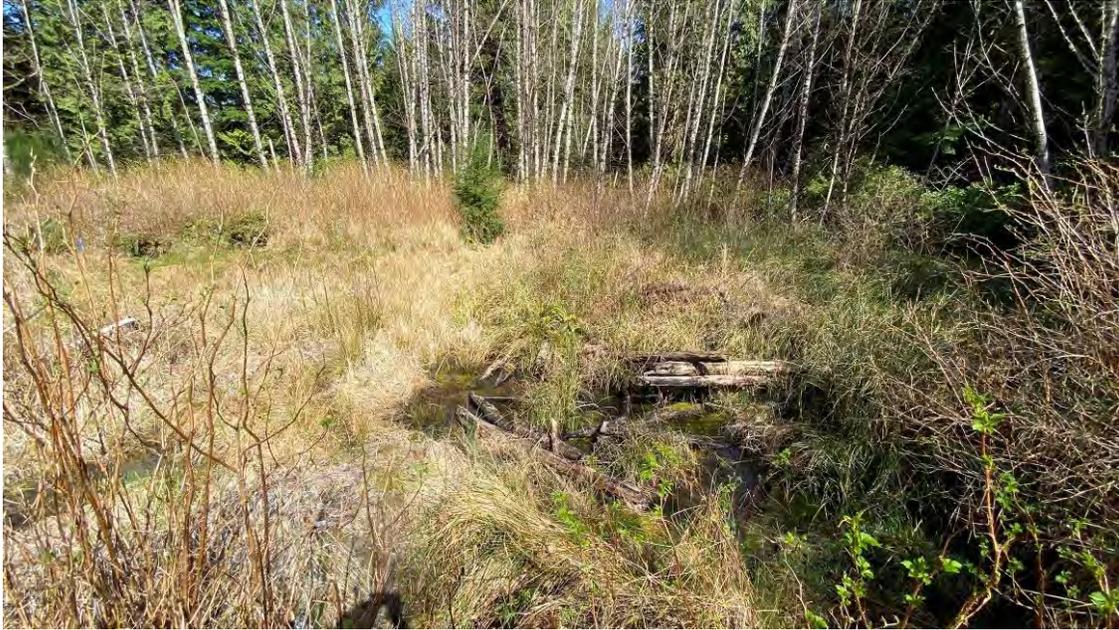
Appendix Photo 3. View of modified Wetland 3 with coarse woody debris and open water.

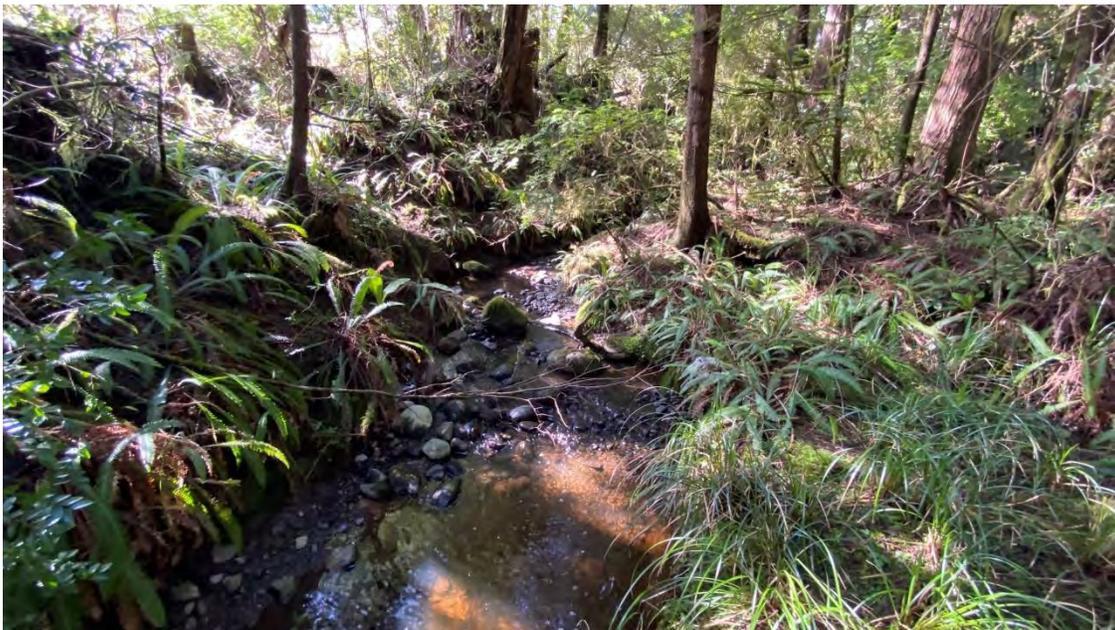
Appendix Photo 8. Upstream view of Raven Haven Creek within adjacent property to the north.

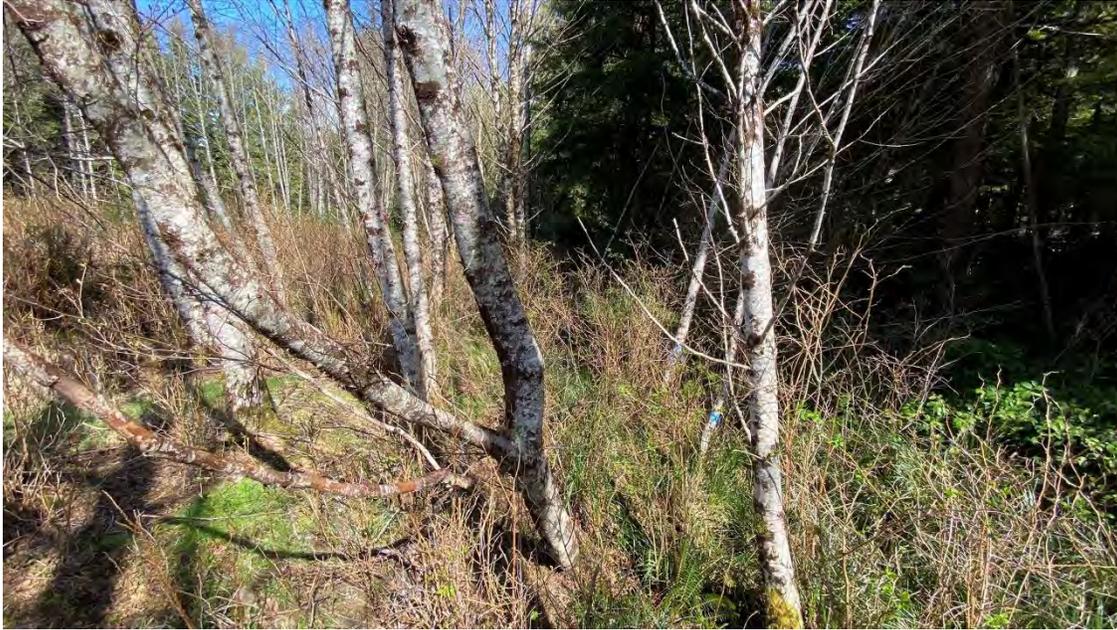
Appendix Photo 9. Downstream view of Stream 1 and alder dominated riparian area adjacent to planned development site.

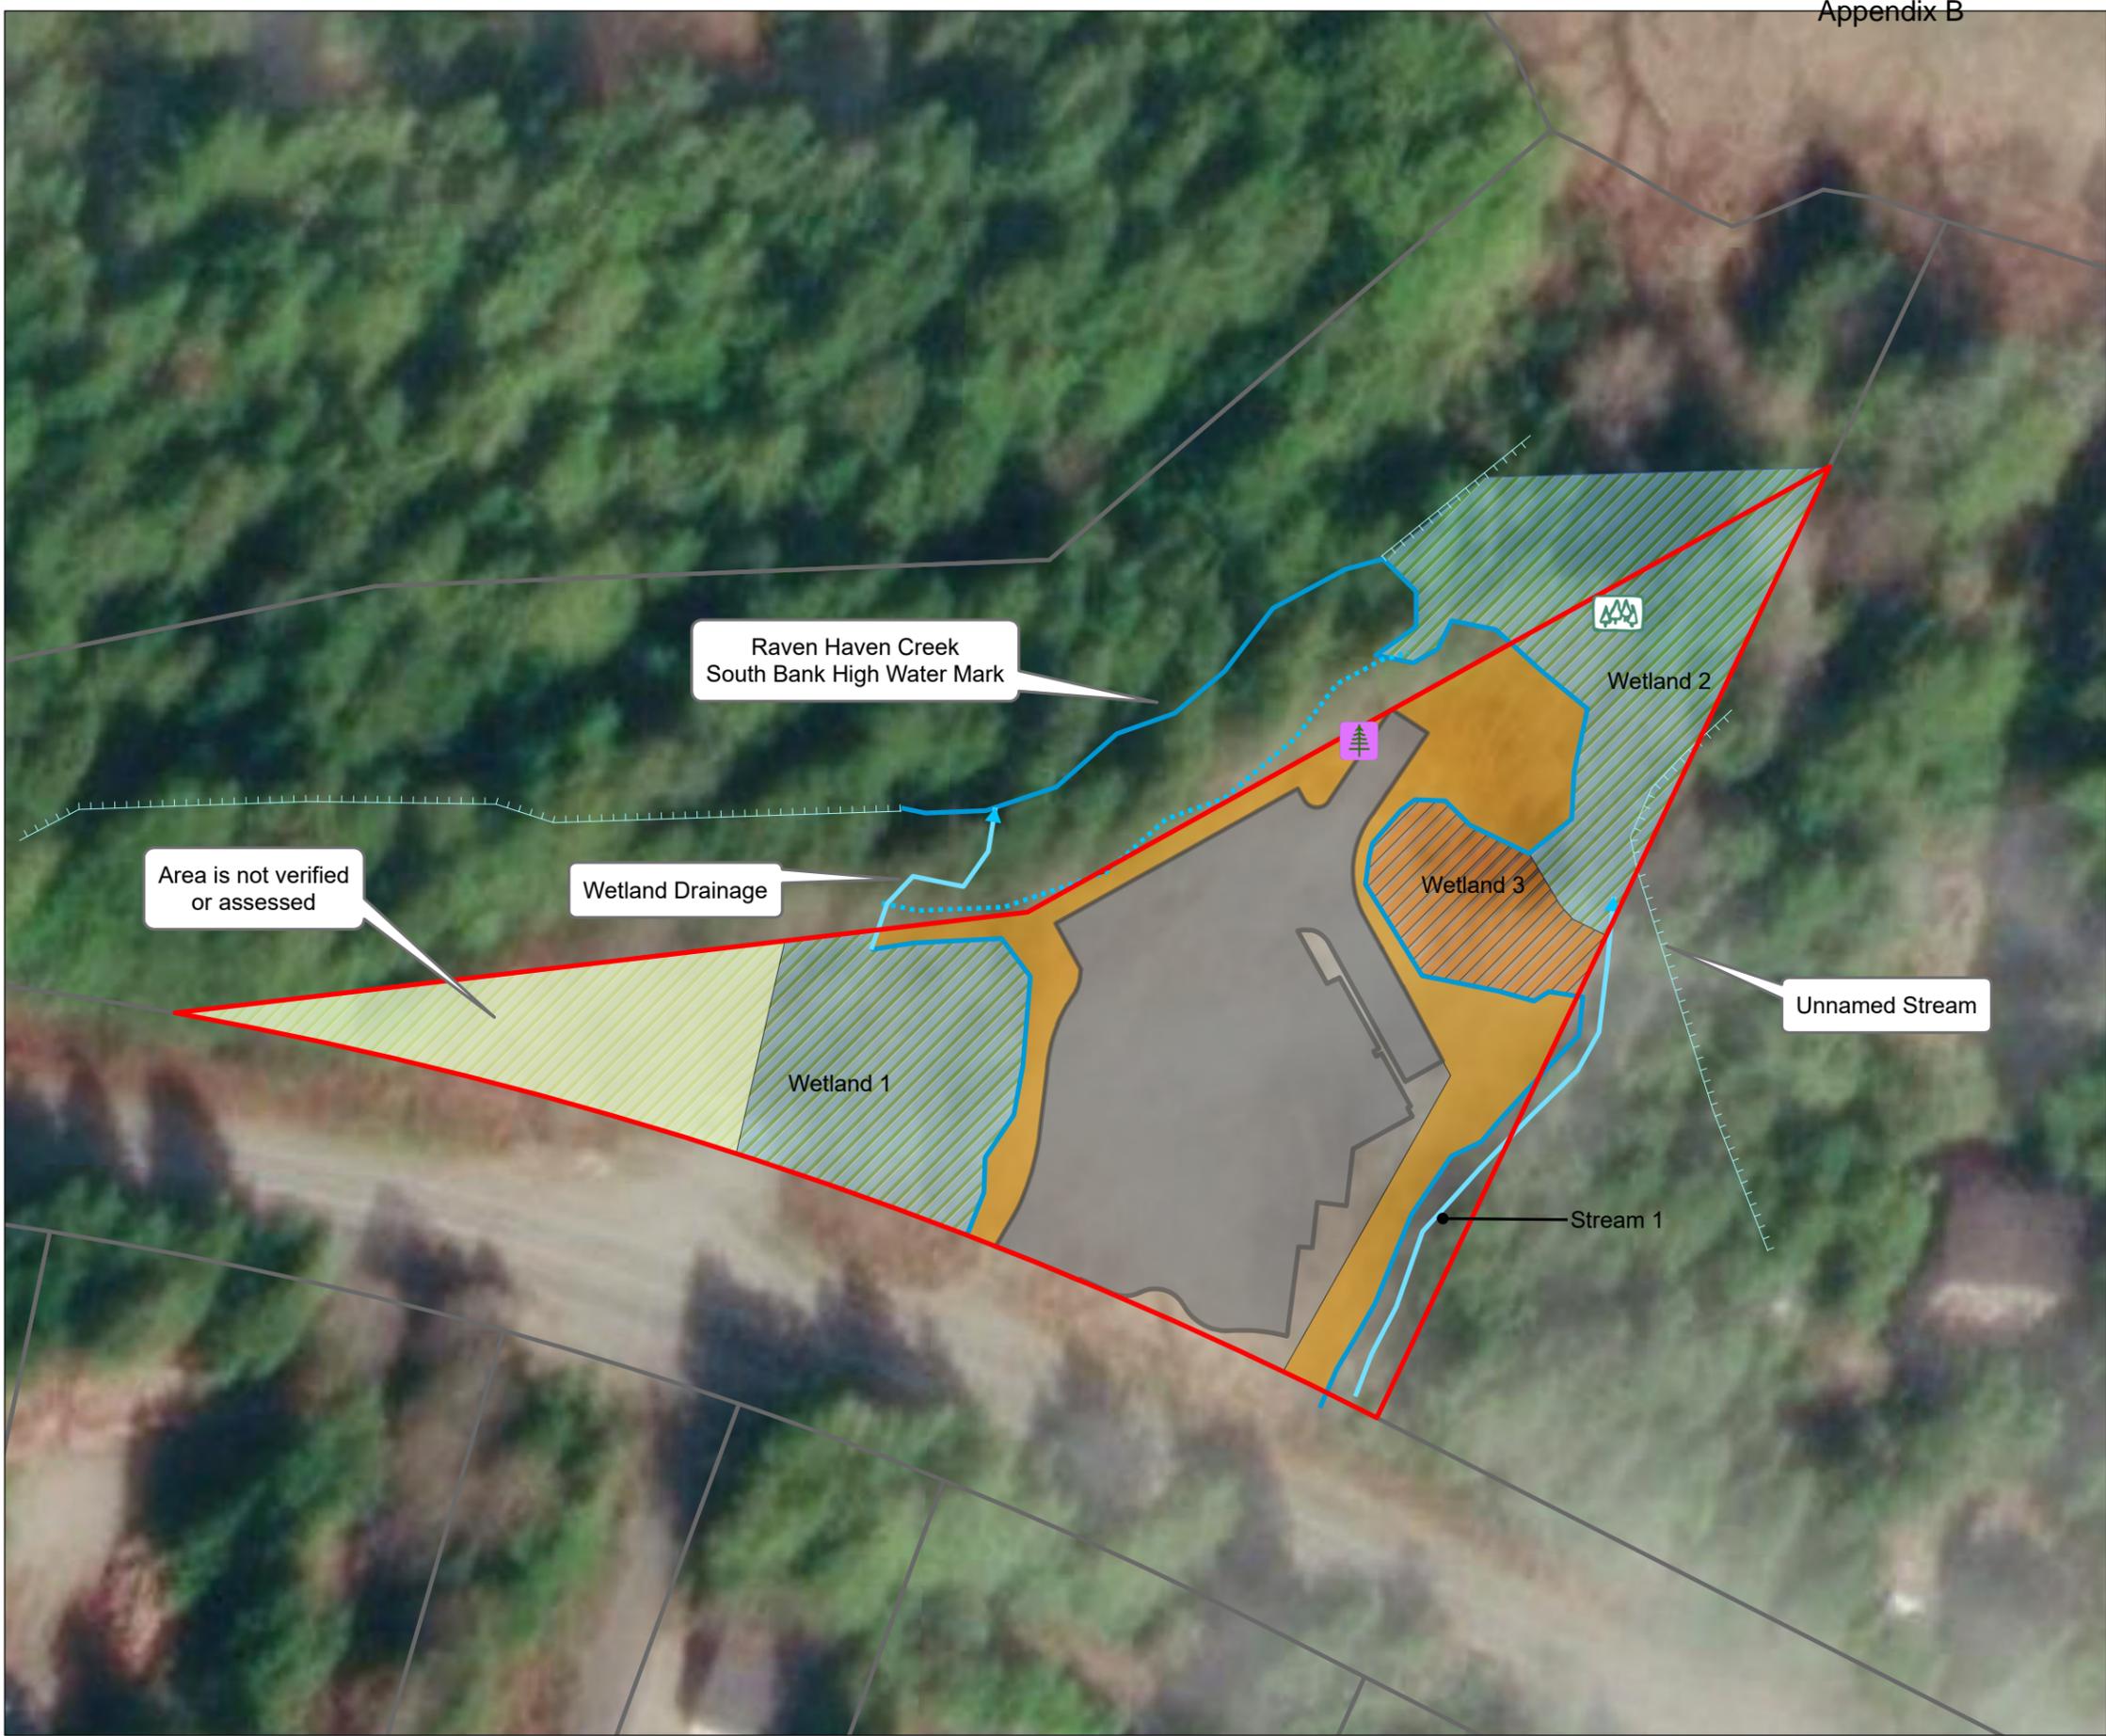
APPENDIX C FIGURE 2

Figure 2. 2091 Peninsula Road Sensitive Features and Setbacks

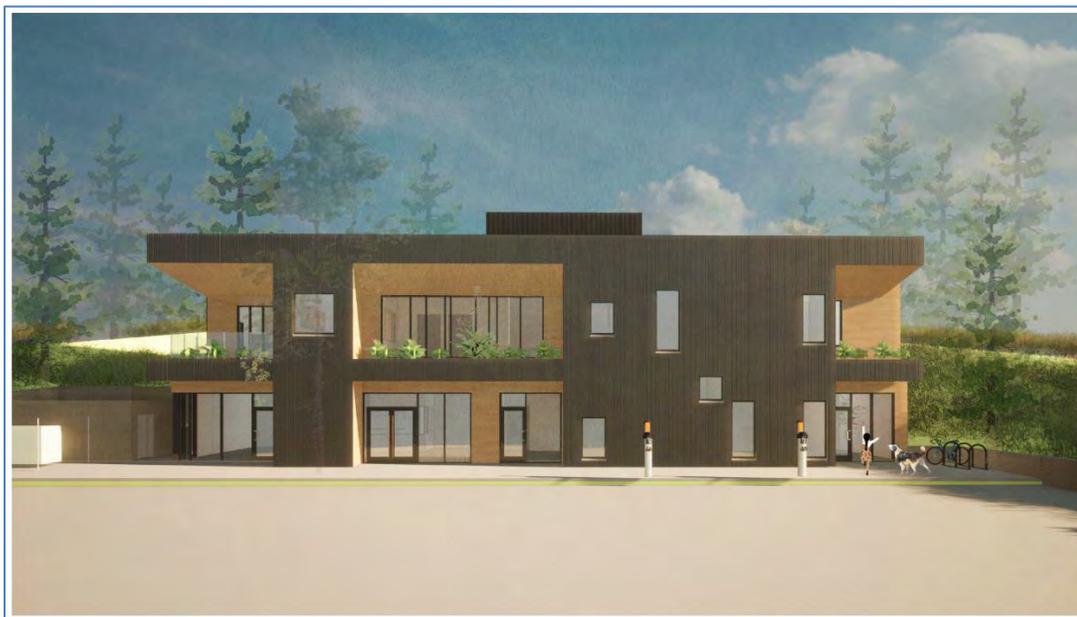
The applicant is proposing a two-storey building with a total floor area of 1,000m² (10,774ft²) specifically designed in collaboration with Island Health as a Primary Care Network Clinic containing a medical clinic, a laboratory, mental health offices, counselling offices, and other health care service space. The building is fully accessible with an elevator located in the central or common ground-floor access point.

Figure 2 – building front

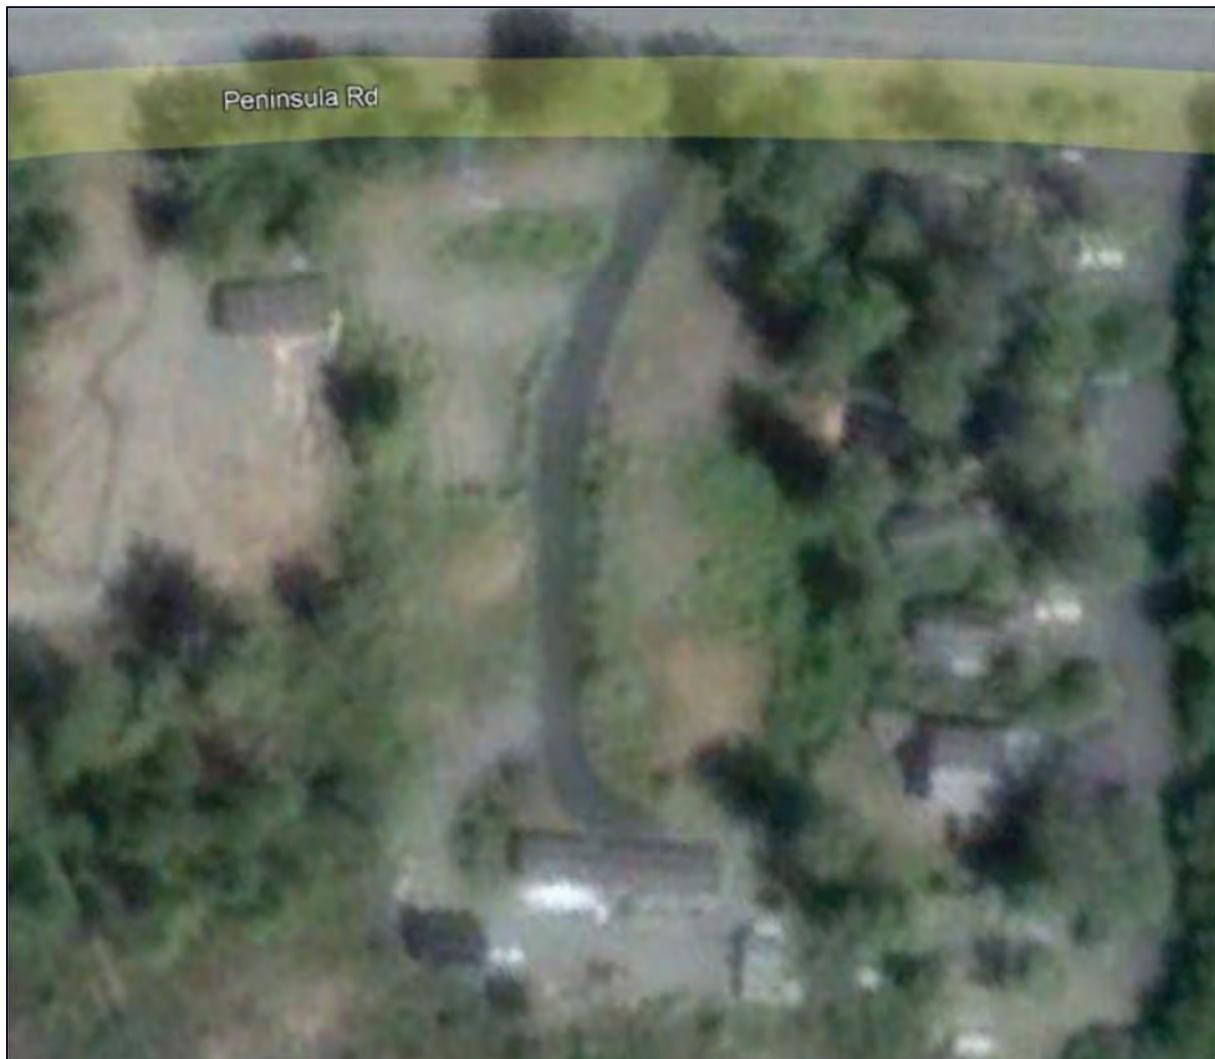
Figure 2.2 – General Site Conditions in 2005 (Satellite Imaging from Google Earth®¹)

- b. LEA noted a stacked block retaining wall on the adjacent parcel near the south property line. The wall appeared to be approximately 1.0m to 1.5m in height above the lower grade of the neighboring property. The wall retains a vegetated soil slope inclined at 2 Horizontal to 1 Vertical (2H:1V) that meets the upper grade of the subject parcel.
- c. Moderate to dense vegetation covers the majority of the Property to the east and west of the existing driveway.
- d. A review of historical satellite imagery provided by Google Earth® indicates the site was partially cleared and manipulated approximately 15-20 years ago. Figure 2.2 and 2.3 below show general site conditions in 2005 and 2010.

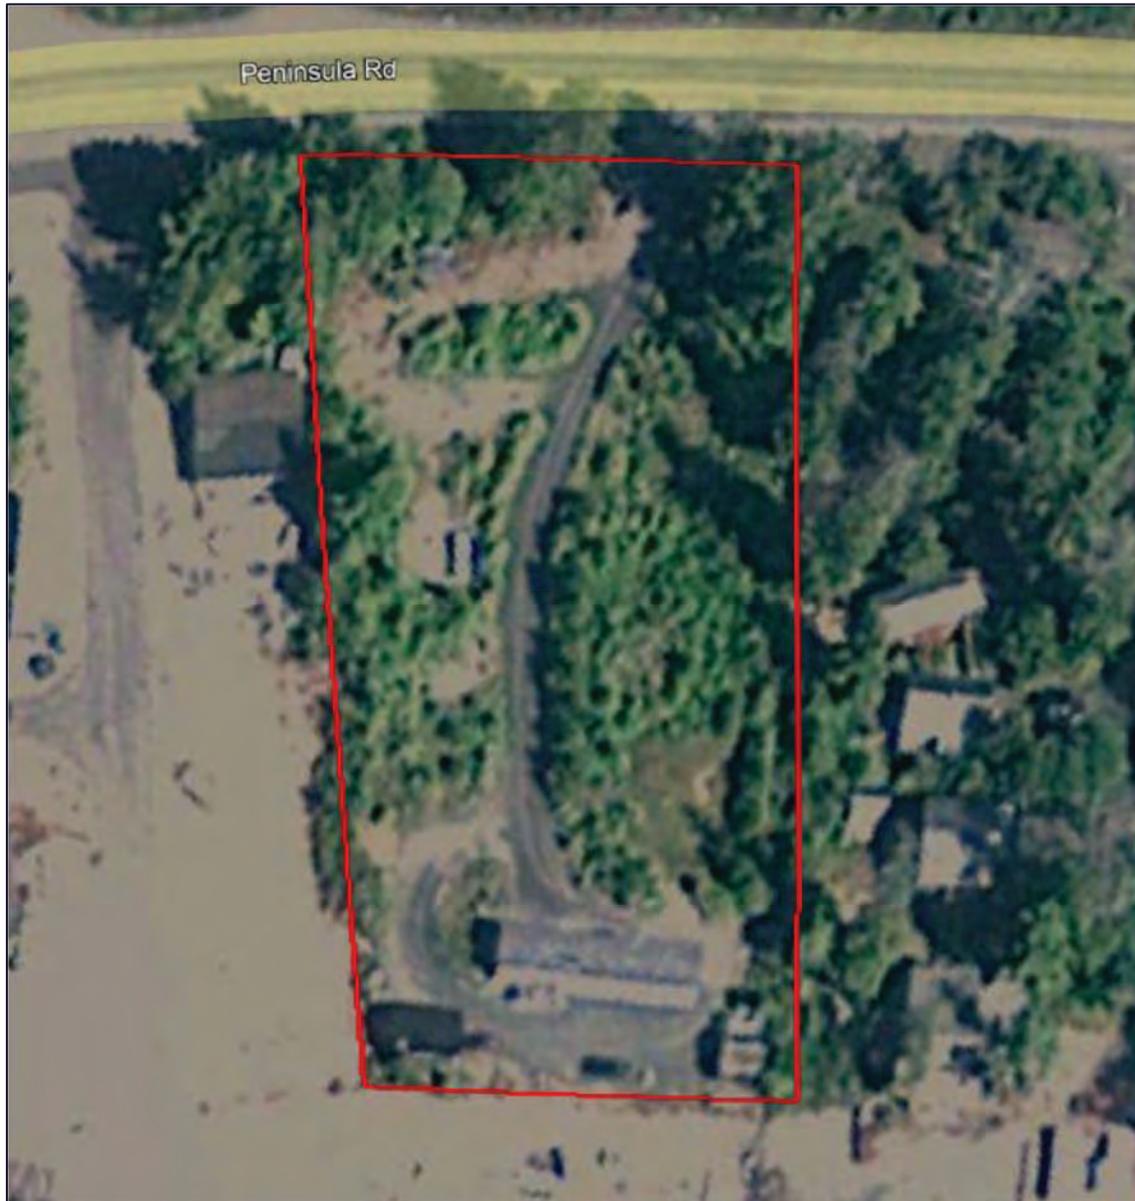
Figure 2.2 – General Site Conditions in 2010 (Satellite Imaging from Google Earth^{®1})

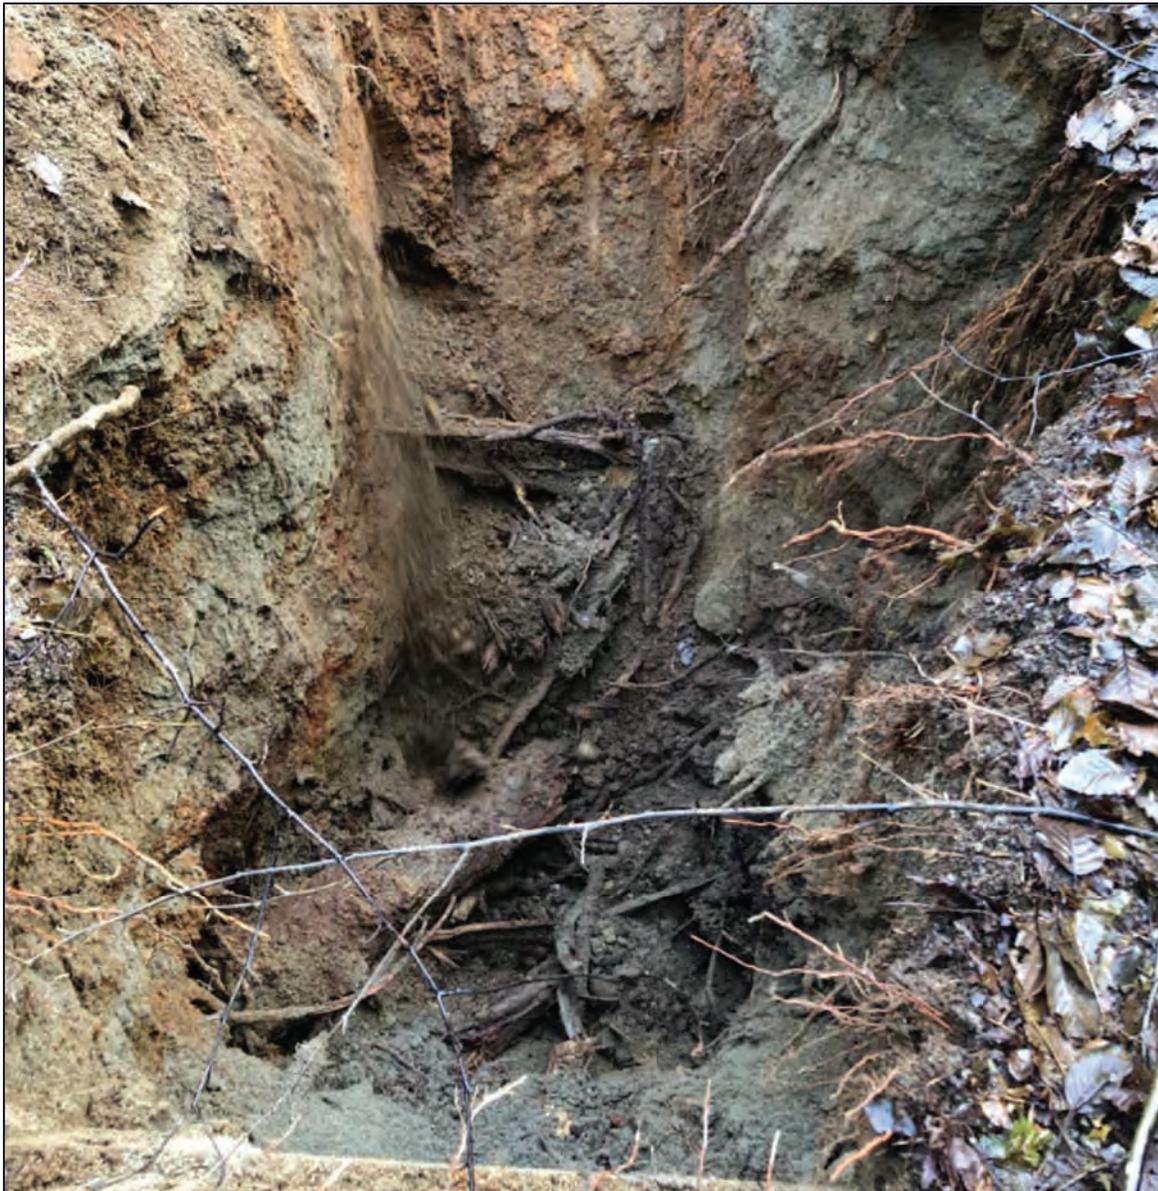
Figure 2.4.1 – Typical Subsurface Conditions (TP 21-02)

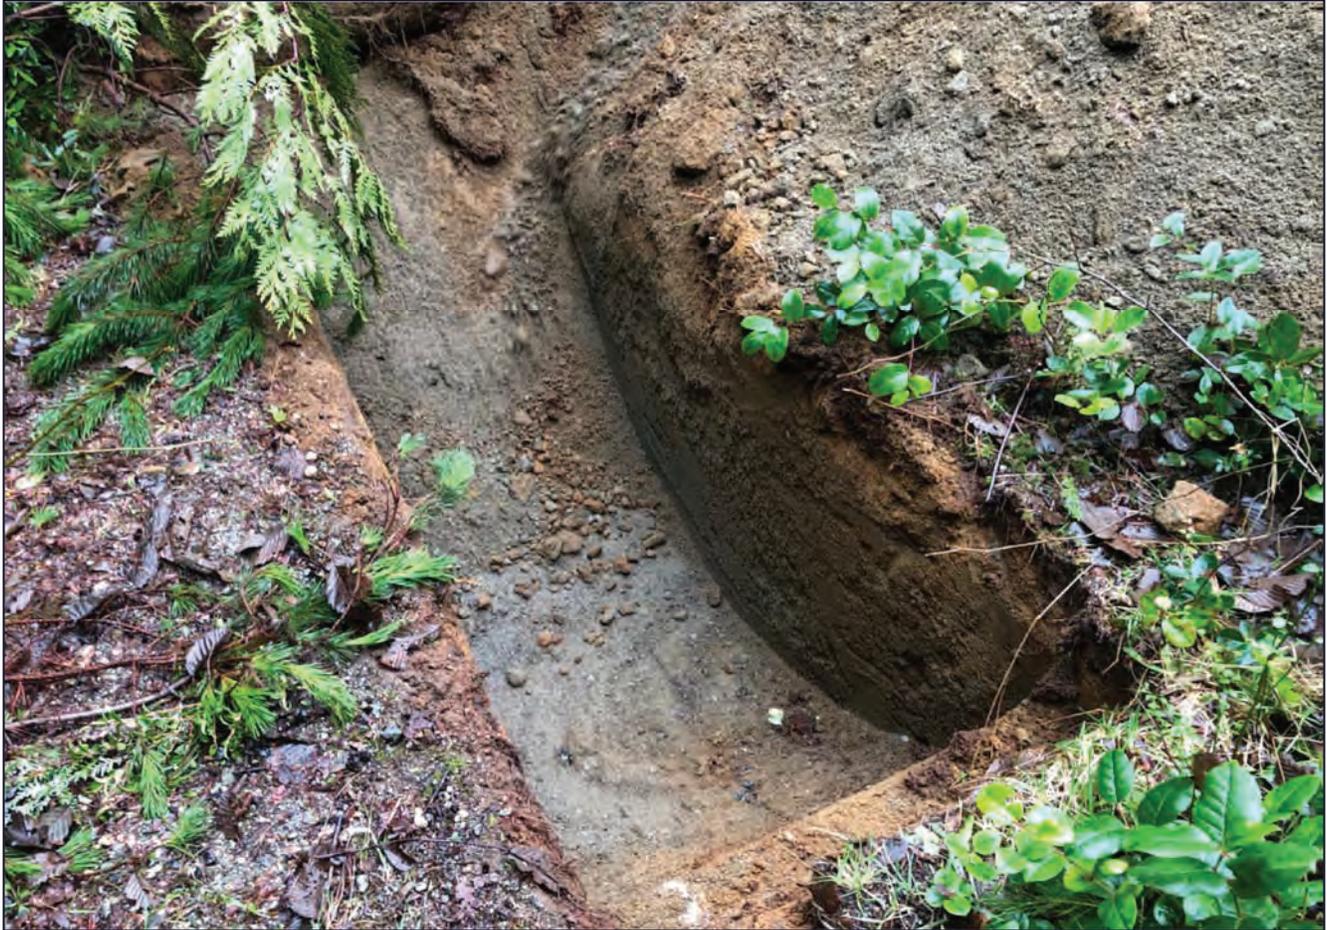
Figure 2.4.2 – Typical Subsurface Conditions (TP 21-03)

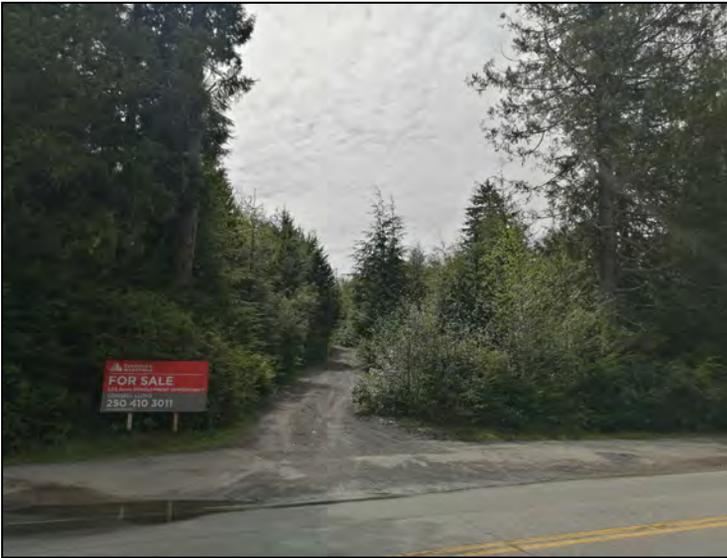
Photo 1: Looking south into the subject parcel from Peninsula Road.

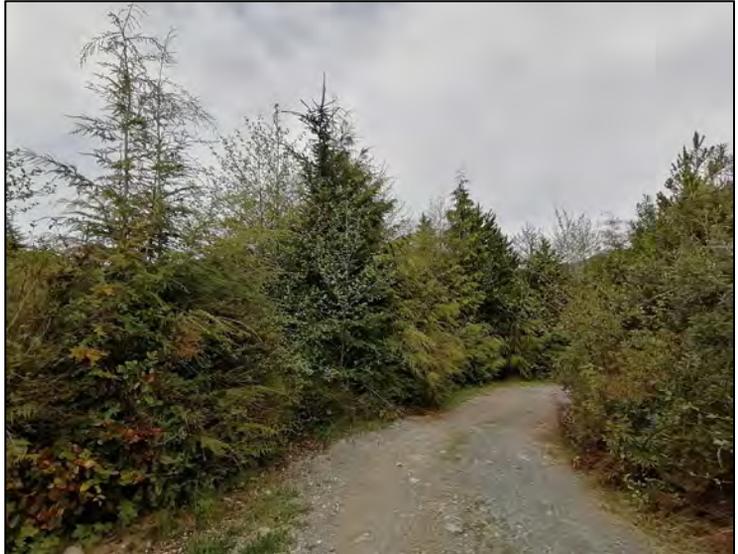
Photo 2: Looking north down gravel driveway from within property. Dominated by dense, regenerating forest cover.

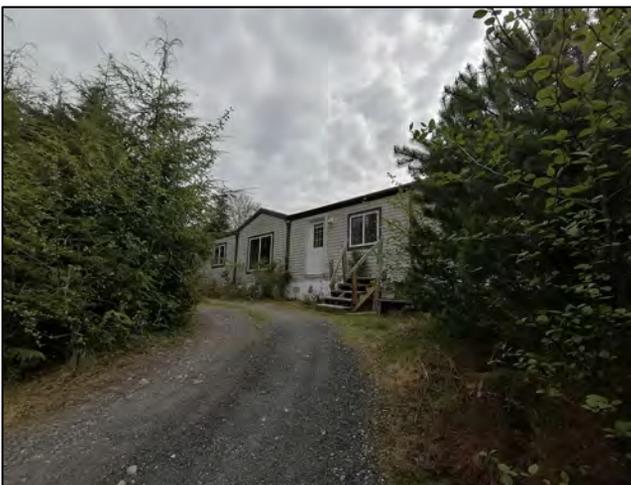
Photo 3: Existing mobile home.

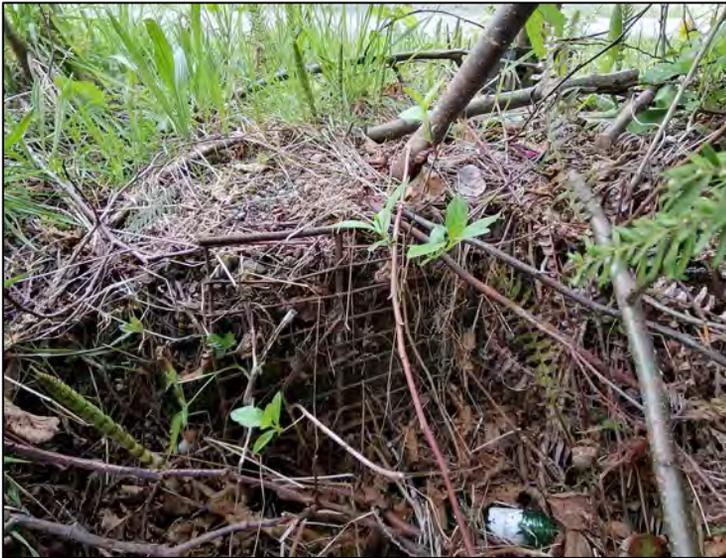
Photo 4: Small mesh-covered storm drain located in northeast corner of parcel.

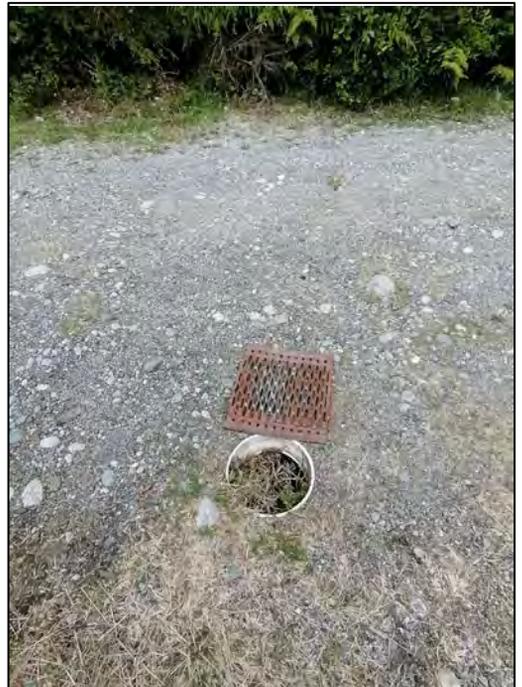
Photo 5: Small PVC pipe storm drain located centrally within parcel.

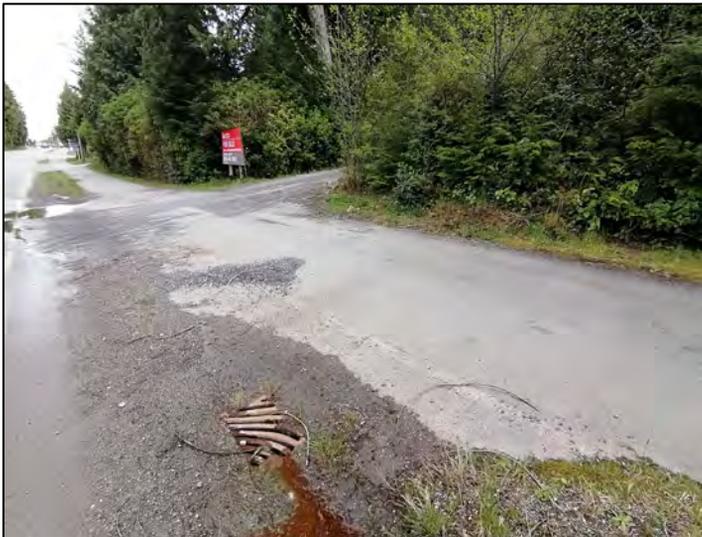
Photo 6: Municipal storm drain located northwest of parcel along roadside.

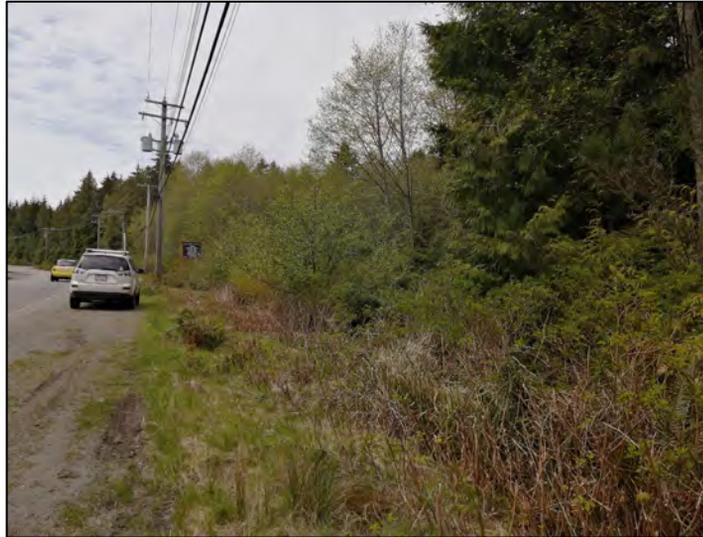
Photo 7: Storm water from road flows overland down this vegetated slope on the north side of Peninsula Road, and storm drains *appear* to discharge into this area.

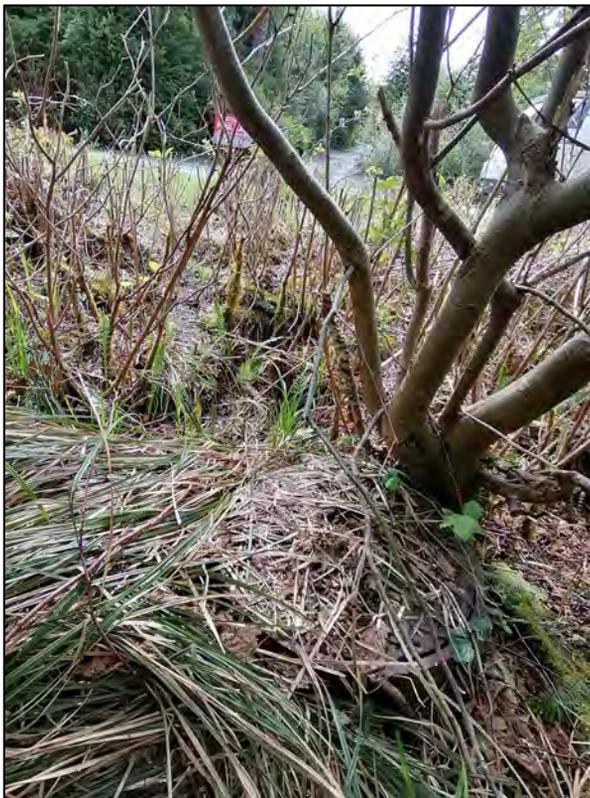
Photo 8: Storm water manhole located on north side of Peninsula Road along vegetated slope to wetland area.

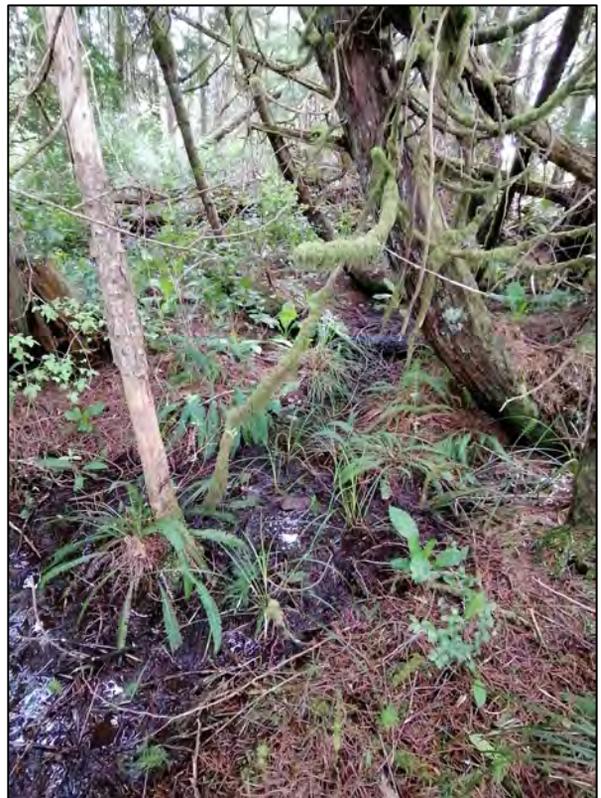
Photo 9: Storm water flows down slope into wetland area.

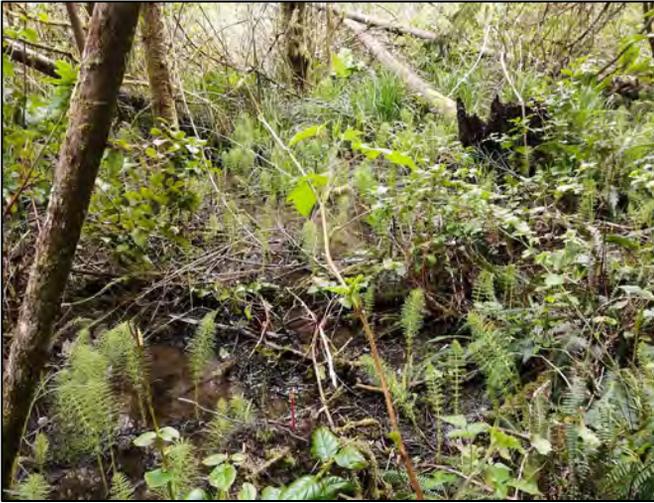
Photo 10: Wetland forms small channels downstream that flow towards saltmarsh.

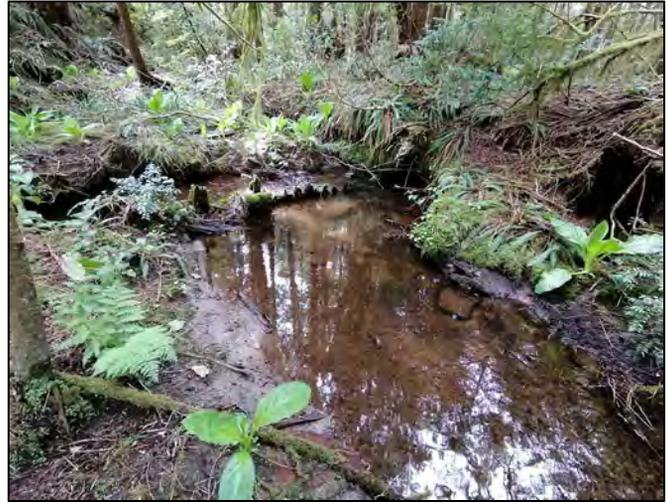
Photo 11: One larger creek observed appears to have fish habitat and would be expected to support some salmonid species.

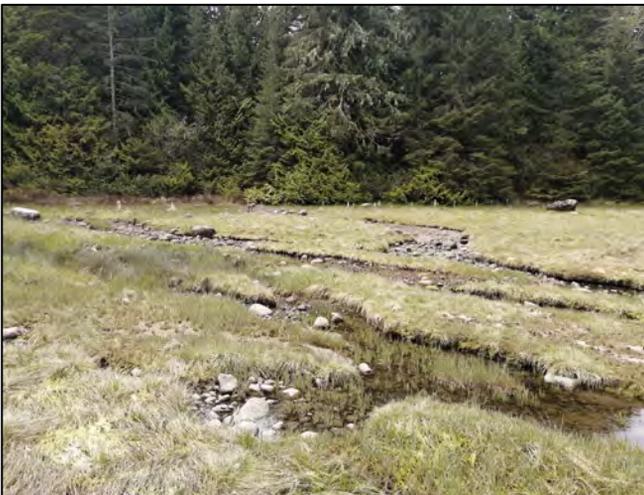
Photo 12: Showing channels flowing out of forest into saltmarsh (facing southwest).

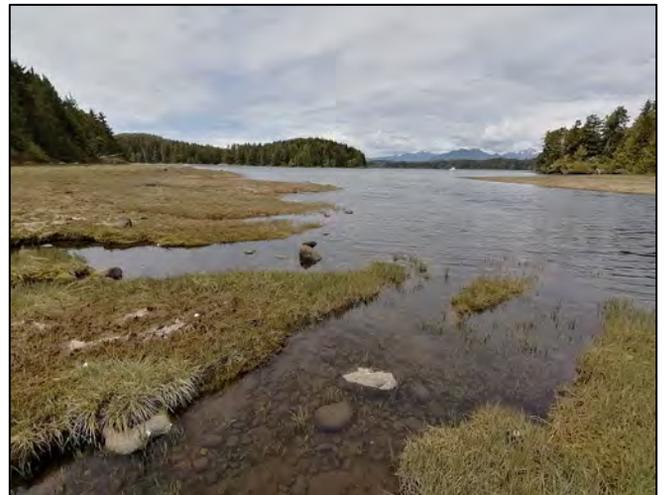
Photo 13: Saltmarsh looking north into bay.

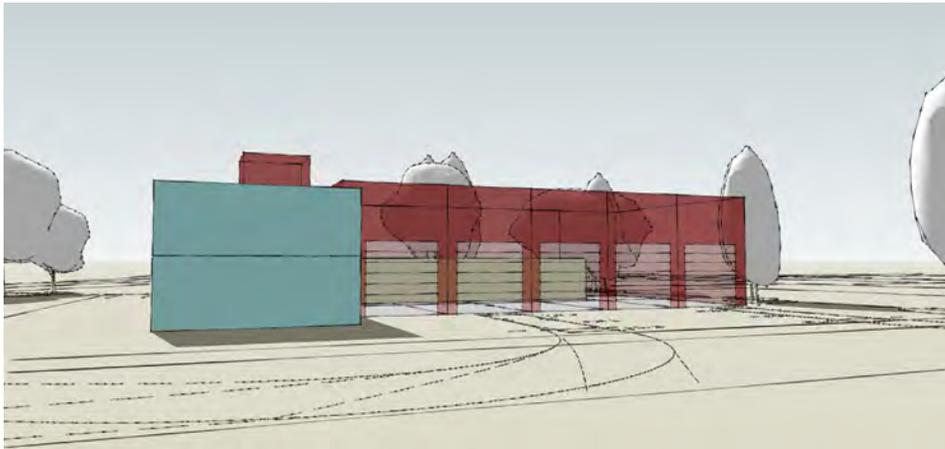
Existing lot addition & renovation conceptual massing model. Aerial view overlooking the intersection at Peninsula Rd and Matterson Dr.

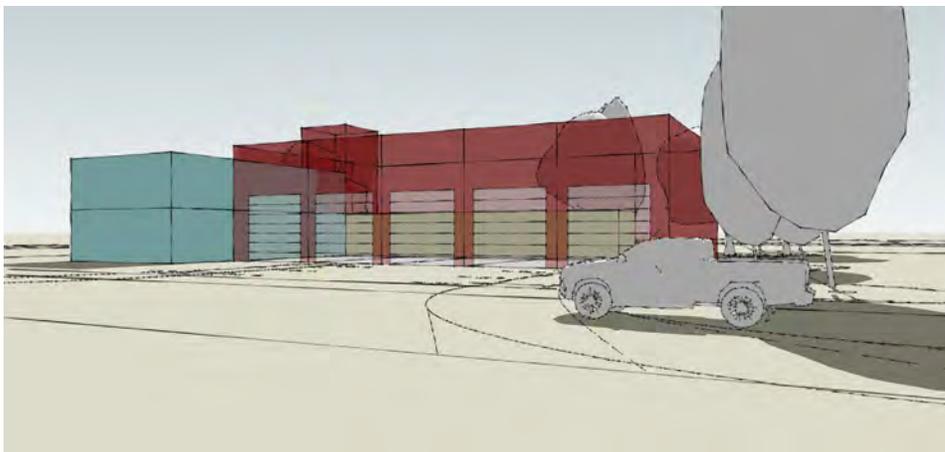
Existing lot addition & renovation conceptual massing model. Front Elevation along Peninsula Rd.

- 5 back-in apparatus bays
- 14x14 overhead doors
- Concrete apron
- 2 Storey Administration
- Hose/ training tower
- Limited overall lot space
- Reduced parking/ training area capacity
- Additional lot space recommended

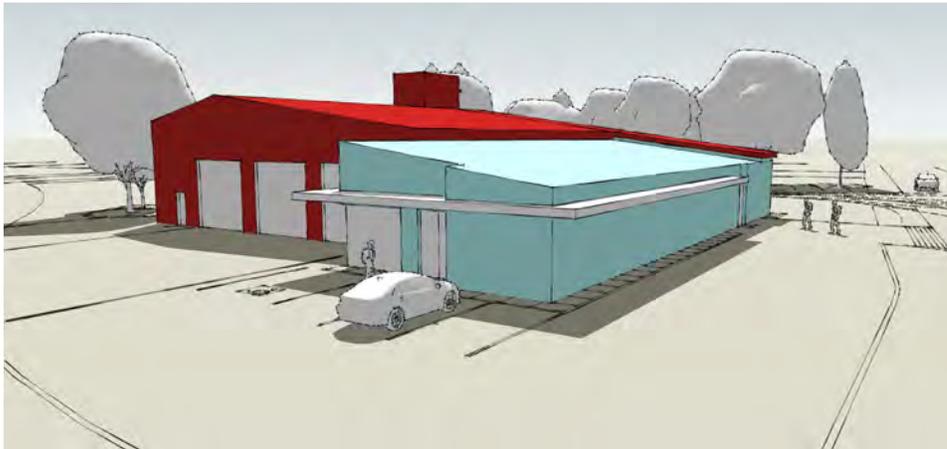
Existing + adjacent lot new construction conceptual massing model. Aerial view overlooking the intersection at Peninsula Rd and Matterson Dr.
