REGULAR MEETING OF COUNCIL
Monday, October 23, 2023 @ 4:00 PM
Ucluelet Community Centre
500 Matterson Drive, Ucluelet

| 7.3 | <p>Fire Hall Replacement

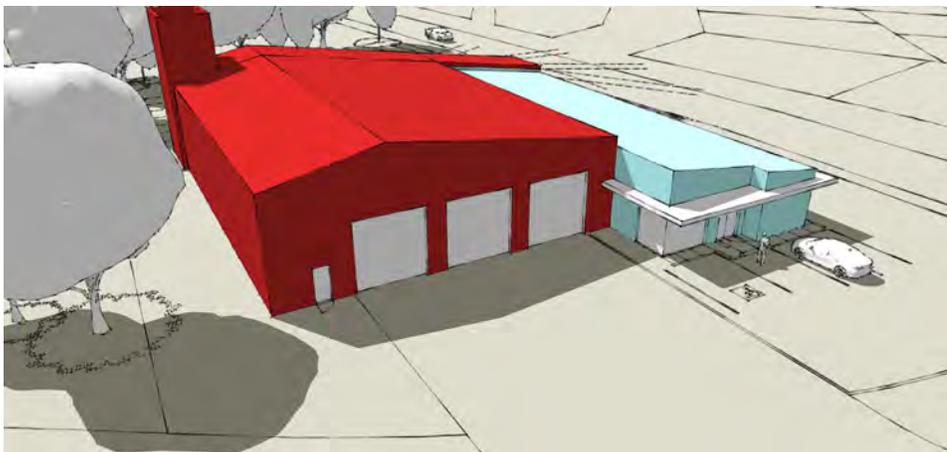
East/ South Elevations.

Front Entrance (driveway access/ egress along Peninsula Rd.)

- 6 apparatus bays (3 double drive-through style bays)
- 14x14 overhead doors
- Concrete apron
- Single Storey Administration
- Hose/ training tower
- Increased overall lot space
- Added gravel parking/ training area capacity

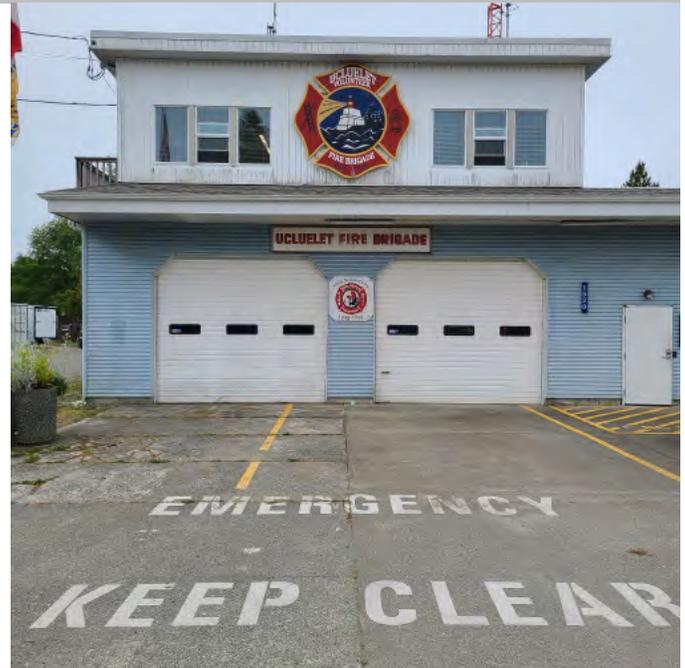
Ucluelet Fire Hall front elevation view from Peninsula Rd. Main Fire Hall concrete apron marked for emergency use only. Concrete apron shows significant signs of wear and degradation. Ucluelet Fire Brigade branding is being updated. Street frontage shows building past life cycle.

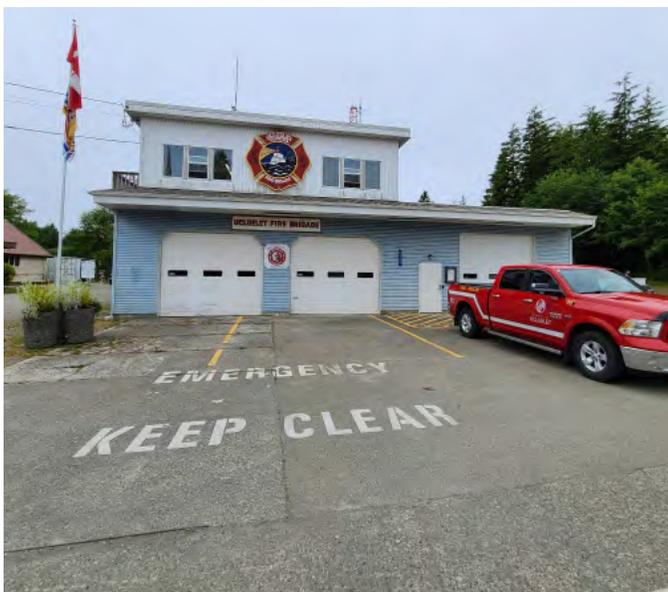
Street view showing main and second floor. Existing apron is very short in length.

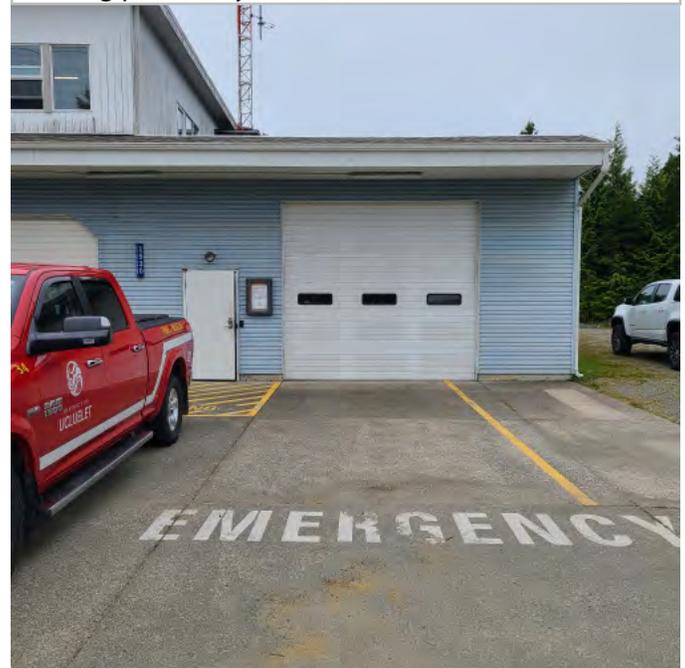
Added apparatus bay. Overhead doors are smaller than industry standard. Needs 12'Wx14'H min. size.

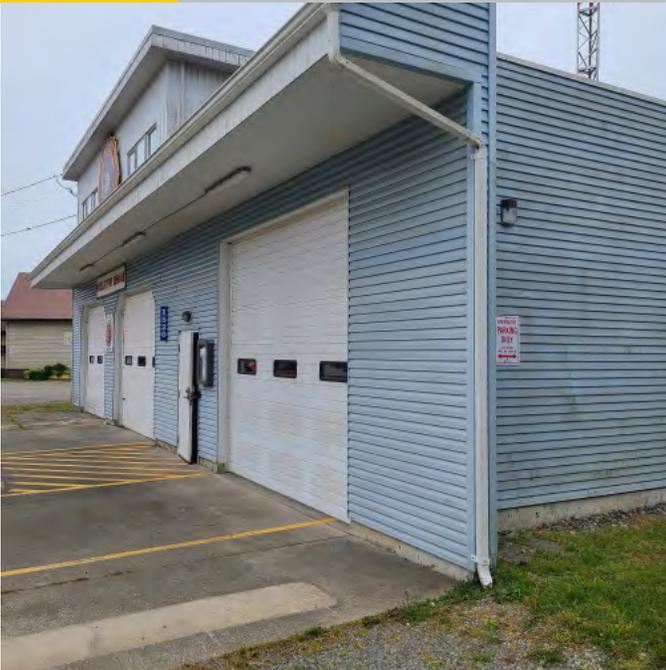
Photo above shows front soffit area/ canopy overhang with surface mounted linear lighting. General lighting appears to be inadequate for an emergency facility. Downspouts appear to be undersized residential style. OH doors show signs of wear and weathering.

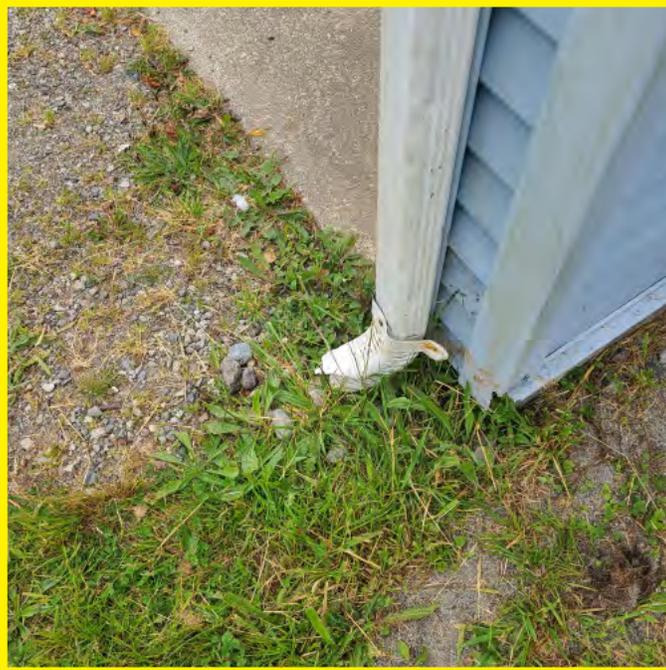
Photo above shows downspouts draining to surface. No splash pads are observed to prevent ground erosion. Ground shows significant organic growth around building in 'non-landscape' areas.

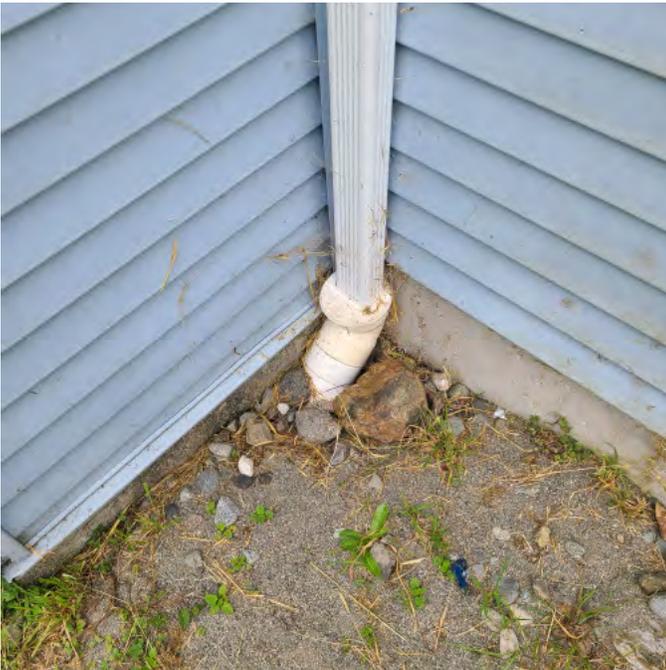
Photo above shows that a perimeter storm water management system is present. The connection appears to be shallow depth. Ground appears unstable due to erosion and organic growth.

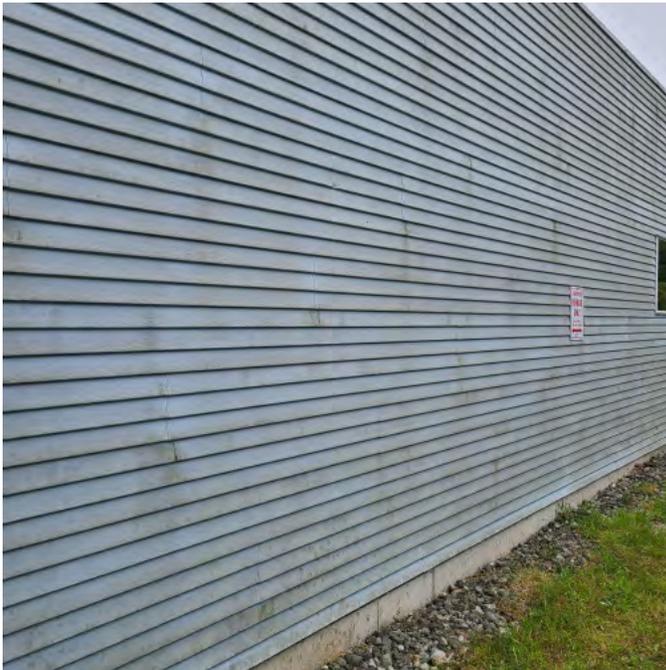
Photo above shows vinyl exterior wall cladding. It is obvious that the vinyl cladding has exceeded its product life cycle and needs to be replaced. Immediate maintenance is required. Significant signs of weathering.

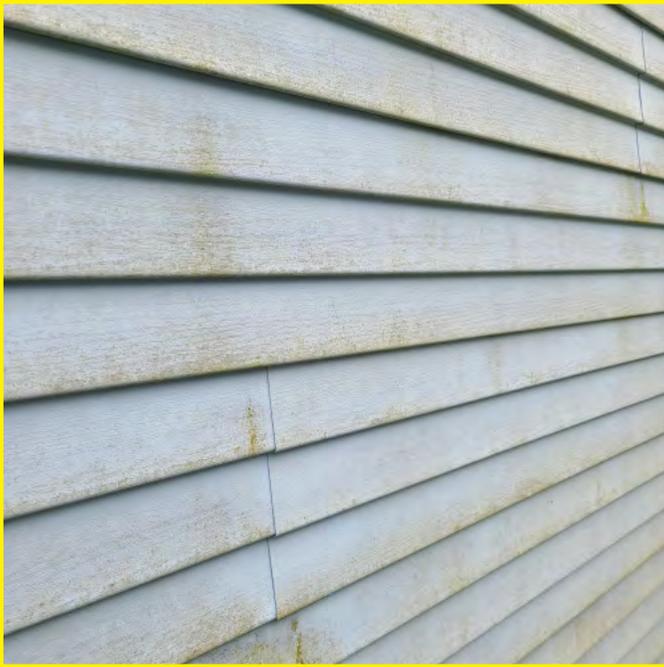
Photo above shows a close up of the exterior vinyl cladding. This material should not be used on a building of this type. Significant signs of weathering are further shown. Exterior cladding should be replaced with a non-combustible material.

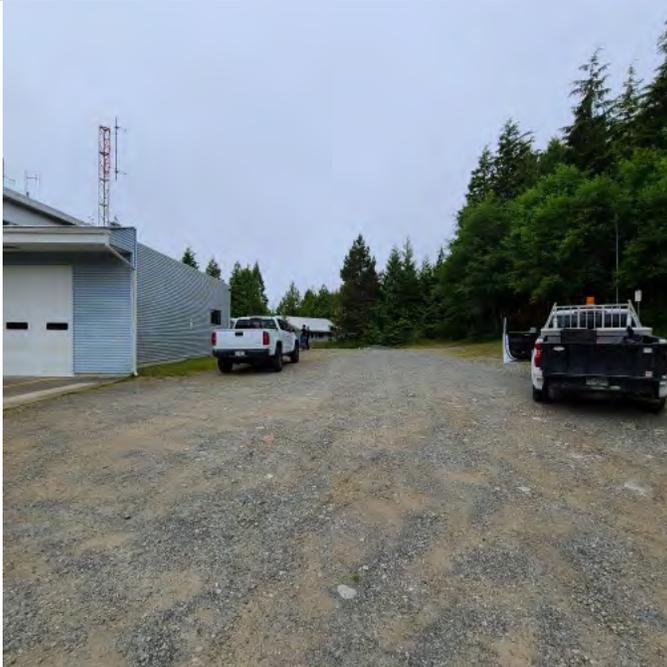
Photo above shows secondary informal gravel apron access to the Fire Hall property from Peninsula Rd. This area of the property is used for parking and training purposes. This area is too small for required uses. Too small for proper truck turning, training, and parking.

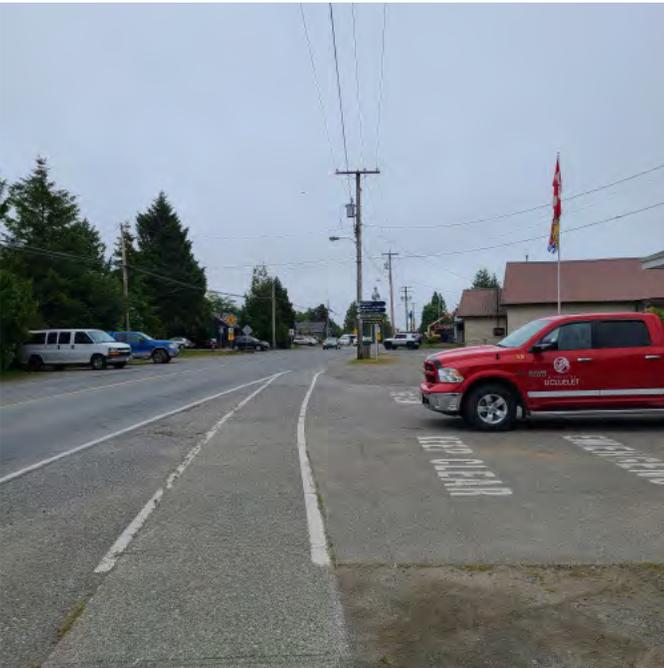
Photo above shows site frontage along Peninsula Rd. (South) There are no flashing lights to control traffic when entering or exiting the Fire Hall. Walking and traffic lanes are shown above with no proper apron delineation. Site grading changes are also required.

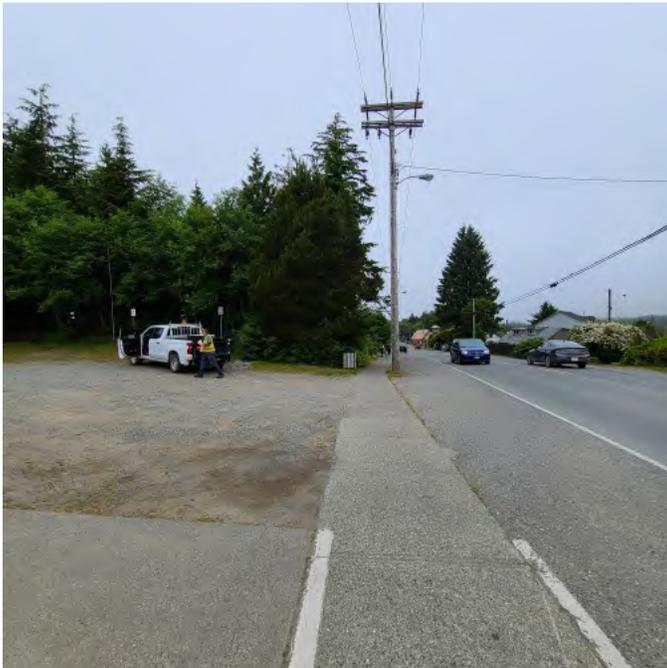
Photo above shows site frontage along Peninsula Rd. (North). Gravel yard area spills debris onto roadway. Trucks block traffic when entering and exiting site. No apron delineation is present. Tree line shown in photo approximately marks lot line.

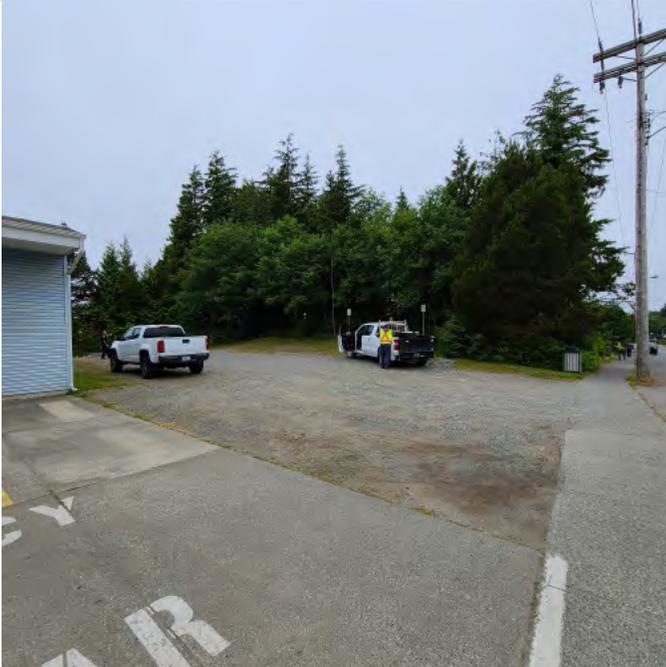
Photo above shows a patchwork apron that needs replacing. Background of photo shows no dedicated parking areas or access and parking for public. Removal of trees and the addition of a retaining wall may be required at property line for Fire Hall upgrades.

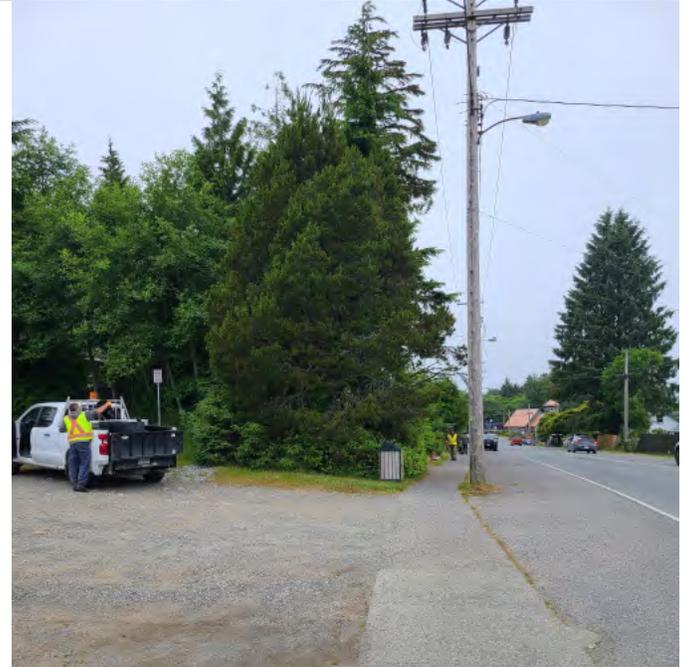
Photo above shows hydro lines along Peninsula Rd. District workers also using Fire Hall lot for temporary purposes.

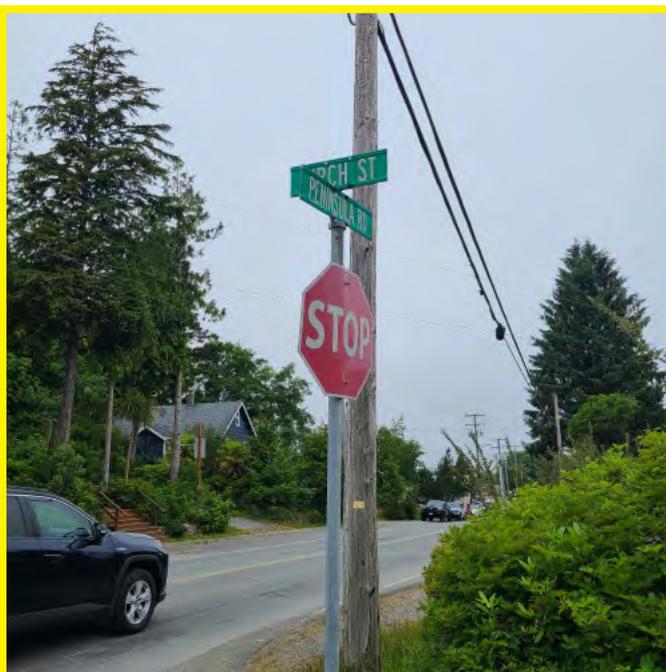
Photo above shows Peninsula Rd./ Birch St. intersection controlled only by a 'stop' sign. Fire Hall access and egress should be controlled by flashing traffic lights for traffic safety due to lane blockages (quick departures/ slow returns backing in off road)

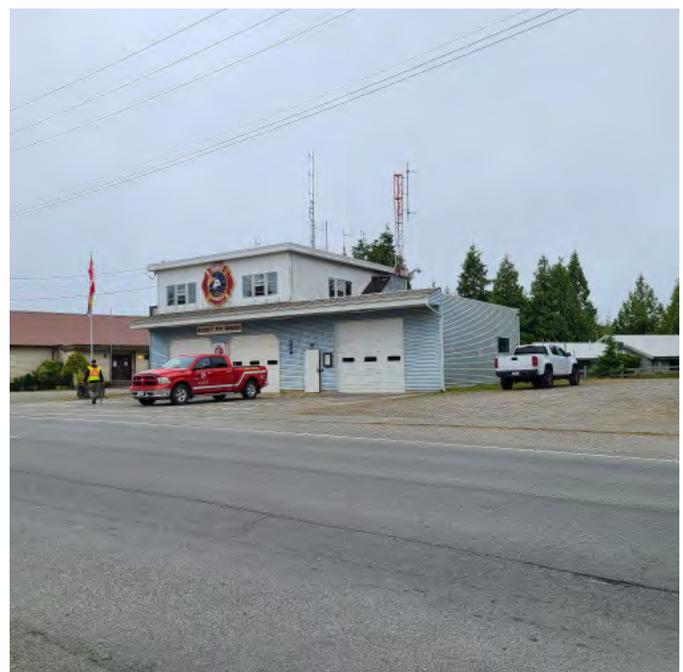
Photo above shows general view of Fire Hall from neighbouring properties across Peninsula Rd. The building is overall outdated and not aesthetically pleasing on the exterior.

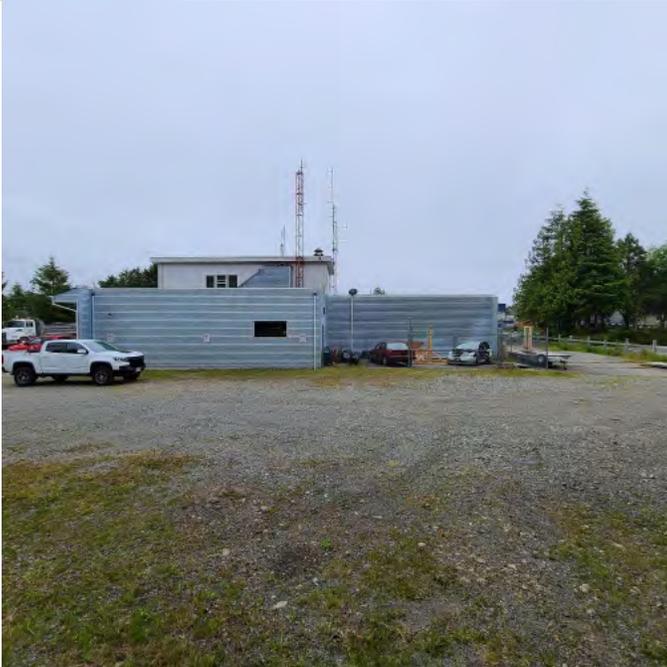
Photo above shows the Fire Hall side (North) elevation and training storage area. The general site conditions are degrading and require upgrade and maintenance.

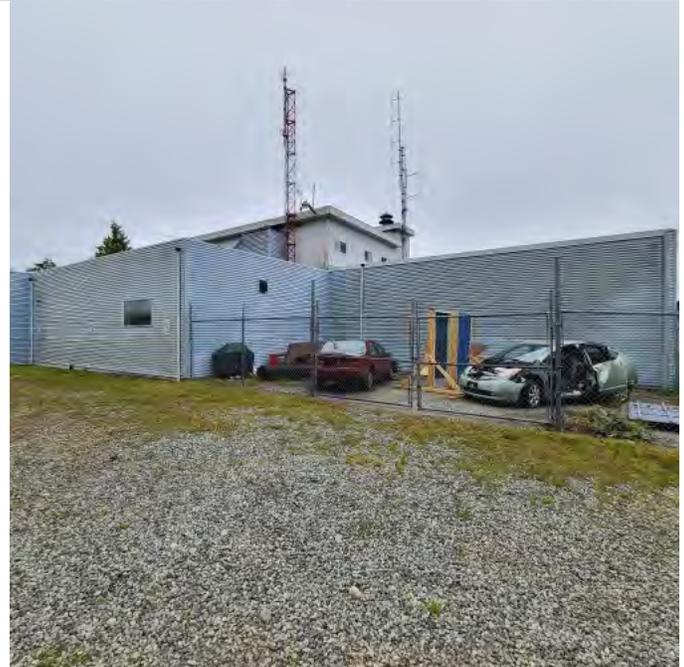
Photo above shows exterior training storage area for vehicles and other equipment or practice materials. Storage space is limited and has low level security. Exterior lighting is limited and not sufficient for night training activities.

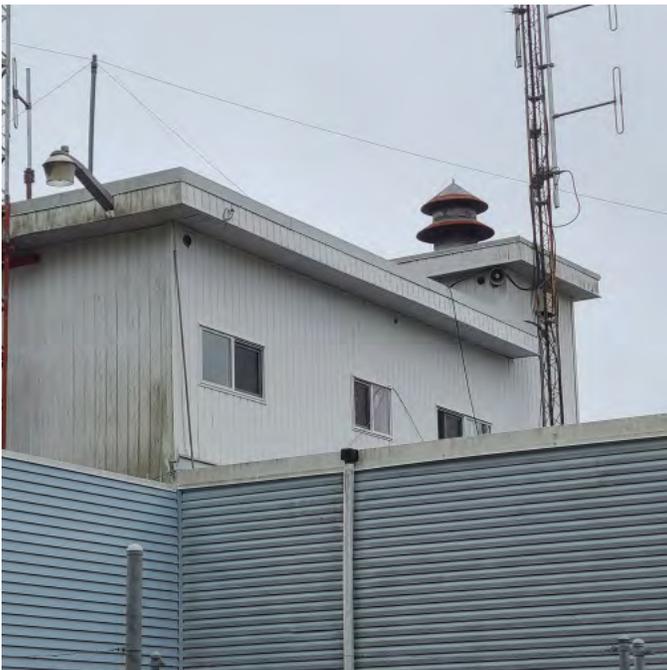
Photo above shows rear of second storage. It is obvious that the building envelope has failed. Roof scuppers require replacement. Exterior mounted equipment needs relocation and proper mounting.

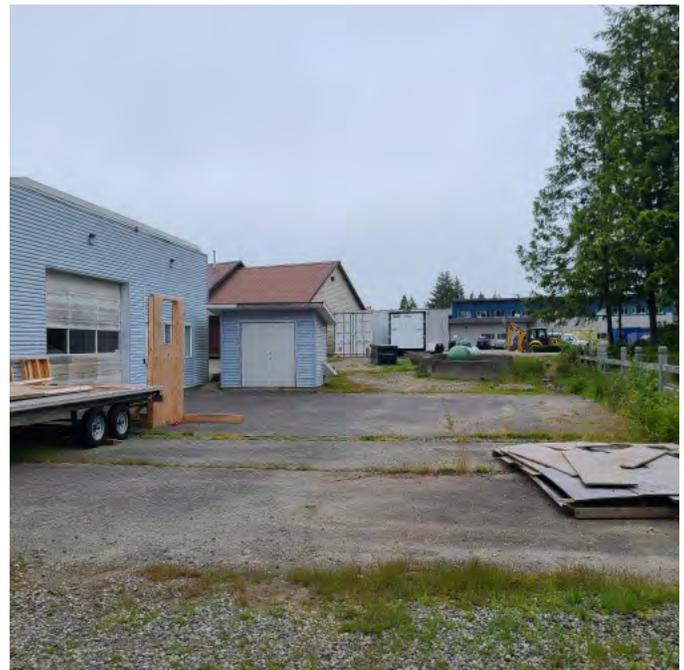
Photo above shows rear yard area. Storage and movement space is limited for trailer storage or other goods. The rear concrete apron has failed. It is assumed that the ground requires structural upgrades to support heavier equipment and training.

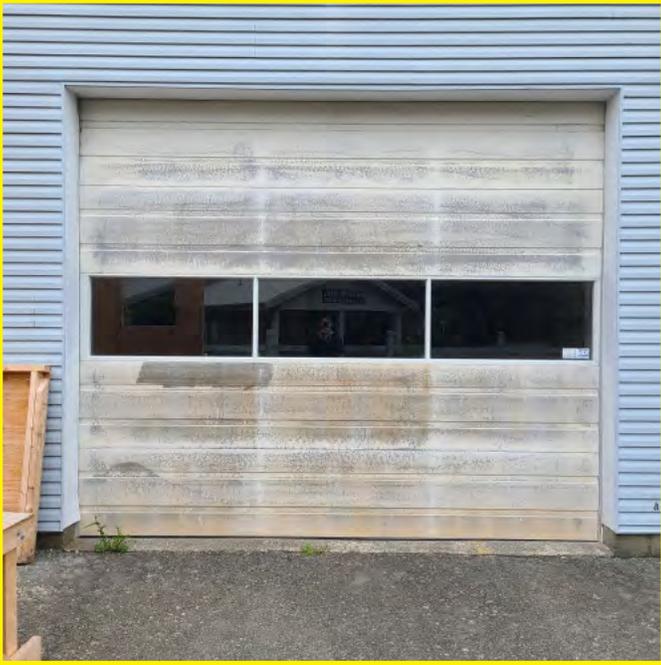
Photo above shows rear overhead door has surpassed its product life cycle. This overhead door may be an acceptable size if used only for access and egress of small equipment.

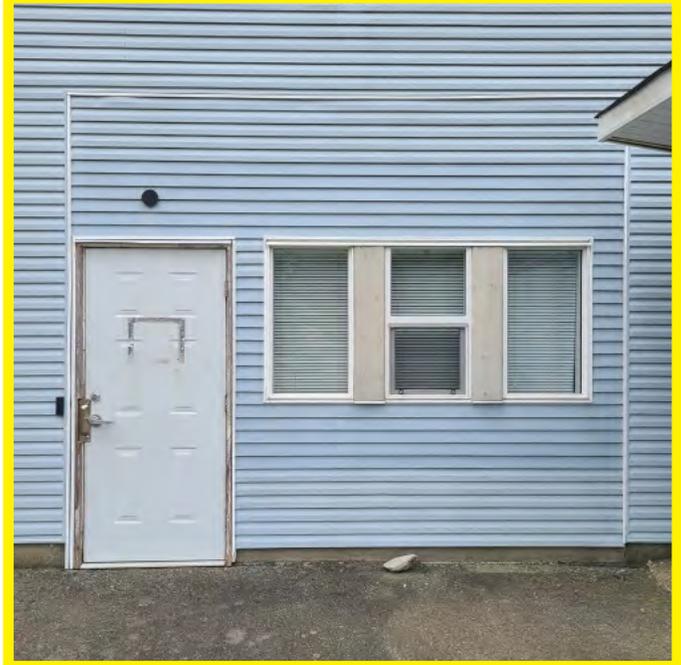
Photo above shows patchwork to building envelope and inadequate window and door details. It is assumed that the building envelope has completely failed and no longer keeps out water from the wall assembly. Windows are old and past product life cycle.

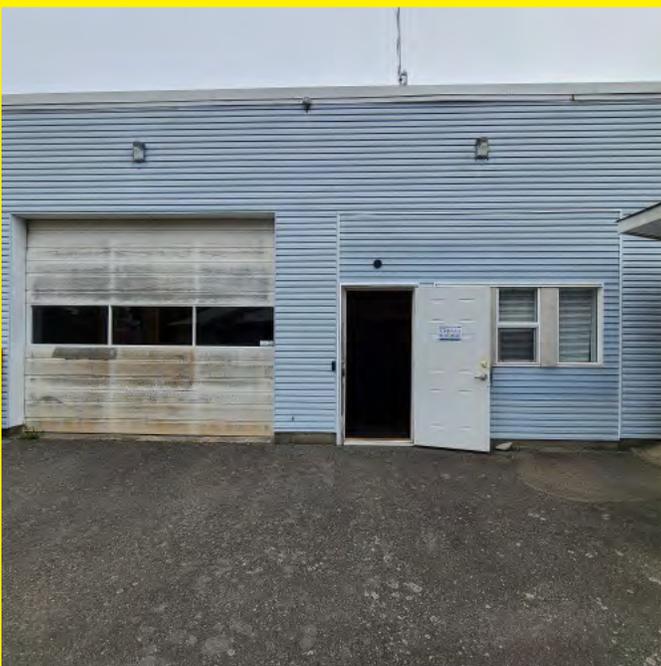
The photo above shows the overall facade deterioration and inadequate site lighting. Lighting should be upgraded to LED for energy efficiency. Windows and doors should be replaced for improved energy efficiency. No door panic hardware for exiting.

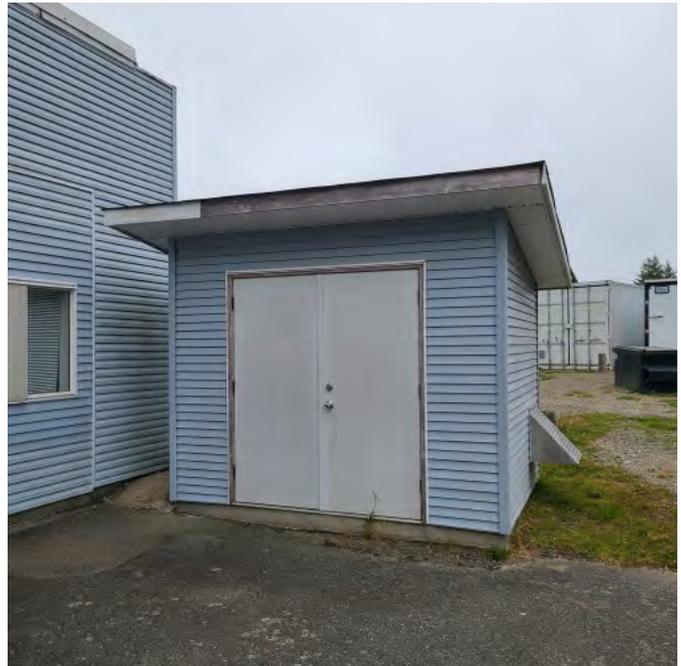
The photo above shows an added exterior shed. The shed is showing similar signs of wear and degradation. An upgraded Fire Hall would cover this footprint area.

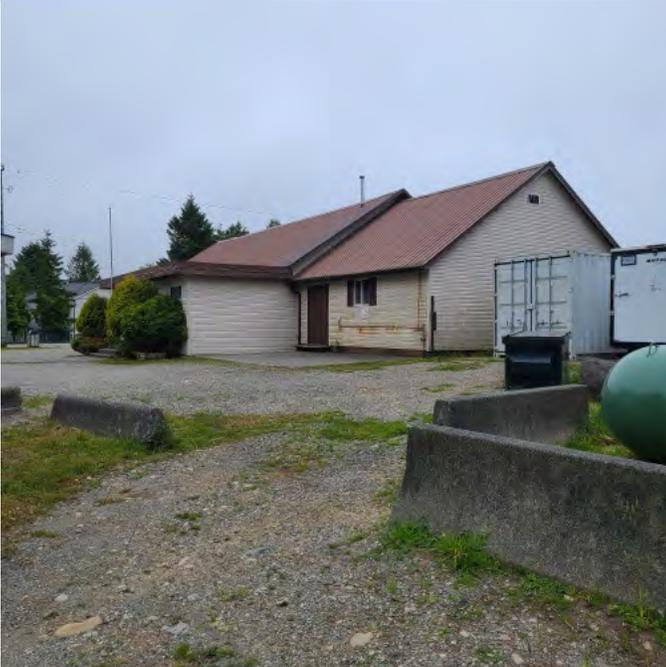
The photo above shows the adjacent Ucluelet Athletic Club (UAC). The UAC is also beyond its building life cycle and needs complete replacement. It is understood that this lot would serve as an excellent space for Fire Hall expansion.

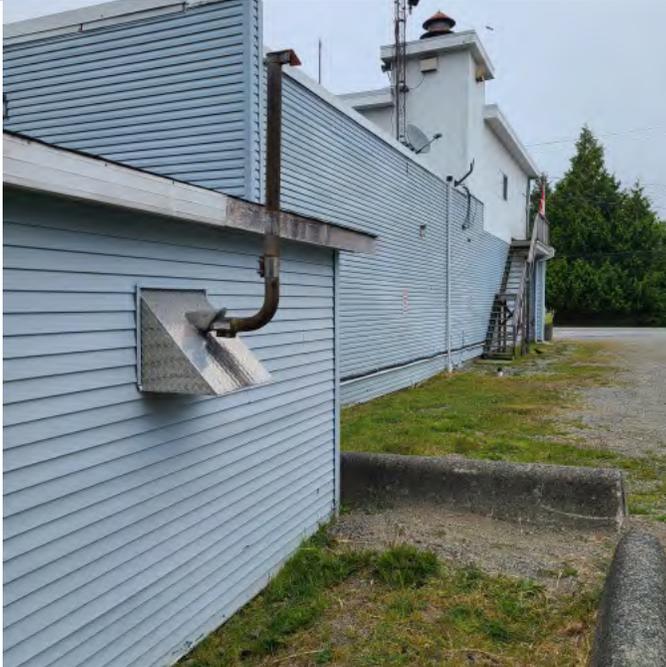
The photo above shows significant organic growth along the building facades. The buildings show outdated architectural and building envelope details. Fascias and flashings are deteriorating.

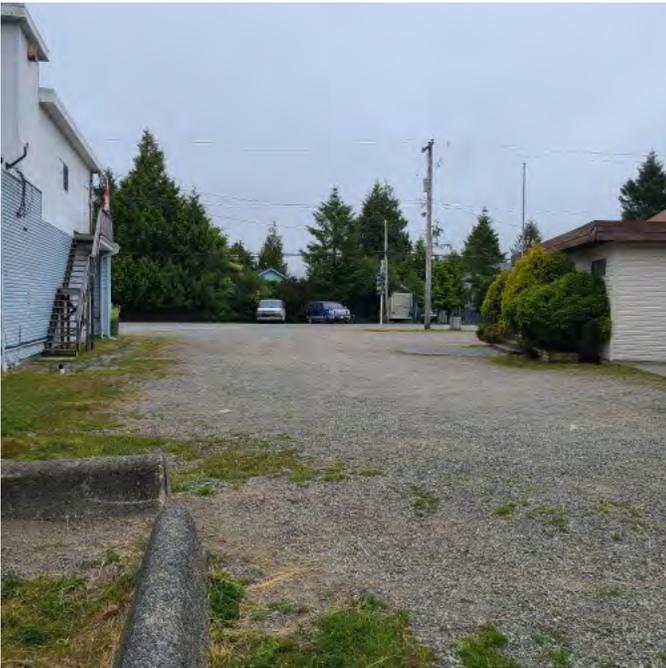
The photo above shows the property line location between the Fire Hall and UAC properties. No property line delineation is present. These lots should have security fencing between the two uses.

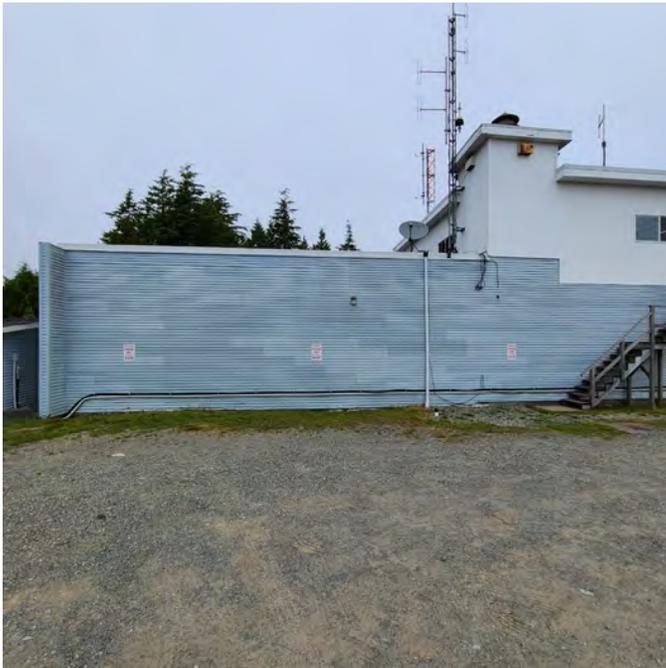
The photo above shows an exterior view of the lower level administrative building components. No parking is available along this facade. The flat roof drains through scuppers and downspouts as shown in the photo above.

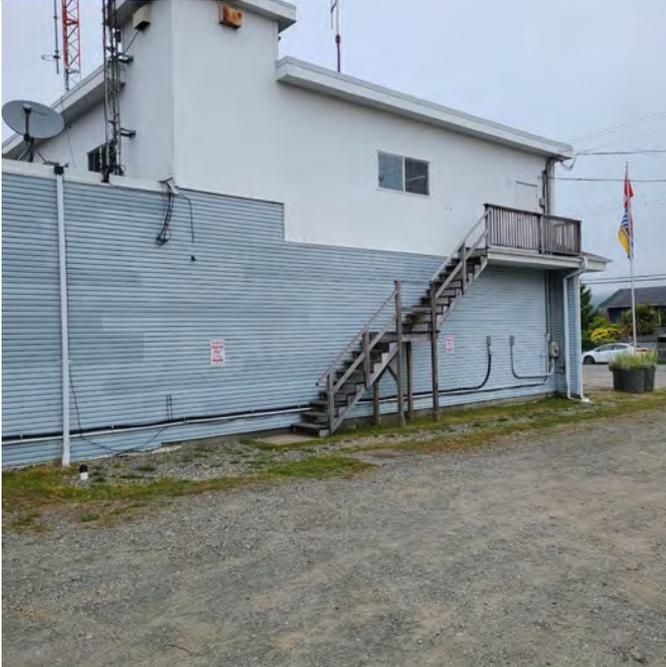
The photo above shows the patchwork of cladding materials and the only second level emergency exit staircase. Consistent lot deterioration is shown in this area as well.

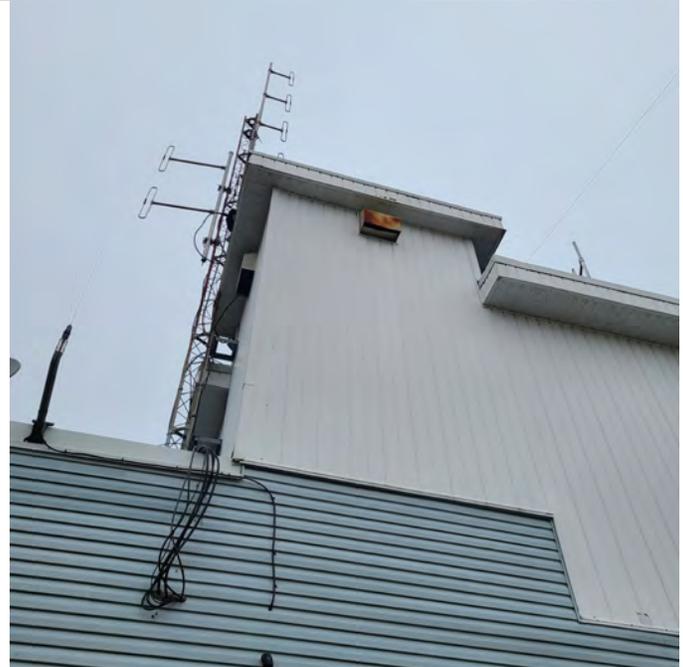
The photo above shows poorly sealed wall penetrations and cladding details. These areas are prone to weather intrusion. Building envelope leaks lead to rot, mold growth, health hazards, and energy performance loss.

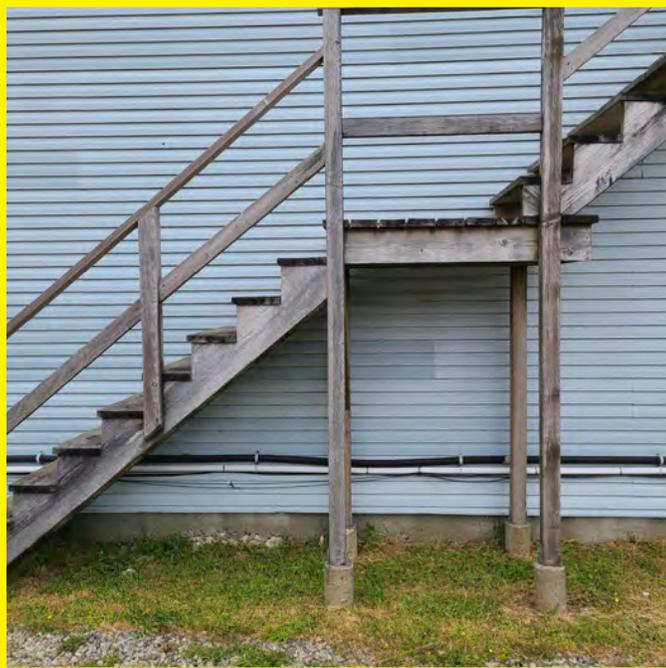
The photo above shows construction of exterior stairs. The staircase is not built to code and is inadequate for use as an emergency exit.

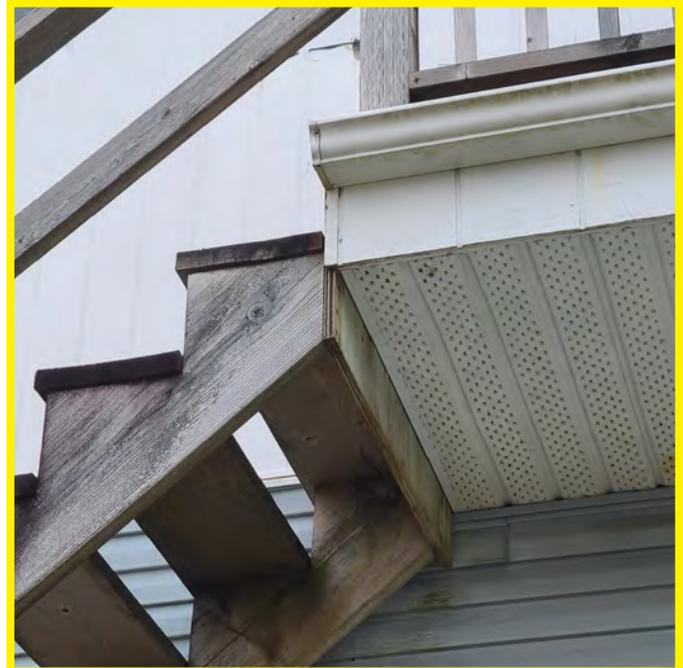
The photo above shows that the stair is not structurally safe. The stairs are deteriorating and should not be used. A small exterior gutter is observed.

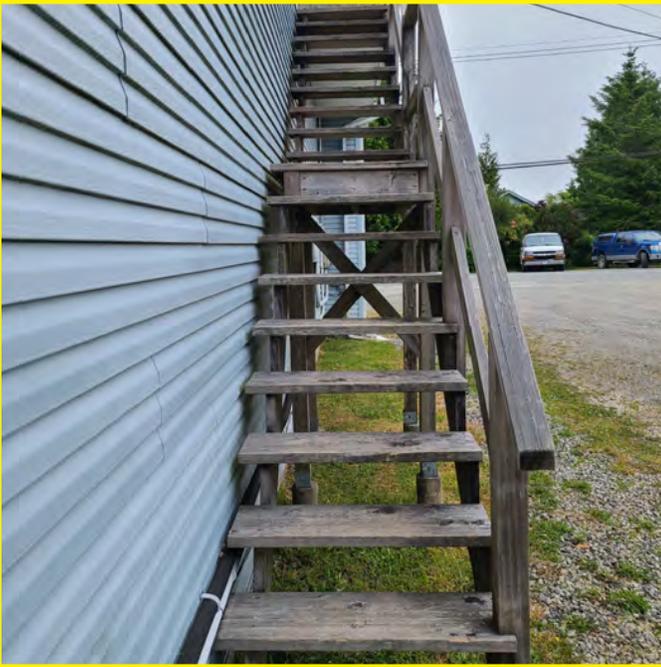
The photo above shows exterior mounted electrical conduit along the vinyl clad wall face. This conduit should be protected. The stairs show significant signs of weathering. The steps and railing are not to building code standards and are loose.

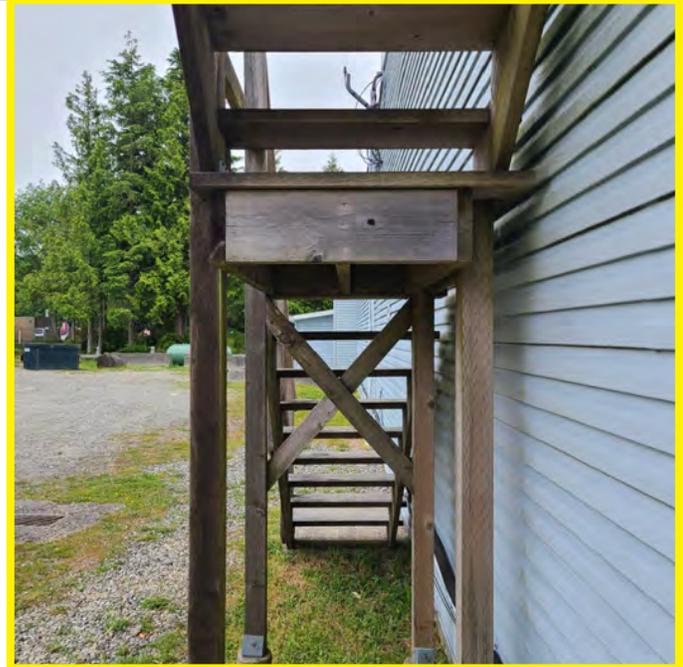
The photo above shows further evidence of the description to the right. The stairs are not properly secured to the building structure.

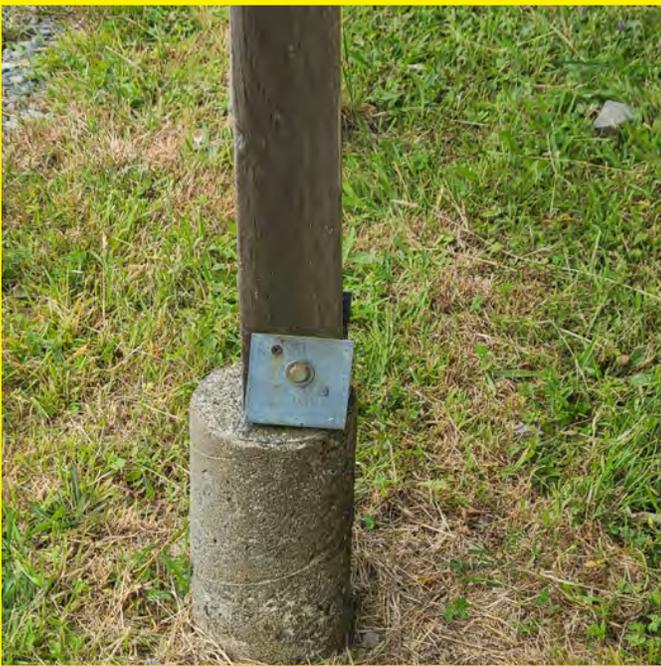
The photo above shows the stairs structural support is inadequately and improperly installed. This detail will cause eventual rot even to pressure treated wood materials. Proper installation and structural fastening is required for life safety areas.

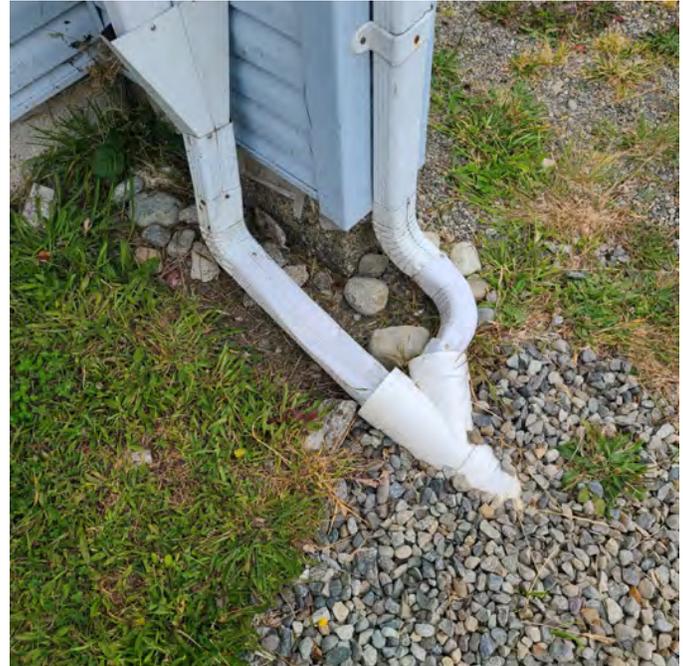
The photo above shows that while SOME perimeter storm drainage is installed, it has not been installed properly and appears to not be installed at the required depth for frost protection. This installation would fail a current building inspection.

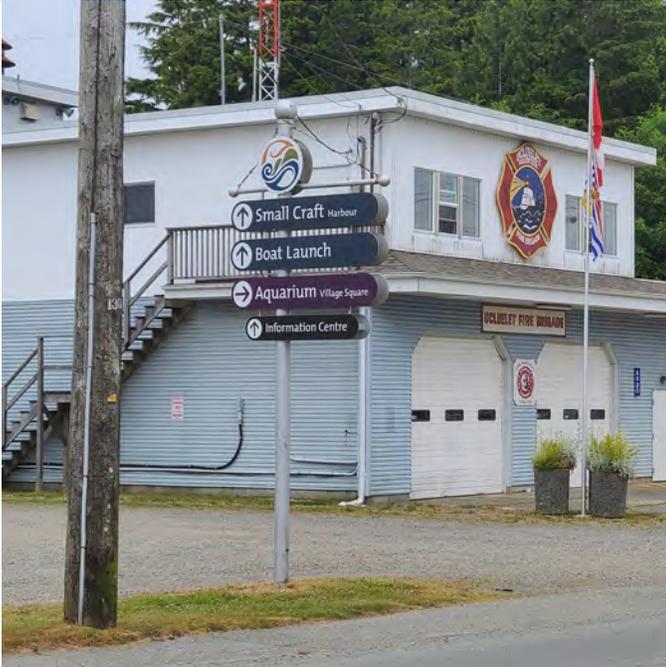
The photo above continues to showcase the overall deterioration of the Fire Hall. The site lacks property delineation and landscaping. The presentation of the existing Fire Hall does not showcase well in a tourist town. District signage directs main attraction sites.

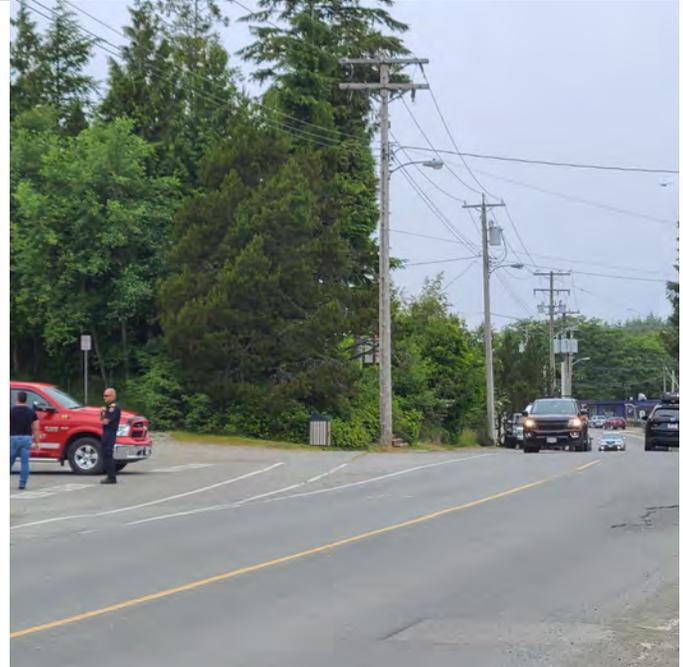
The photo above shows northbound and southbound traffic lanes along Peninsula Rd. in front of the Fire Hall. Traffic levels appear consistent along this main town thoroughfare. Roadway lines should be upgraded to ensure Fire Hall apron is not blocked by traffic stops.

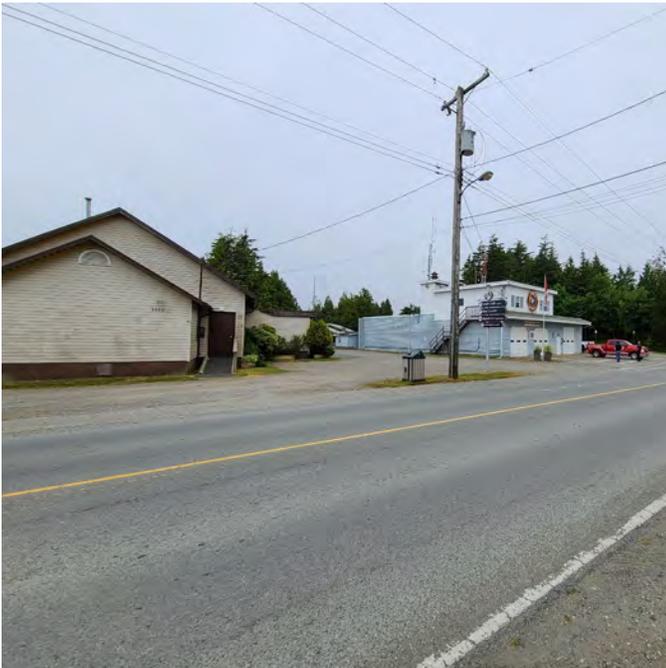
The photo above shows an overall view of the UAC and Fire Hall sites. Both are on generally flat, level ground which would be ideal for building on. These sites are outside the District Tsunami Hazard zone. It would be desirable to run hydro underground from the pole.

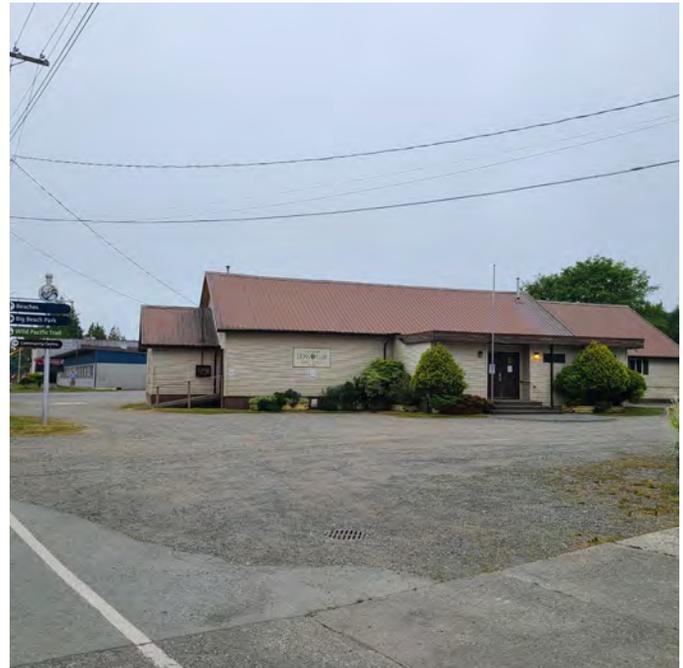
The photo above shows an overall view of the UAC and USS sites at the intersection of Peninsula Rd. and Matterson Dr. It is understood that this intersection is very busy during morning and afternoon pickup times which could slow emergency response.

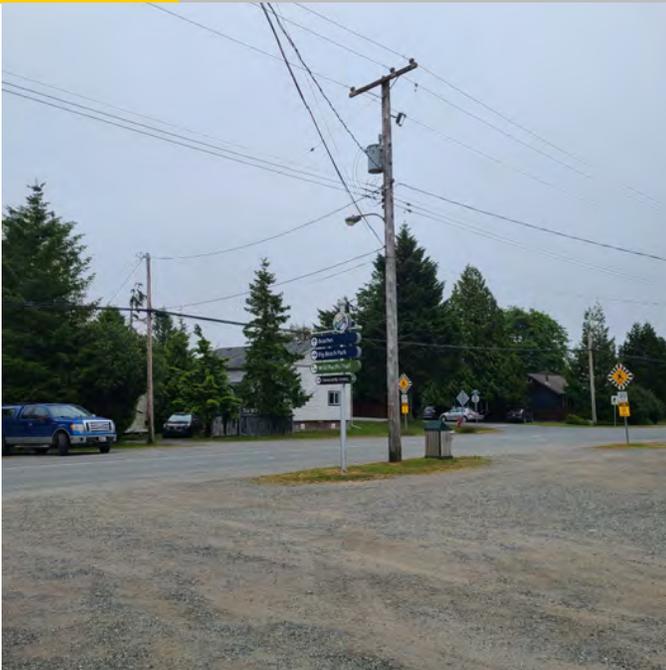
The photo above shows the overhead hydro lines feeding the Fire Hall. There is no post protection to prevent pole damage and possible power outages. Some traffic control signage is noted between the Fire Hall and USS. Neighbouring properties seen in photo.

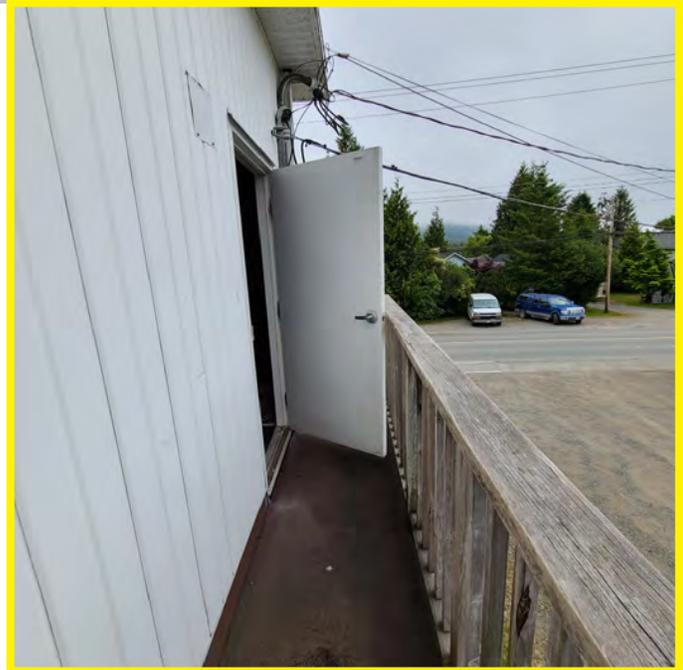
The photo above shows a number of building code and life safety concerns. This exit stair is unsafe for use. The railing is not secure, the door does not open fully, there is no door panic hardware for exiting, the landing is deteriorating, the overhead power lines to the building are not placed safety or neatly, etc..

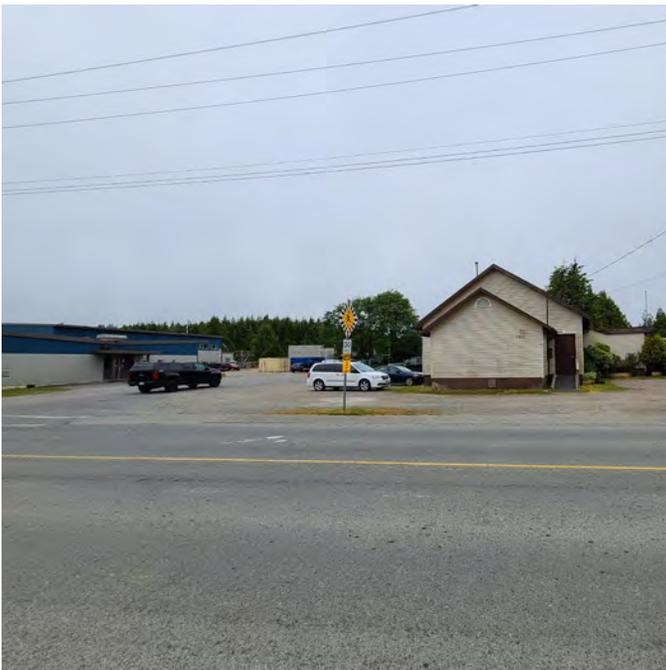
The photo above focuses in on the Peninsula Rd./Matterson Dr. intersection. This intersection may need upgraded traffic controls if the UAC site was used for Fire Hall expansion.

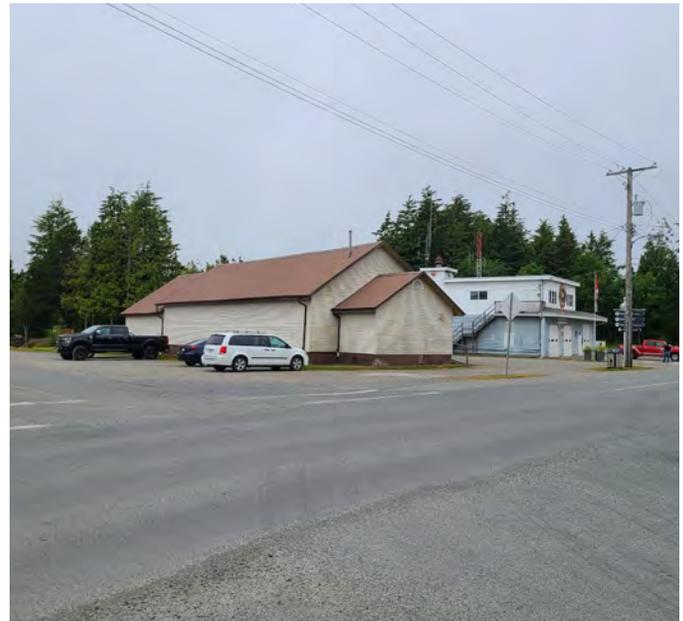
The photo above shows a possible new Fire Hall administration main entry location and possible location of an apron entrance for a drive through apparatus bay configuration.

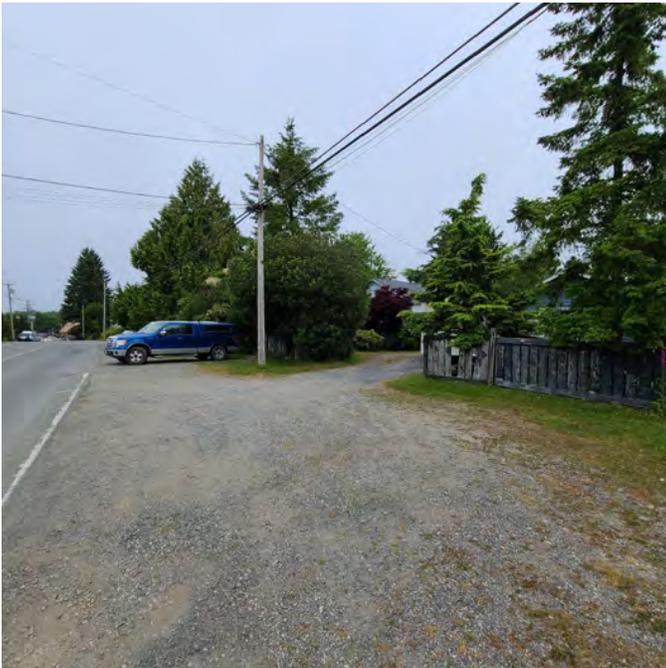
The photo above shows neighbouring property driveways and gravel parking areas. No formal sidewalk or bike lane is present for pedestrians.
