REGULAR MEETING OF COUNCIL
Monday, October 23, 2023 @ 4:00 PM
Ucluelet Community Centre
500 Matterson Drive, Ucluelet

| 7.3 | <p>Fire Hall Replacement

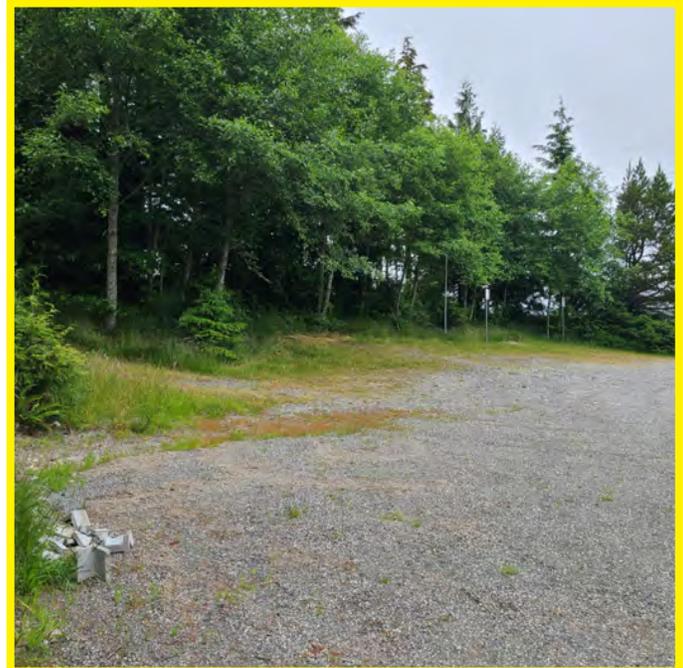
The photo above shows the property line and grade elevation difference between the existing Fire Hall and the Francis Boutique Inn. If an A&R was made to the Fire Hall using the existing property only, tree removal and retaining walls may be required.

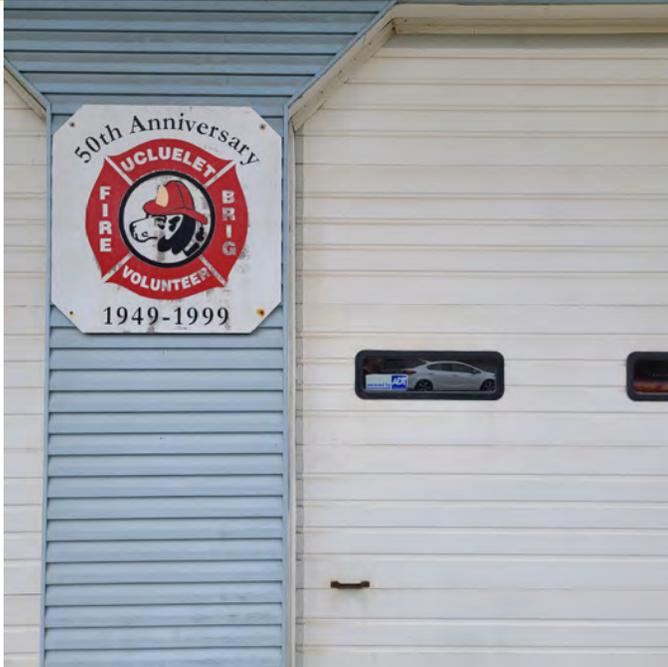
The photo above shows the old Fire Hall branding which is in the process of re-branding.
Limited apparatus bay natural lighting or security view toward apron.

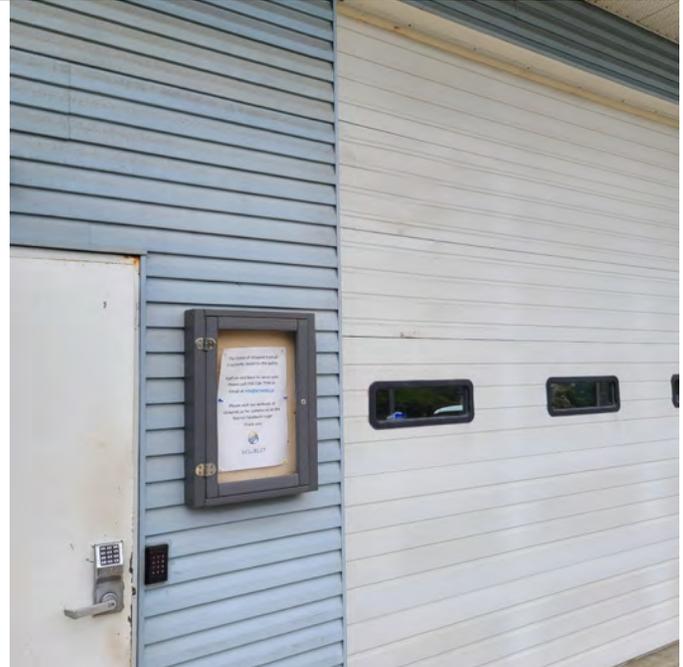
The photo above shows the main entry door and apparatus bay overhead doors. The doors and front facade have consistent wear and signs of weathering as the rest of the building. While the style of overhead doors are acceptable, they are too small.

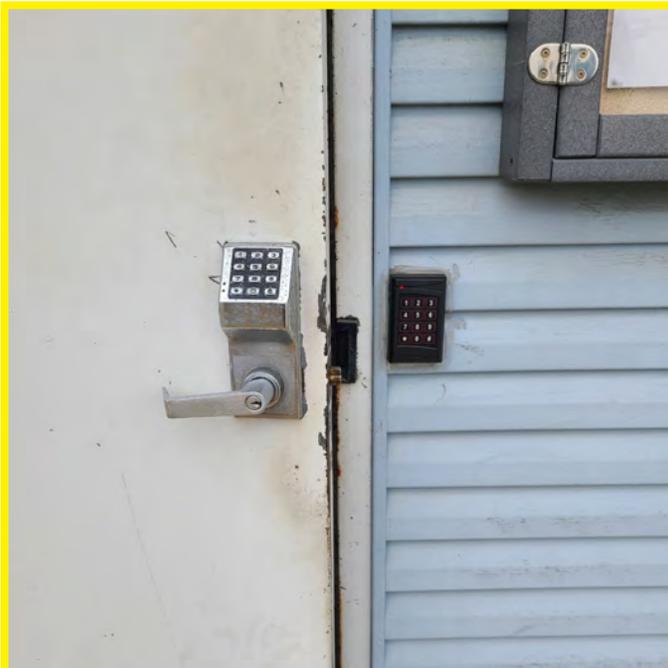
The photo above shows the main Fire Hall entrance. Moderate security is provided with the keyed and coded hardware. Metal door and frame wear is clearly shown.

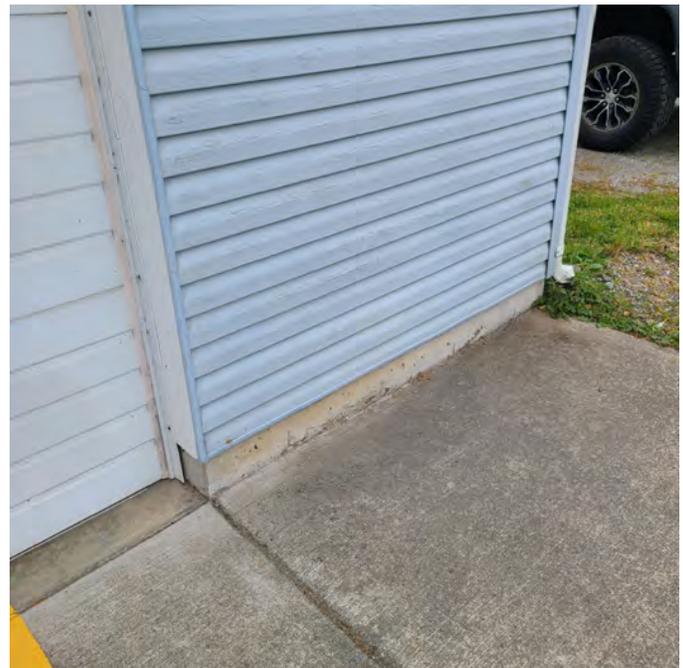
The photo above shows OH door weather protection detail issues. Water may enter the apparatus bays during major rainfall or significant wind driven rainfall events with inadequate sloping and lack of slab drainage.

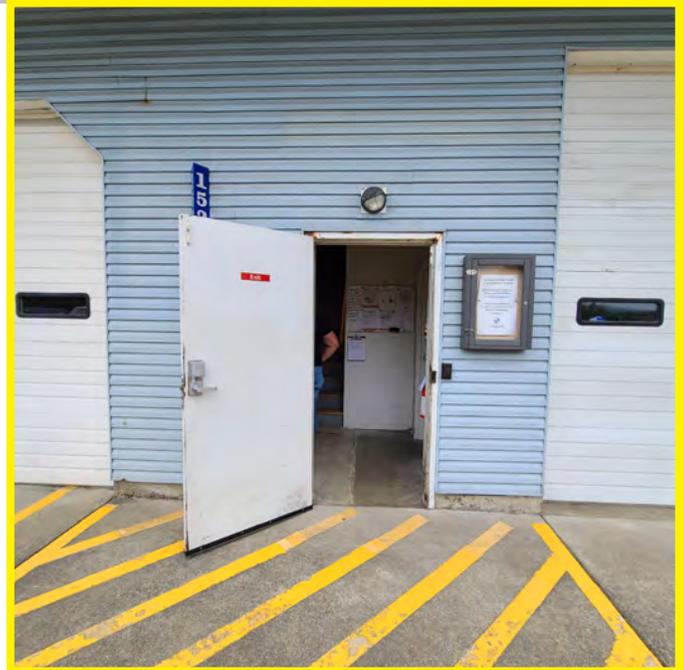
The photo above shows inadequate main entry lighting. The main entrance is not suitable for public access. Emergency egress (panic) hardware is not present.

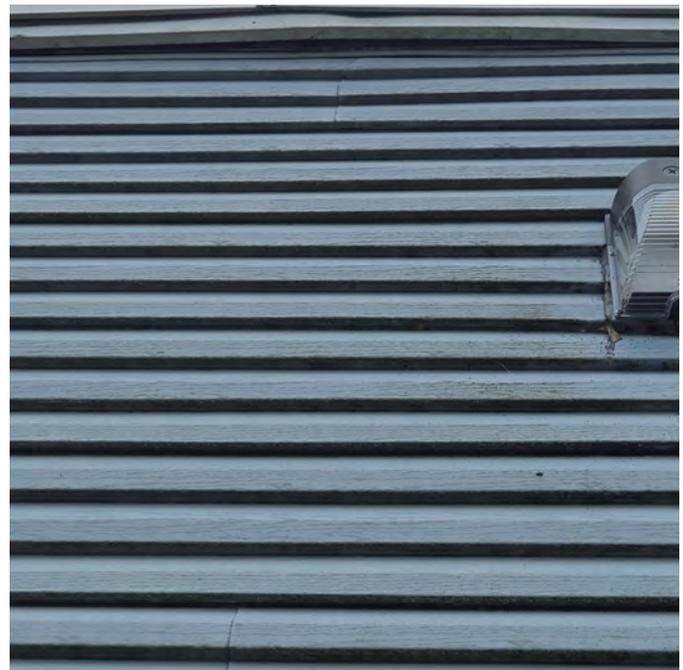
The photo above shows another facade view of the failing building envelope.

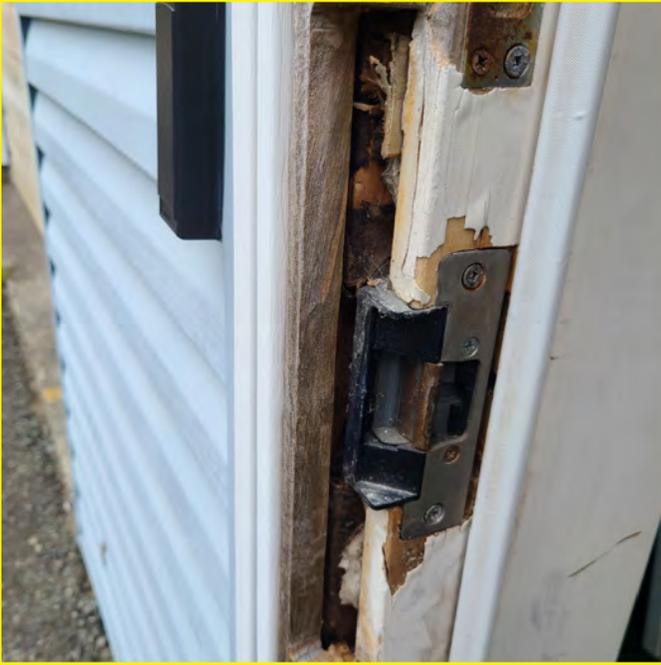
The photo above shows a clear example of building envelope failure at the rear entry door jamb. Rot and deterioration is clearly present and likely is also present within the wall assemblies. The section of rot lessens the security level of this entry point.

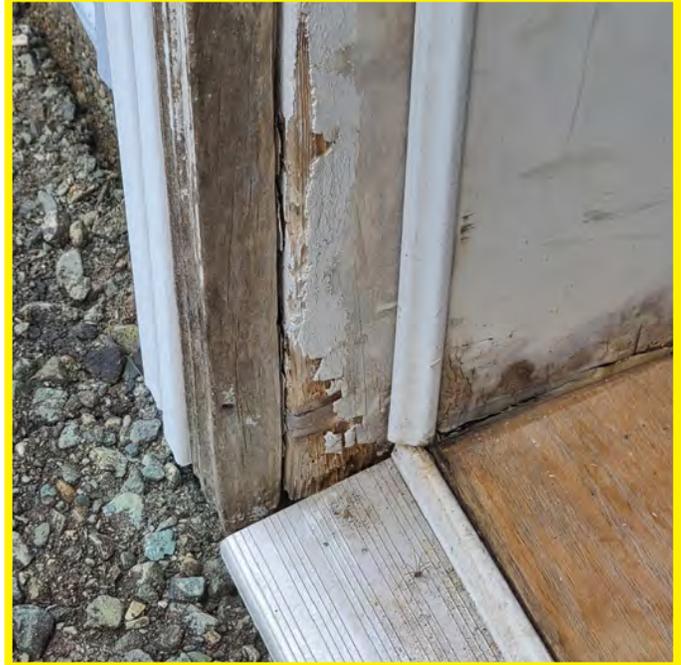
The photo above shows a rotting rear door jamb and interior base of wall near the sill. It is clear that proper door installation details were not followed allowing water leakage into the building envelope. A commercial type door should have been used.

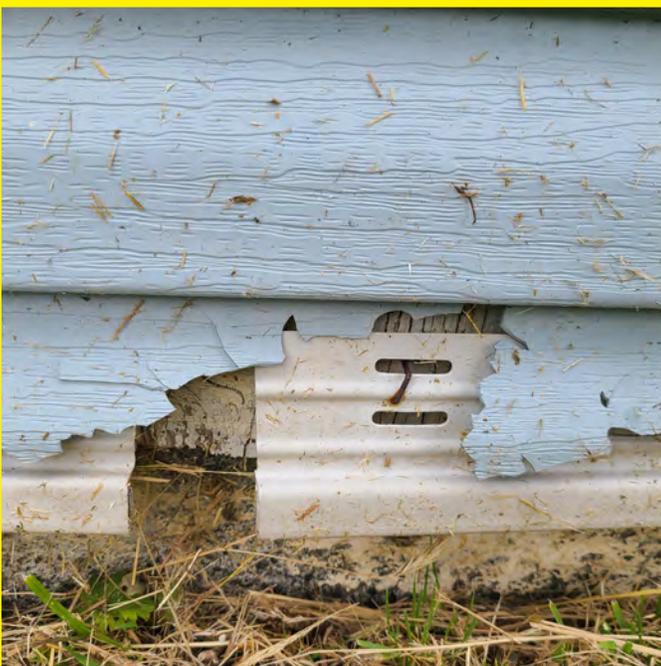
Photo 'A' above shows one example of complete building envelope failure. The vinyl cladding has long passed its product life cycle and is brittle and crumbling. This residential style product is combustible and not suitable for this application.

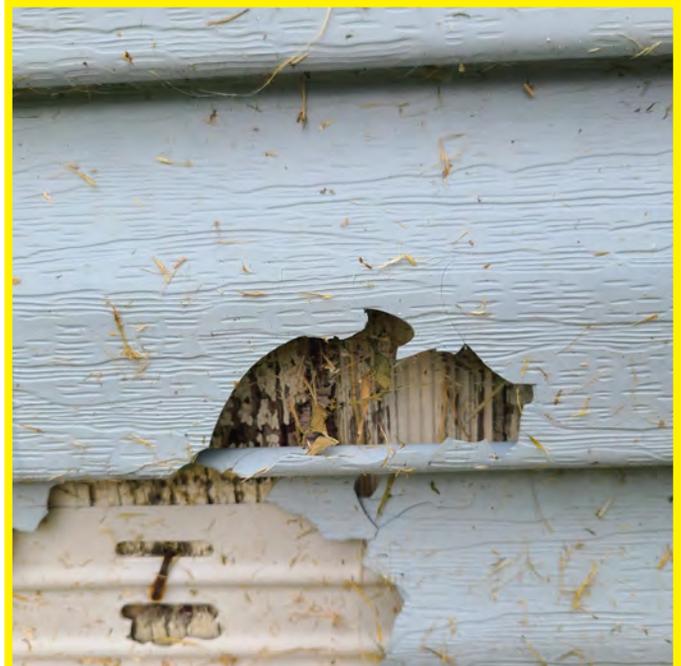
Photo 'B' above shows another location with the same issues as seen in photo 'A' to the left. The plywood wall sheathing is exposed and no building paper or weather barrier is seen which is a major building envelope assembly issue.

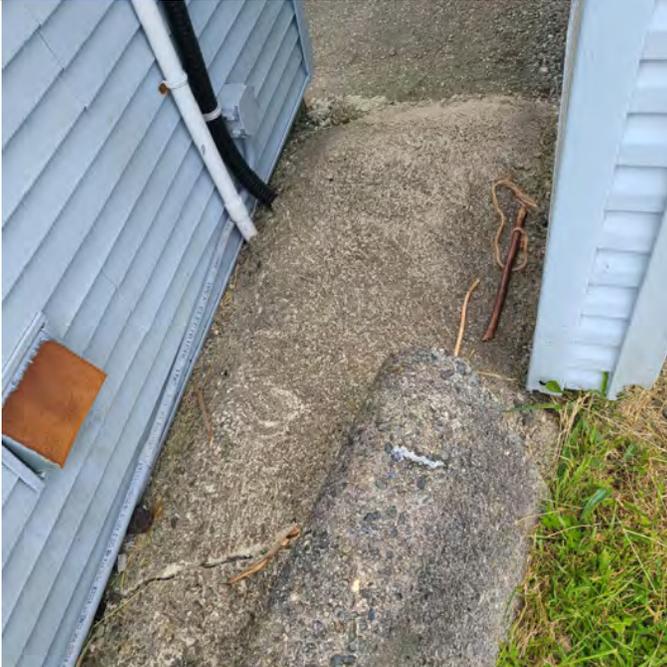
The photo above shows patched concrete slab sections. Large cracks and overall deterioration in seen in all areas of this photo including rusting metal wall vents, lack of foundation wall curb, and proper separation of organics from the building structure.

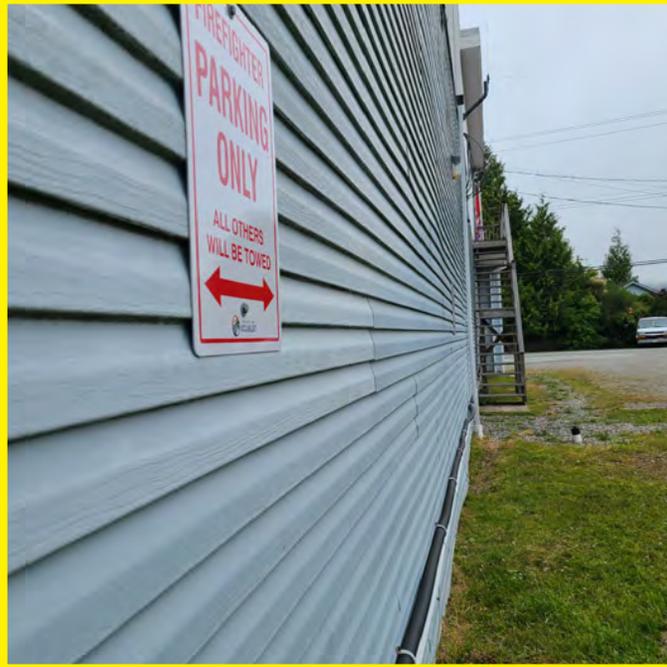
The photo above shows firefighter parking. Site parking for Fire Hall volunteers is very limited. The parking surface is overall not acceptable for a Fire Hall facility. The ground surface and lack of lighting poses safety issues for Fire Hall personnel.

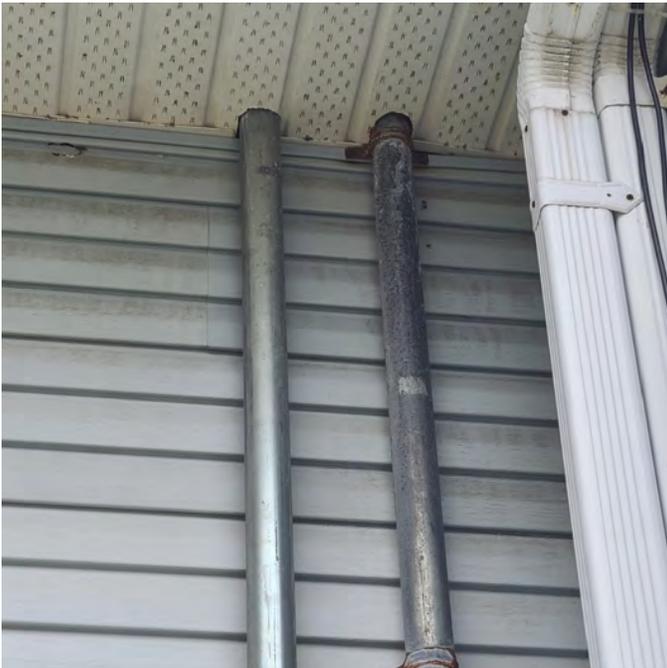
The photo above shows surface mounted conduit passing through the roughly cut metal soffit.

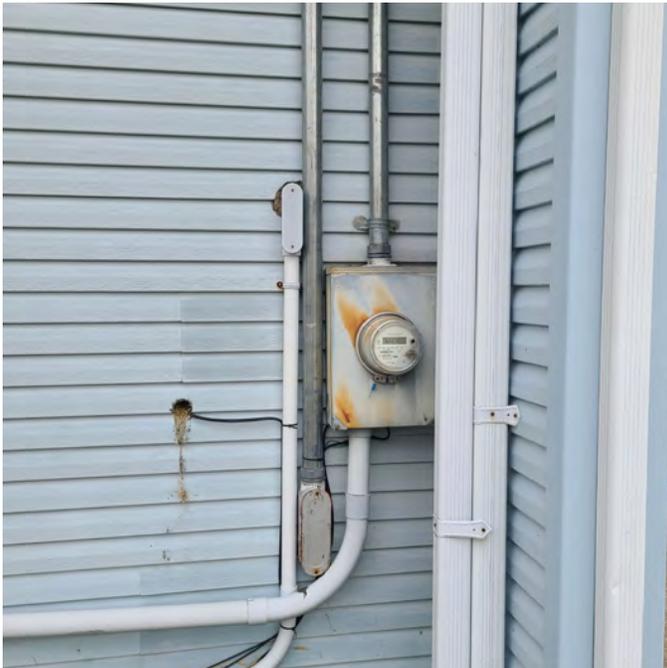
The photo above shows clear building envelope penetration weather protection issues. The meter is placed in a poor location and should be relocated for easy access.

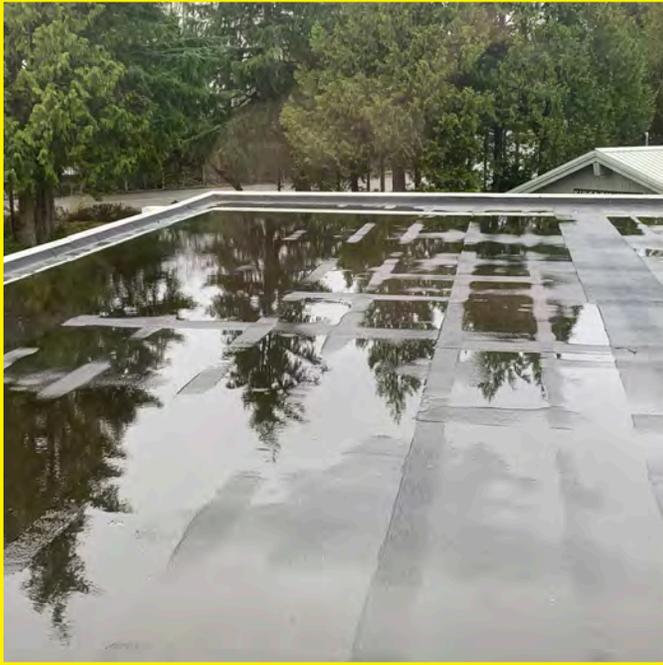
The photo above shows the general condition of the roof. The roof system is inadequately sloped causing water ponding during the fall and winter months. It is clear that the roof requires replacement.

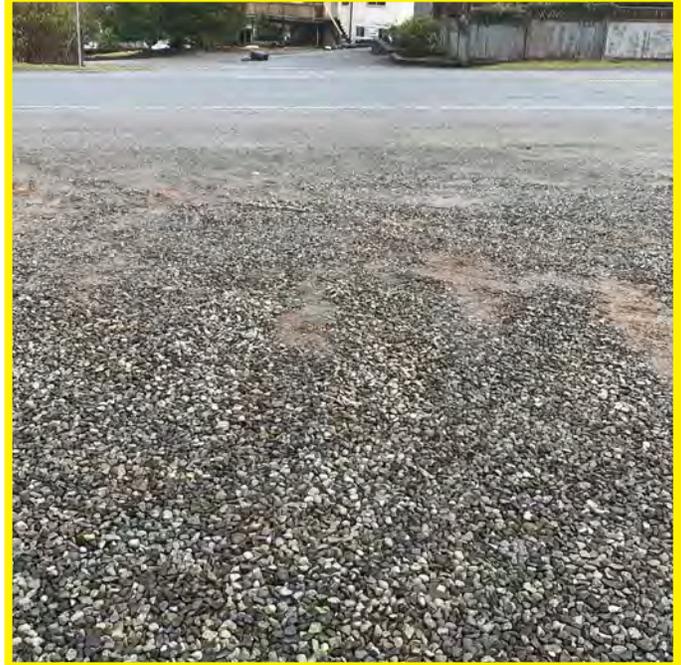
The photo above shows that although most of the site appears generally stable during warm dry months, poor soils conditions and soft spots become visible during the fall and winter months. Geotechnical investigation should be conducted.

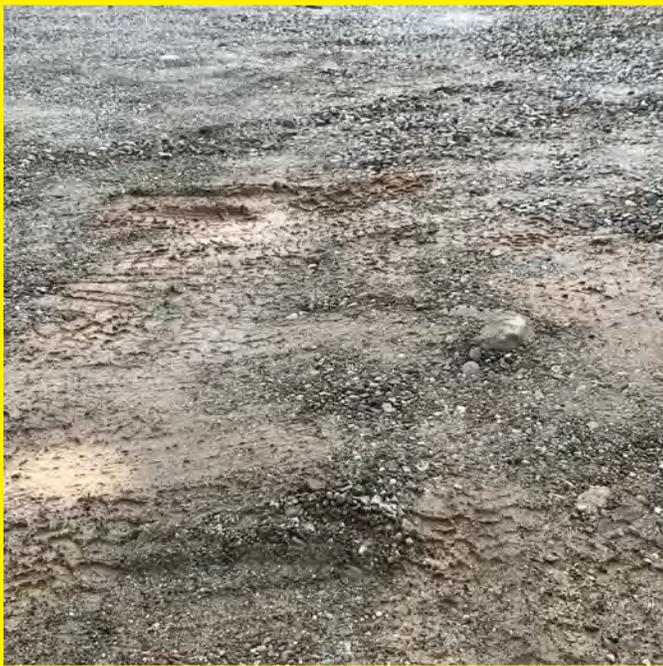
The photo above shows soft spots in the parking and training area of the site that become too soft to drive apparatus trucks over in the fall and winter months. Removal of soft areas and installation of structural fill materials is required in these areas.

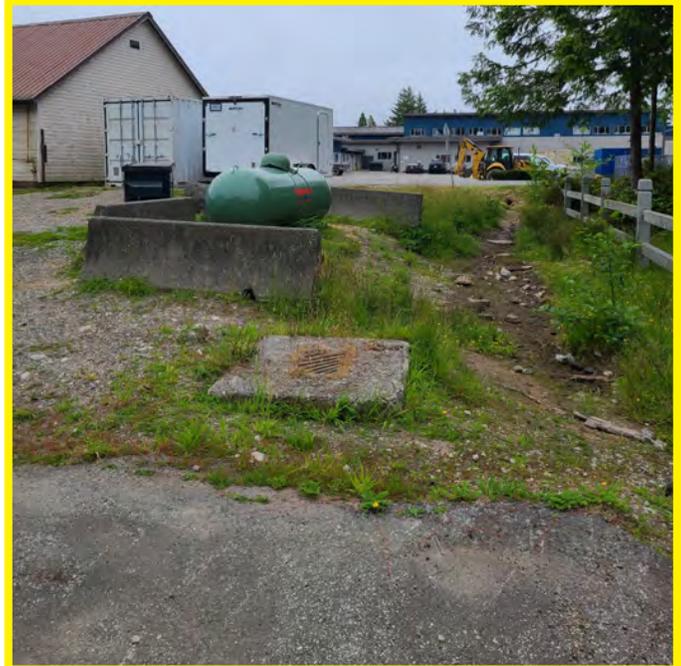
The photo above shows potential site hazard areas. While the propane tank is protected, the security level is low. This area shows much site deterioration and blocks much movement and training area. This needs to be relocated and site repairs are needed.

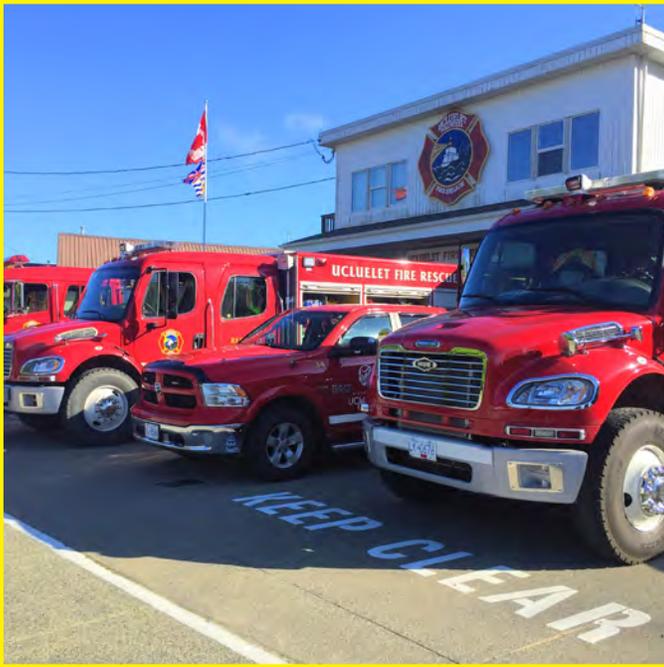
The photo above shows the current trucks owned by the Fire Department. The department needs an aerial apparatus truck. However, there is no room in the current Fire Hall to fit another truck. The existing Fire Hall and apron cannot even fit an aerial truck.

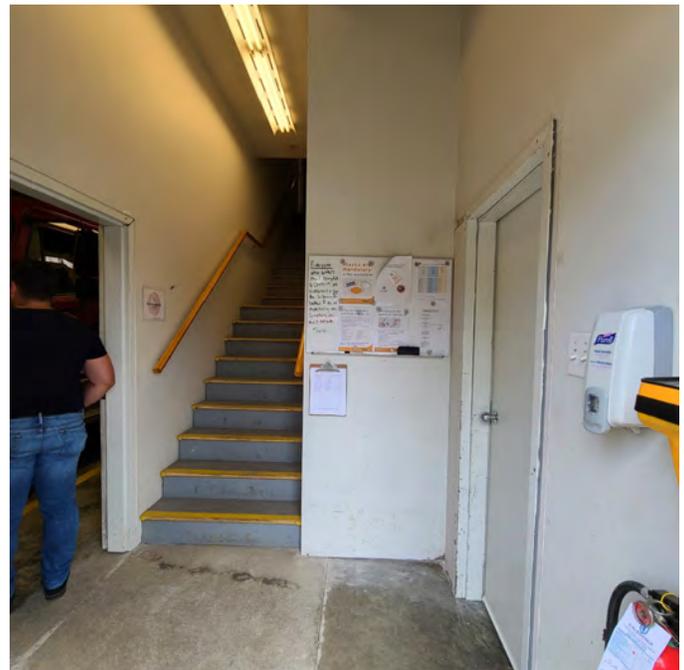
The photo above shows the existing Fire Hall main entry vestibule. The apparatus bays on accessible through single doors to the left and right. The main entry does not meet accessibility requirements. The stairs and handrails are not built to code.

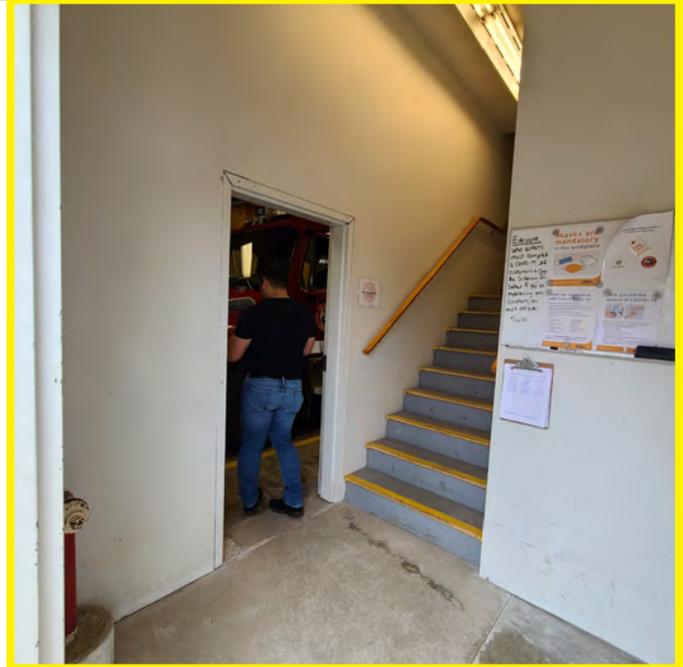
The photo above shows the existing condition of the bare concrete flooring. No concrete sealer appears present or has worn away. The areas of addition are seen. The **fire rating** of this exit stairwell cannot be confirmed adequate.

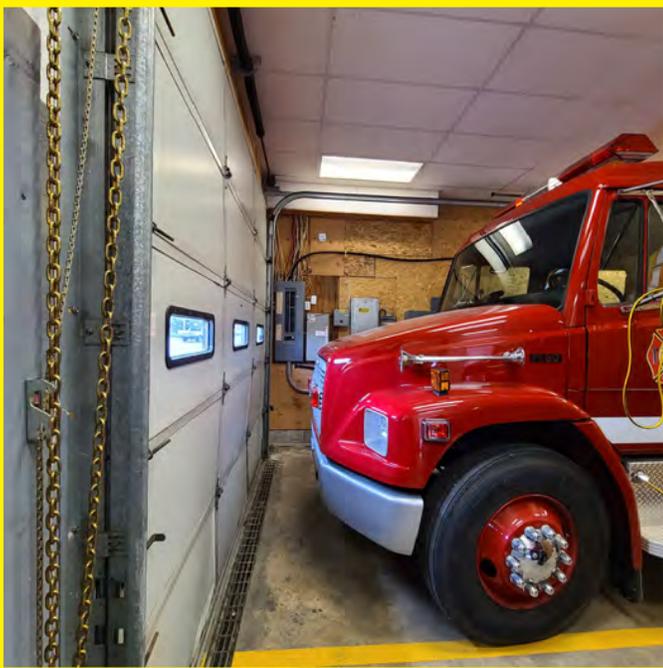
The photo above highlights a number of major issues with the existing Fire Hall that further stress the need for an A&R or new Fire Hall to be constructed: OH door/ drainage, electrical issues/ fire hazards, there is NO ROOM for an aerial truck of adequate walking rm.

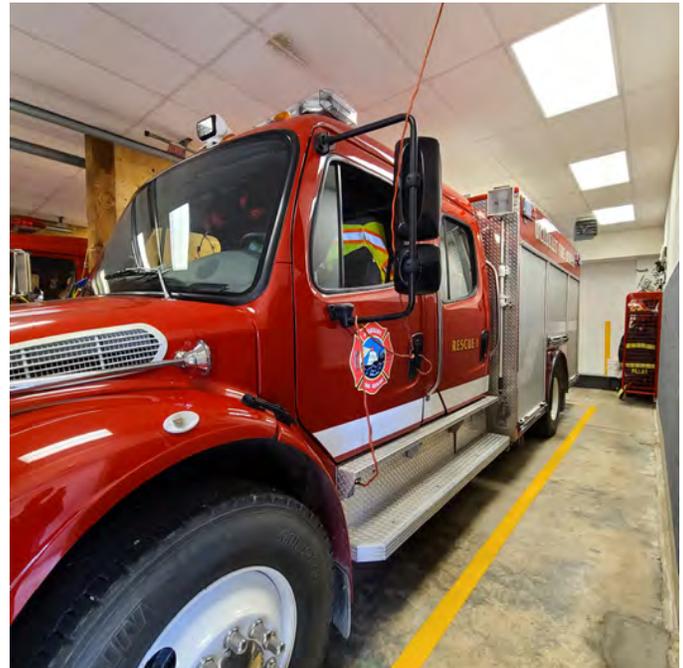
The photo above shows one of the Fire Hall apparatus bays. Walking room is generally clear but is very tight according to industry standards. The ceiling finish height is low. Lighting is just sufficient. The concrete floor is worn and stained.

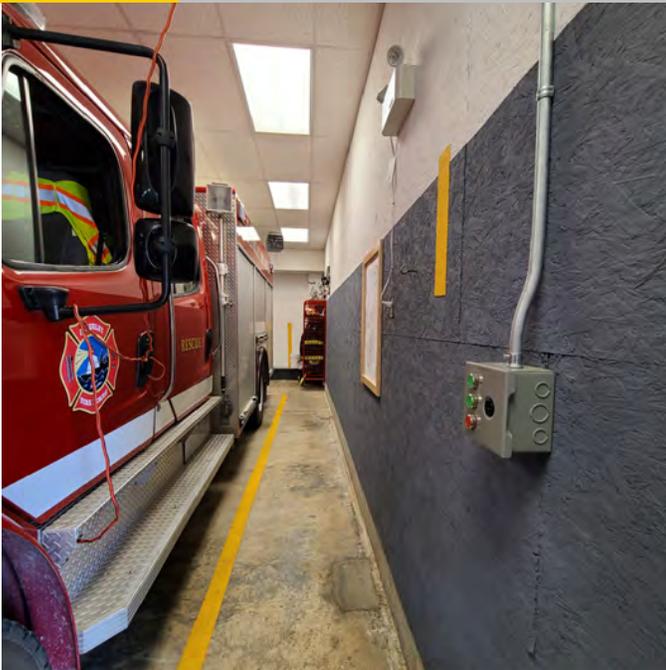
The photo above shows how tight the walking space is around the fire trucks. Movement is limited and will be completely block by an open truck door. The wall finish seen here is just painted OSB plywood which does not serve as a required fire rated material.

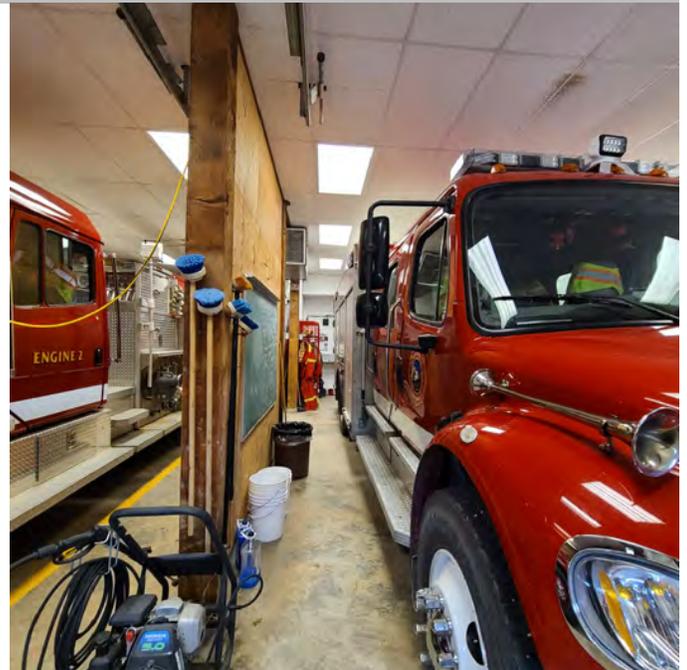
The photo above shows the space between the two original apparatus bays. Movement is limited and the lack of storage space for washing equipment creates tripping hazards. It is also assumed that this dividing wall is load bearing but has no fire ratings.

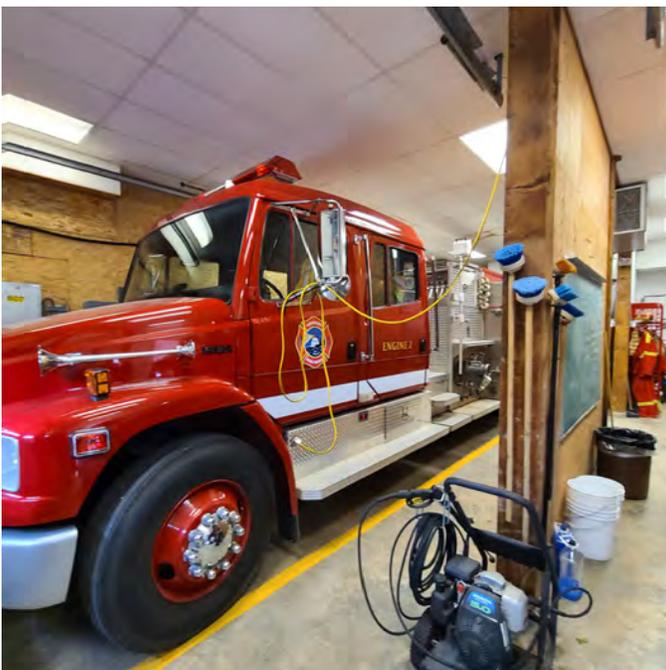
The photo above shows a second apparatus bay. Limited movement around the truck and other issues are consistent with items mentioned in previous photos.

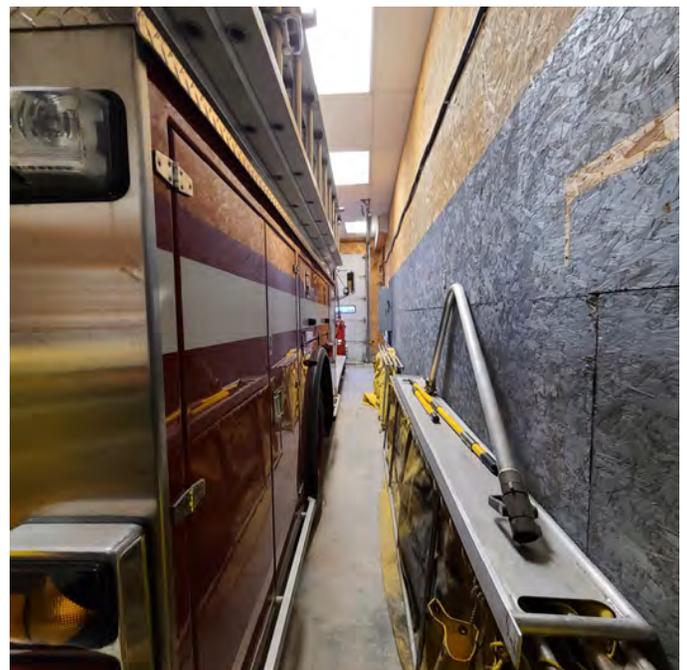
The photo above shows a look at the back of the apparatus bay shown in the photo to the left. There is virtually NO movement space due to storage and narrow bay sizes. The wall finish is half painted, no fire rating is observed with surface mounted electrical.

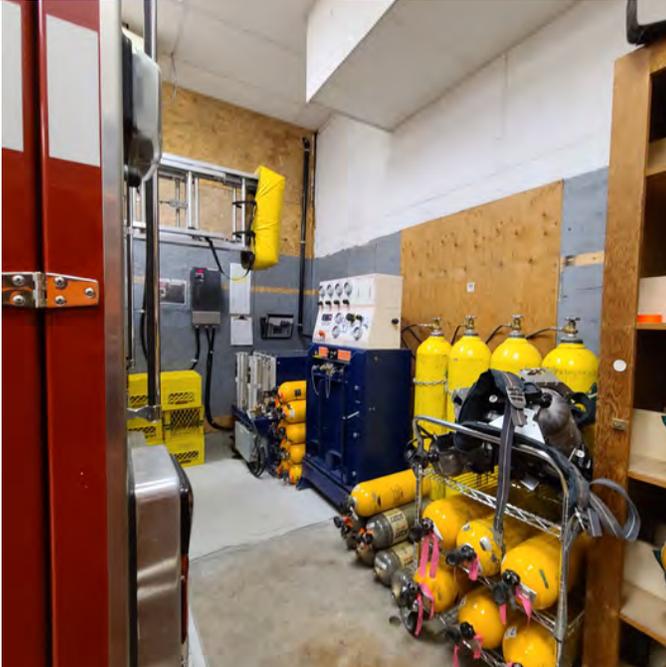
The photo above shows the SCBA and compressor station. The fill station is positioned at the rear of the apparatus bay and has potential for exhaust contamination. Functionality and movement in this area is very limited due to the small space.

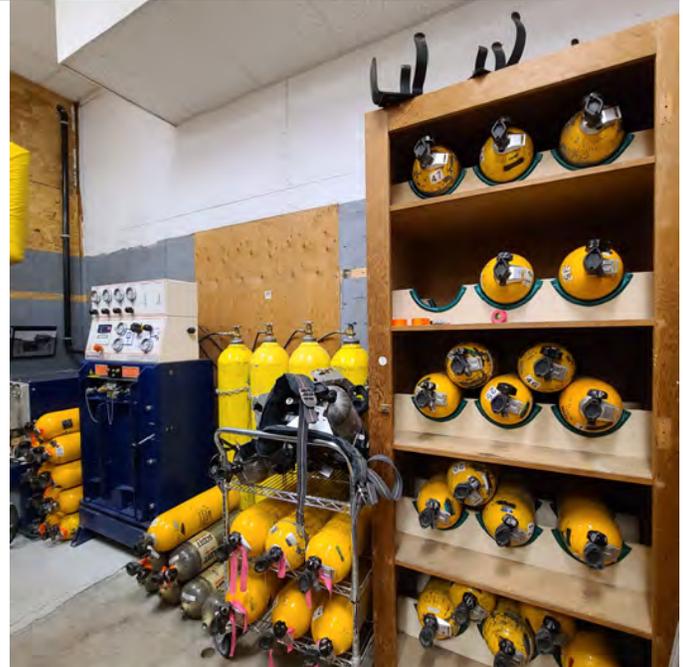
The photo above further highlights the issues noted in the photo to the left. SCBA and compressors required a dedicated 'clean room' for proper separation from apparatus bays and intake of fresh air. Clean work area is needed for storage and maintenance of equipment.

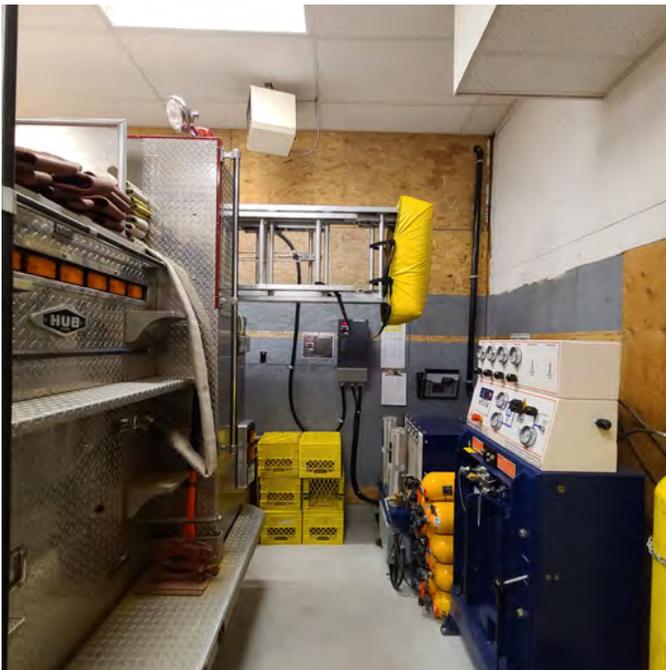
The photo above shows a ladder protruding from the back of the fire truck which poses a safety hazard and movement limitations. The SCBA and compressor should be relocated and items should not be stored in this area.

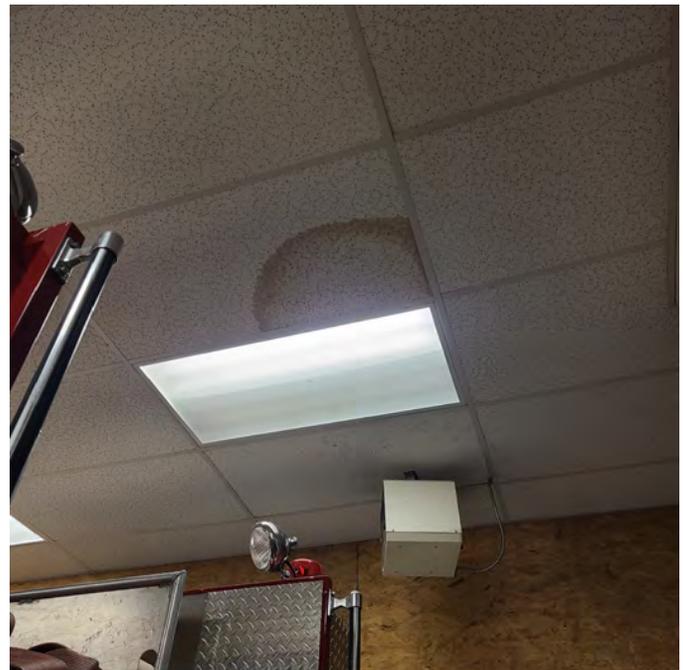
The photo above shows evidence of a previous water leak and subsequent water damage to the ceiling finish. It is assumed this did not cause any structural damage. A small unit heater is hung from the ceiling space and does not appear adequate for the space.

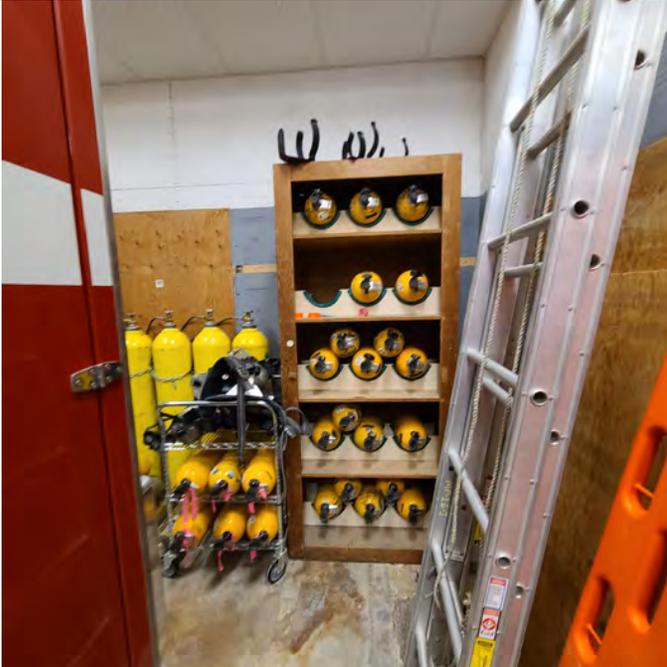
The photo above shows miscellaneous SCBA bottle storage along with other maintenance and rescue equipment.

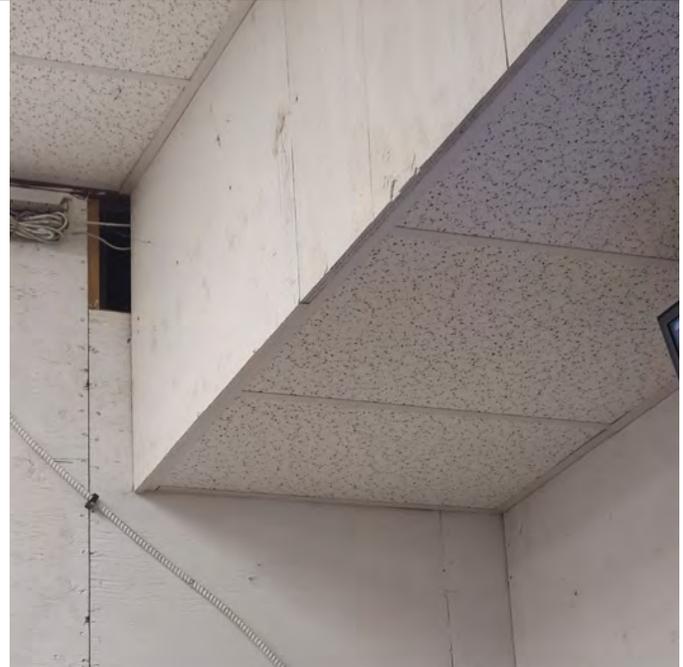
The photo above shows the poor patchwork condition of the interior wall 'finishes' and surface mounted electrical. No fire rated material is observed around bulkhead areas.

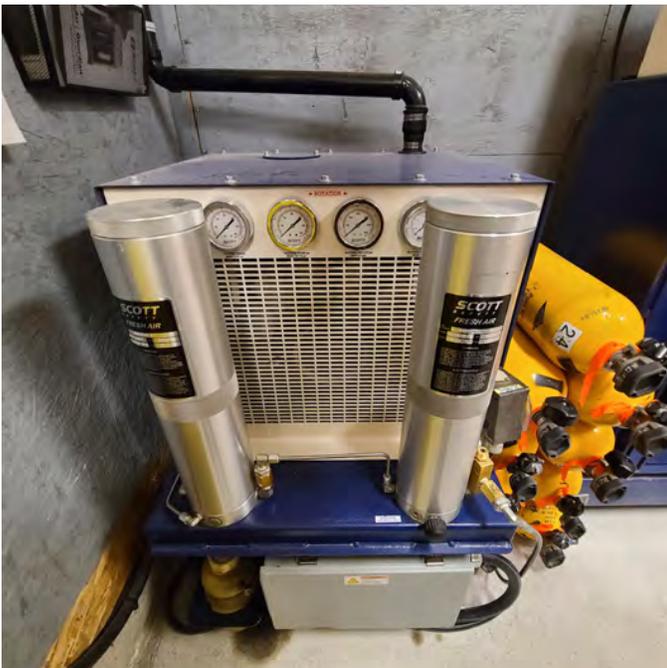
The photo above shows equipment that needs to be relocated to a proper clean environment.

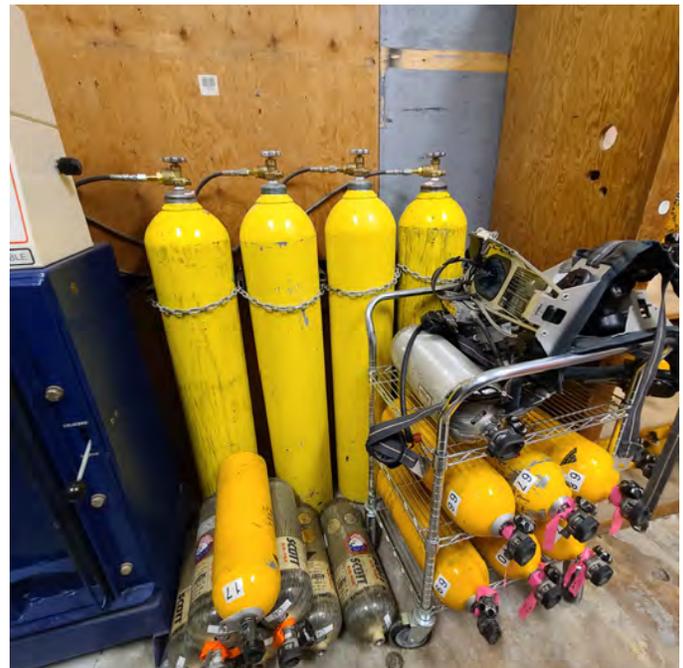
The photo above shows equipment that needs to be relocated to a proper clean environment. There is no access to a sink for washing masks or clean work bench for gear maintenance. There is no available space for either in the existing facility.

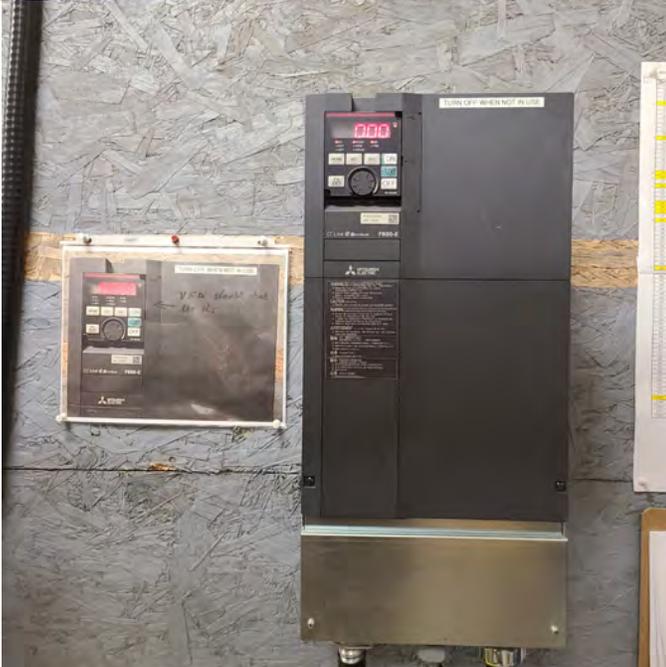
The photo above shows surface mounted equipment controls and surface mounted wiring again a painted OSB wall finish.

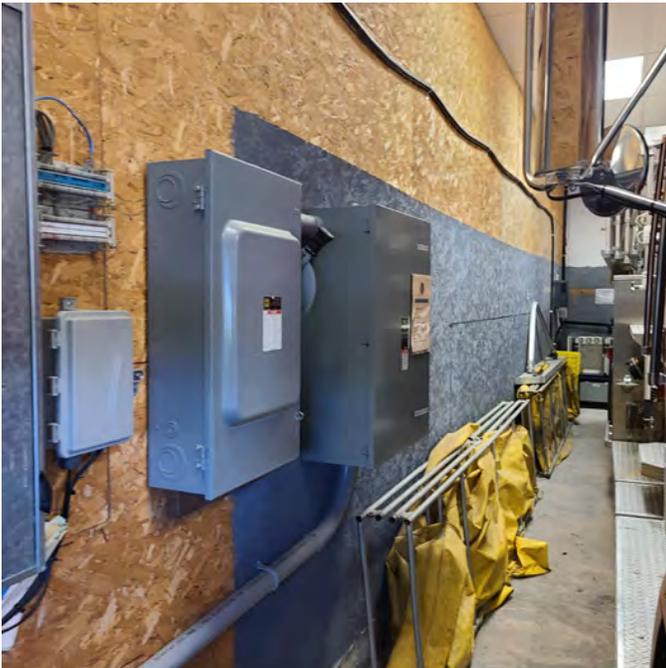
The photo above further shows that movement is limited around all sides of the trucks in the fire hall. Electrical equipment needs relocation to a proper electrical room.

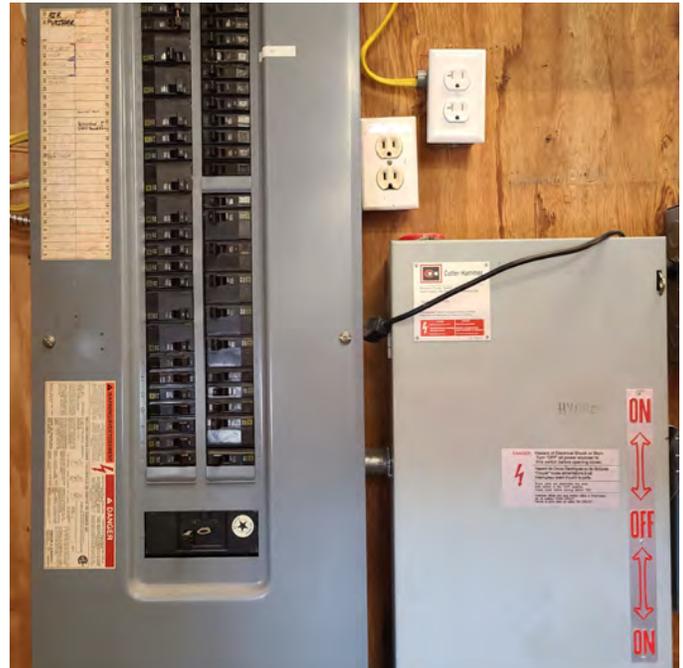
The photo above shows the electrical installation issues in the existing Fire Hall which likely need to be completely upgraded to meet current codes. If the OH door is open, wind driven rain could cause electrical issues due to the proximity to the door.

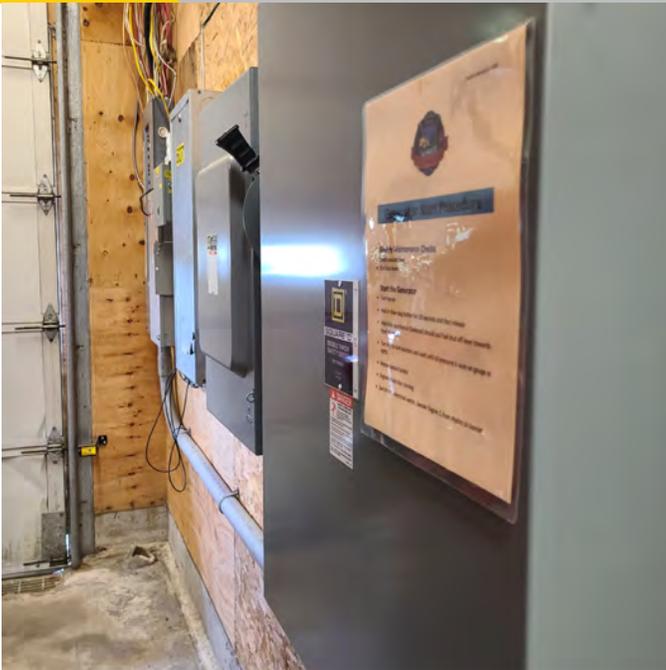
See previous photo notes. Additionally, daylight can be seen along the edges of the overhead door resulting in significant energy loss.

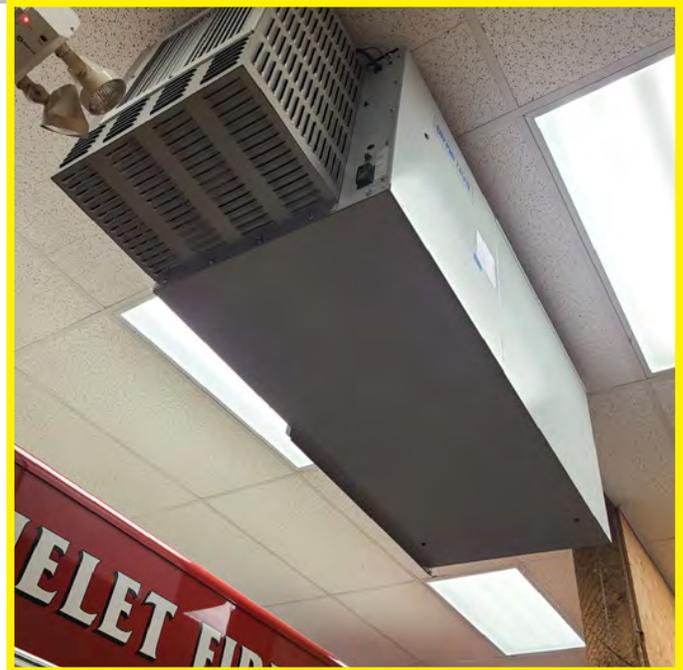
The photo above shows a single air scrubber unit centrally hung over the main apparatus bays. Efficacy cannot or proper operation cannot be confirmed to meet WCB standards with respect to controlling carbon monoxide levels from truck exhaust.

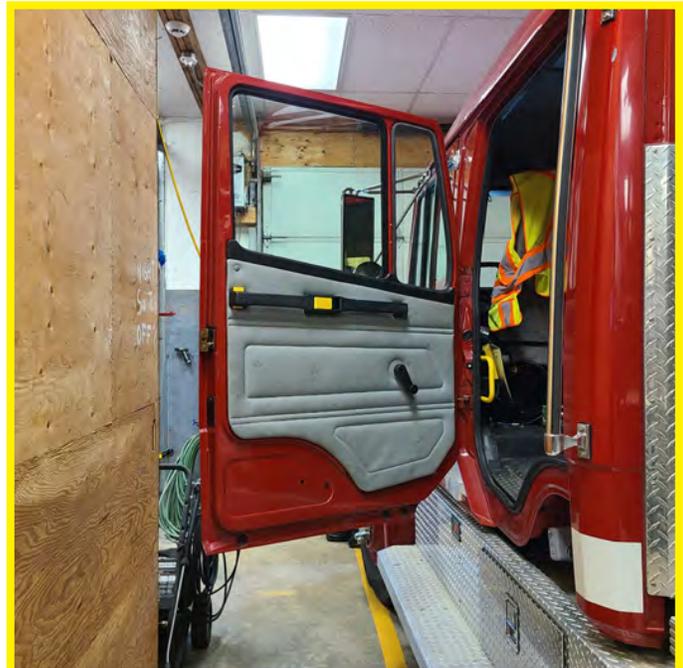
The photo above shows the narrow apparatus bays. The trucks can open the doors fully, but movement is severely limited.

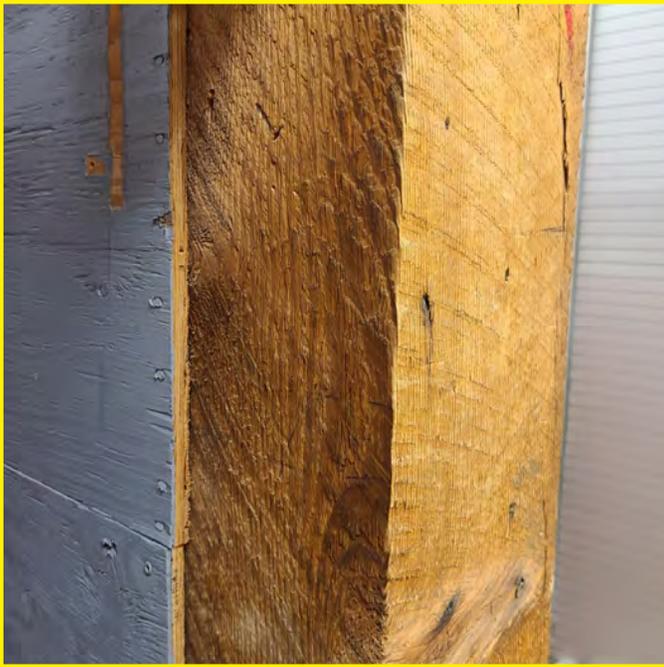
The photo above shows a close up look at the rough-sawn columns and what is assumed to be a shear wall nailing pattern at the edges of the plywood sheathing. The structural adequacy of the columns and acceptability of the nailing cannot be confirmed.

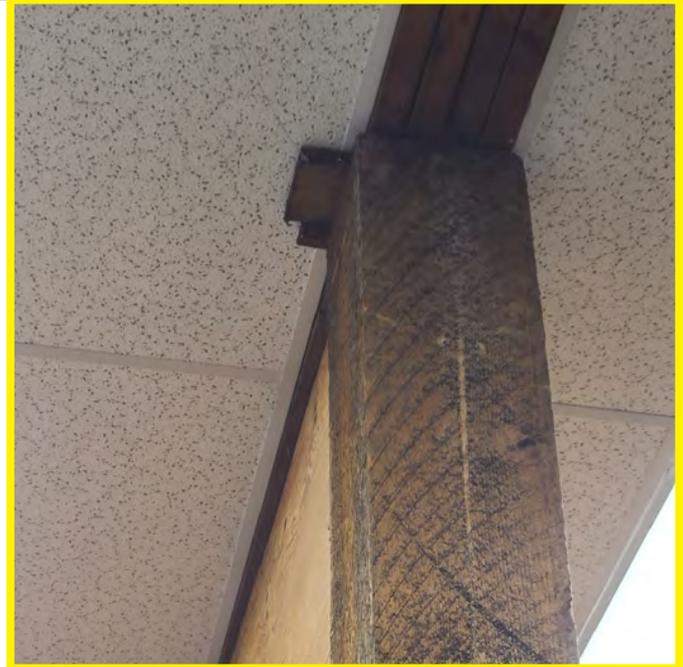
The photo above shows an exposed 4-ply built-up wood beam supporting the floor above. It is assumed these members are continuous over the column support. Proper structural fastening or metal brackets appear completely absent. Shimming is wedged.

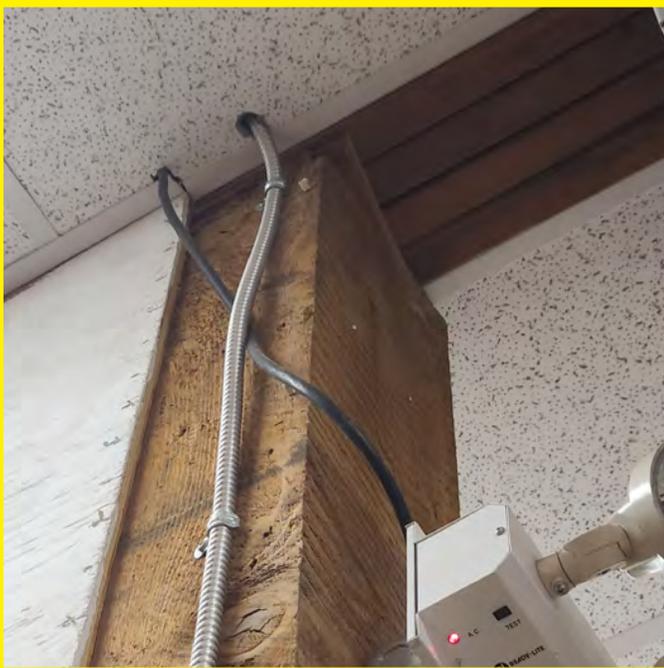
Reference previous photos for further information on photo above. This photo shows another partition wall. Exposed electrical and emergency lighting wiring is observed. The beam above is shimmed and appears to lack appropriate fastening requirement.
