REGULAR MEETING OF COUNCIL
Monday, October 23, 2023 @ 4:00 PM
Ucluelet Community Centre
500 Matterson Drive, Ucluelet

| 7.3 | <p>Fire Hall Replacement

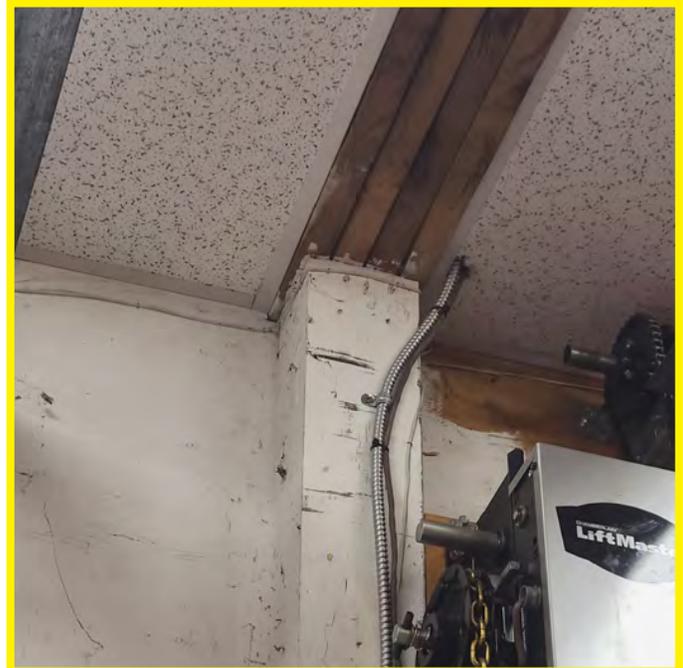
The photo above shows the continuation and support of the structural floor beam member terminating at the front wall location. The size of column is unknown. The column is assumed similar rough-sawn wood. Proper bearing? Lack of fastening. NON-SEISMIC.

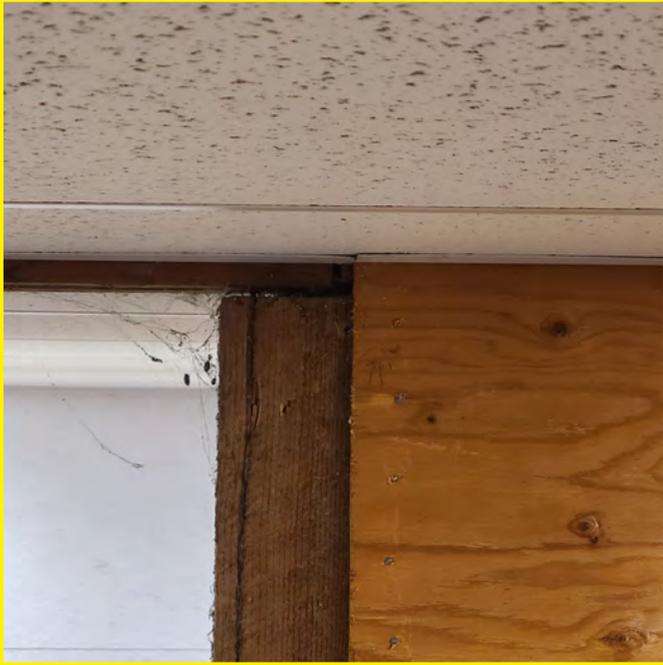
The photo above shows a close up look at one of the interior partition walls. This wall is assumed to be a structural shear wall supporting the floor above. The connections do not appear to be seismically sound.

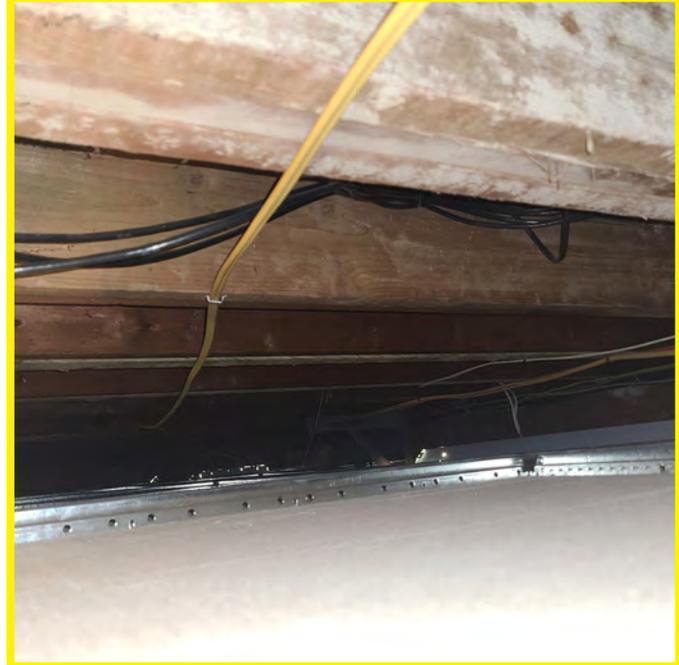
The photo above shows a look above the apparatus bays acoustic ceiling tile finish. The t-bar does not appear to be seismically fastened to the underside of structure. No fire rating is observed. The structure appears to just be dimensionally wood framed.

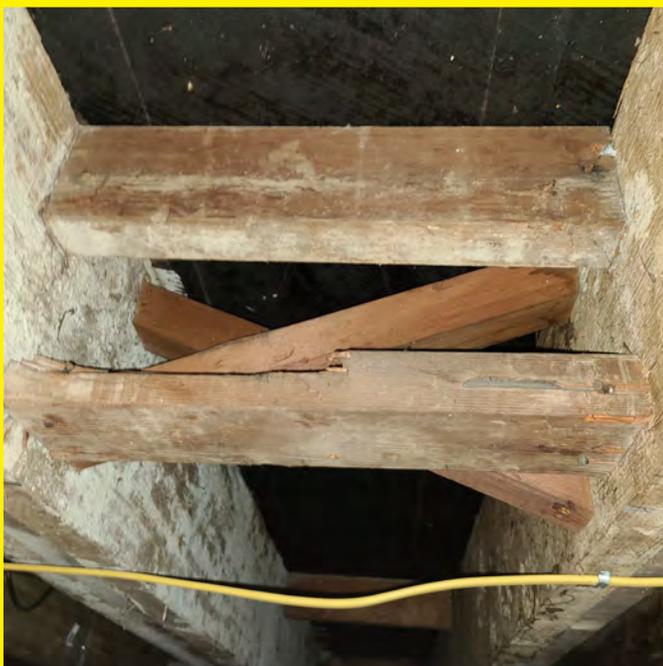
The photo above shows a closer look at the 2nd floor framing elements. These do not appear to be seismically sound. The wood is dry but it not in good condition. The wood has the appearance of used forming material. - structural details needed.

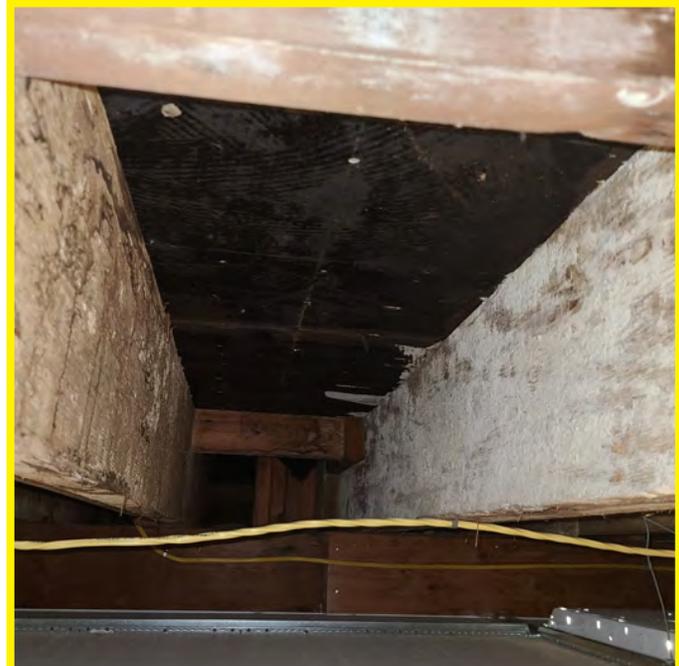
The photo above shows a closer look at the 2nd floor framing elements. Joist bracing or blocking appears to be inadequate. No fire rating is observed. Stuctural framing needs to be inspected by an engineer. Replacement and increased fastening requirements.

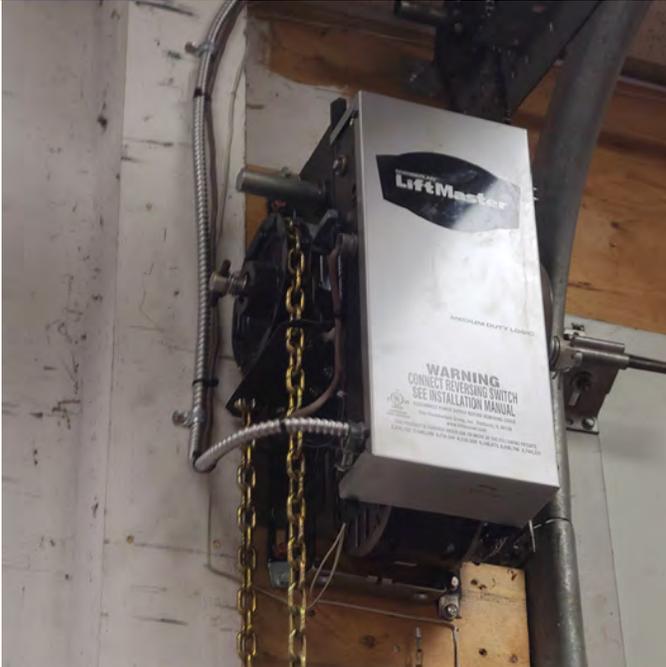
The photo above shows the existing Lift Master overhead door openers. Effective condition cannot be confirmed.

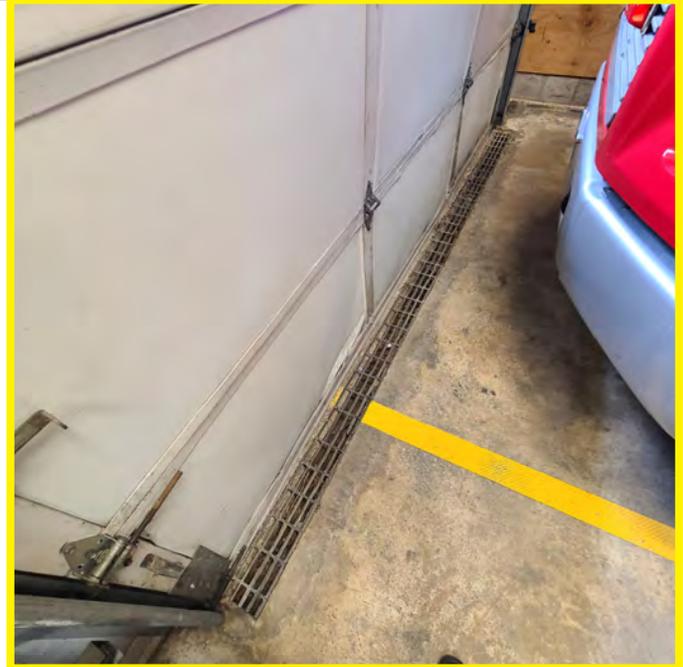
The above photo shows two main areas of concern:
1- improperly positioned undersized trench drain
2- undersized apparatus bays

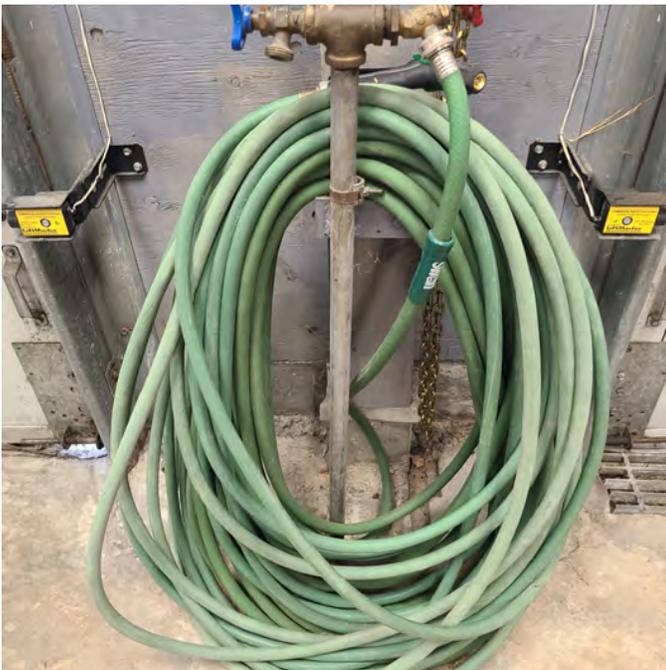
The photo above shows an interior hose bib that is used for vehicle washing. This needs to be relocated and mounted for proper storage.

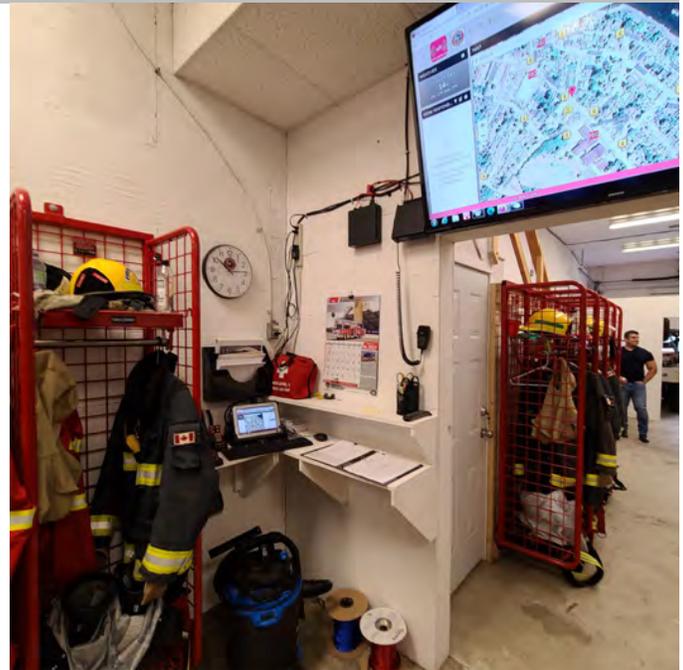
The photo above shows a closer look at this crowded station.

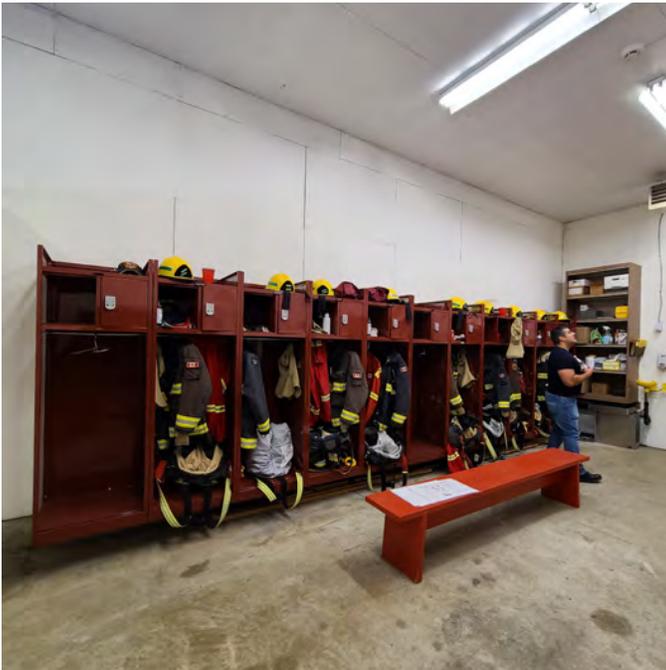
The photo above shows old style gear racking units and single lockers that need to be replaced as they do not allow for the use of an integrated drying system. The lighting in the gear room is adequate but could be upgraded for better efficiency.

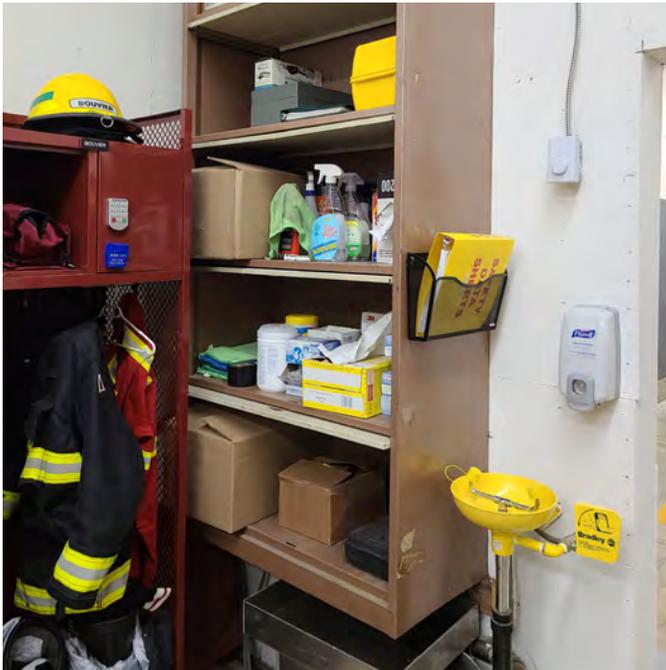
The photo above shows every corner of the Fire Hall being used for some sort of storage. A proper janitorial supply closet is required. The eye wash station is good to have and is acceptable. Hand sanitizing stations should be installed at all high traffic areas.

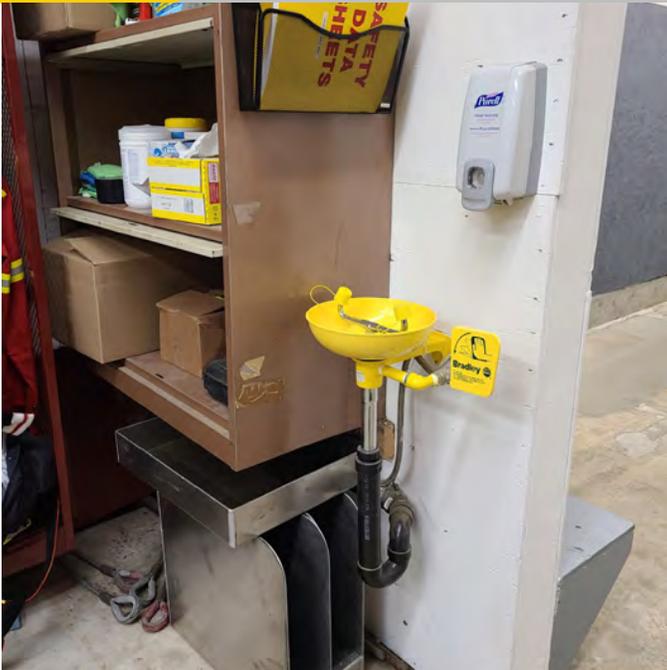
See previous photo for further information. Storage needs to be improved.

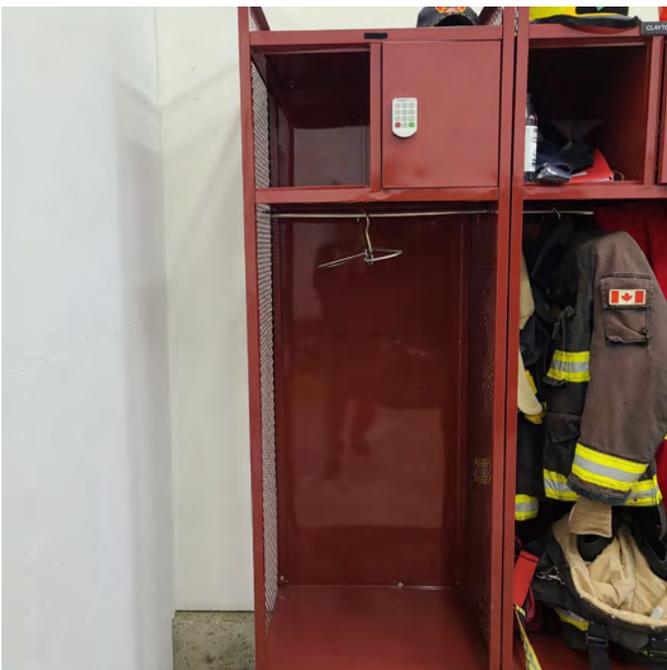
See previous photos for further information. It appears that no gear drying system is available in the gear room which makes gear drying difficult and very inefficient.

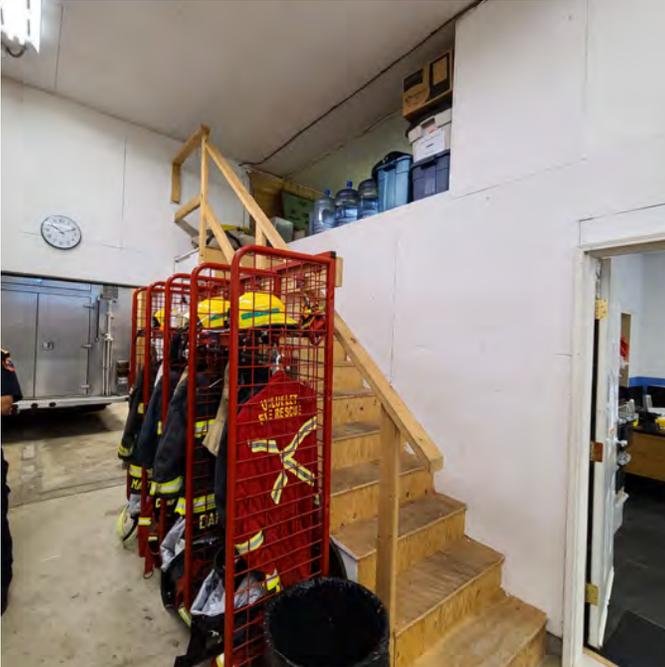
The photo above shows the access stairs to the storage mezzanine and the door entering the office, gym, and radio rooms to the right. The storage space is not safely accessible.

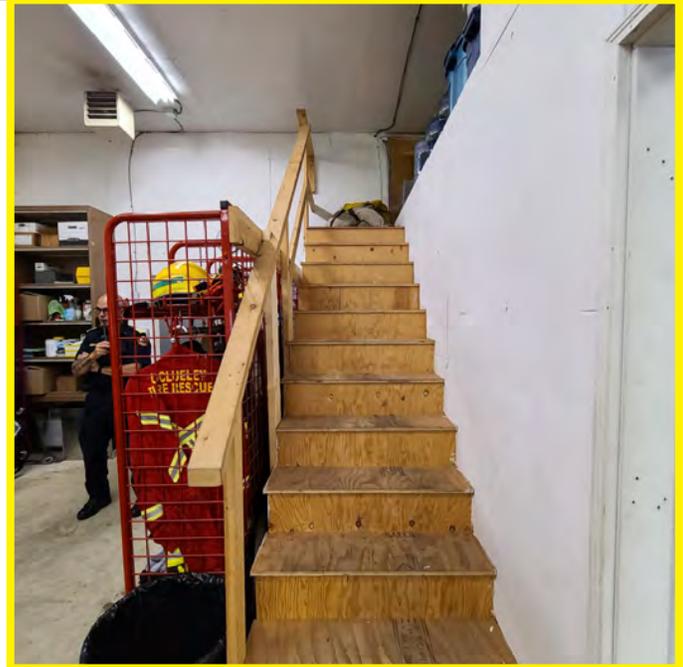
The photo above shows access stairs to the storage mezzanine. The stairs and railing are not built to code. A small unit heater is observed to be mounted to the underside of the ceiling in the gear room.

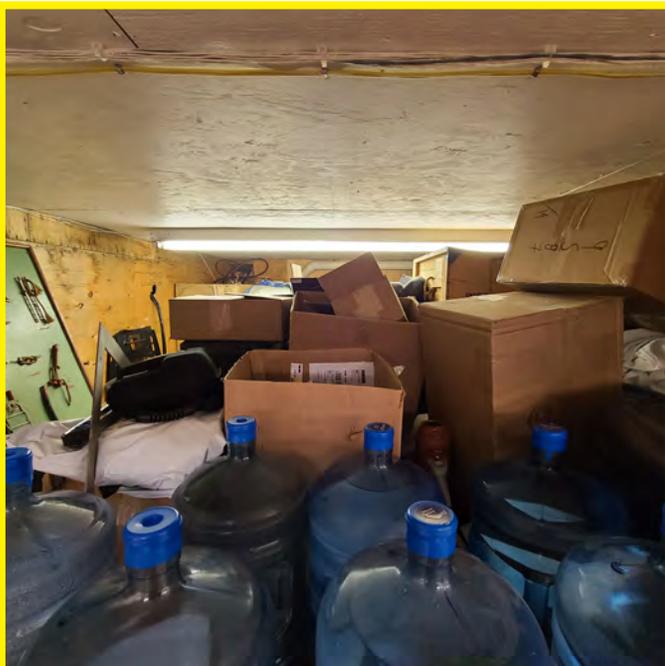
The photo above shows an over packed storage area.

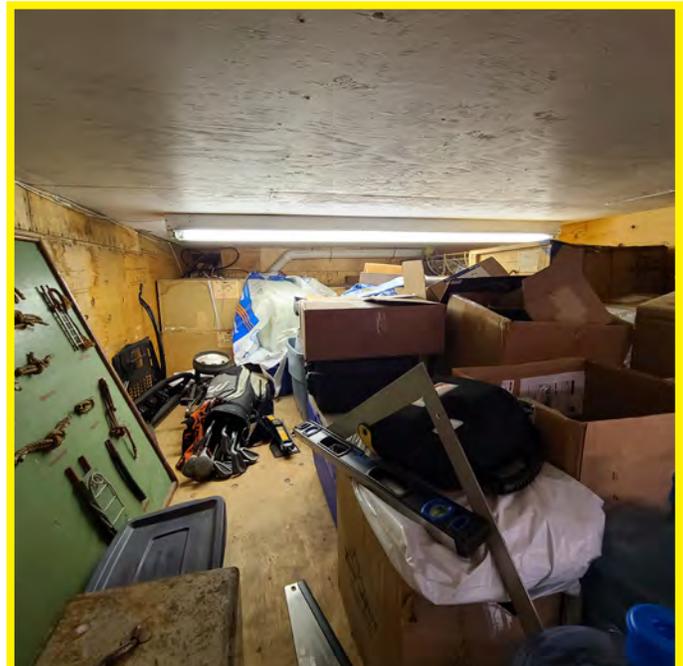
The photo above shows an over packed and inaccessible storage area. There is no room to properly store disaster relief or first aid supplies.

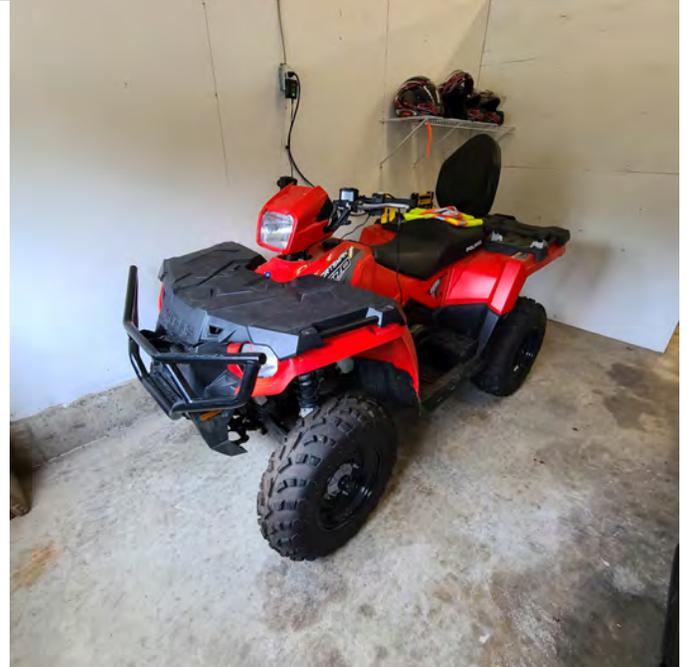
The photo above shows rescue equipment and storage area.

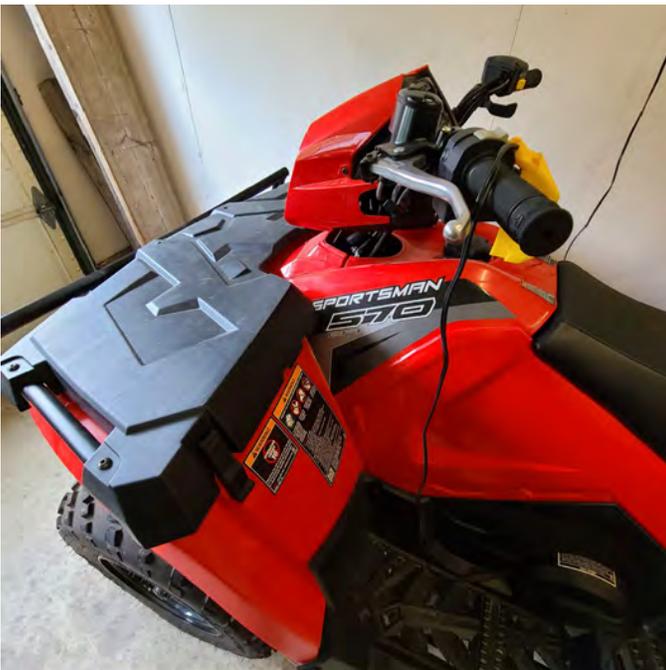
The photo above shows rescue equipment and storage area.

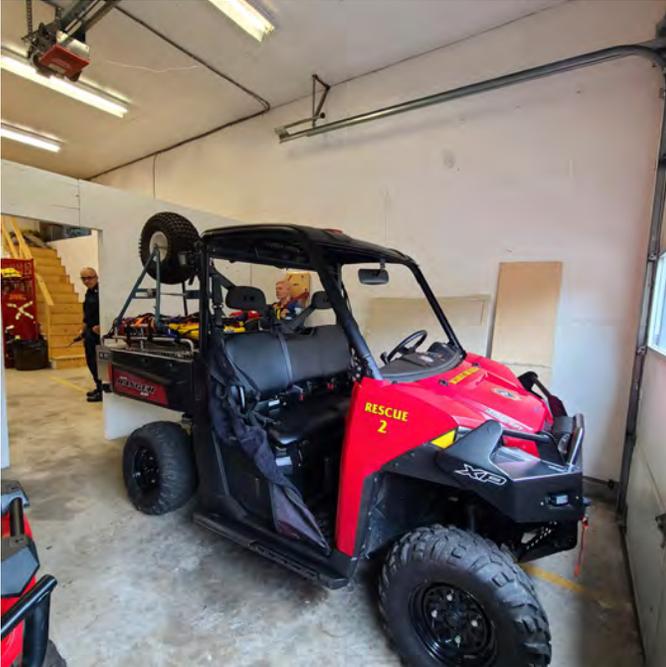
The photo above shows rescue equipment and storage area. Storage space is limited and the bays are too small to properly fit the required equipment.

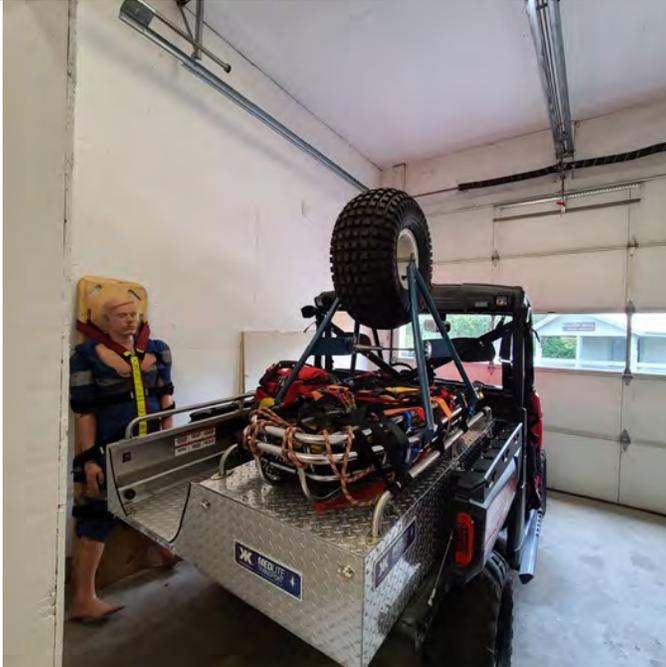
The photo above shows rescue equipment and storage area.

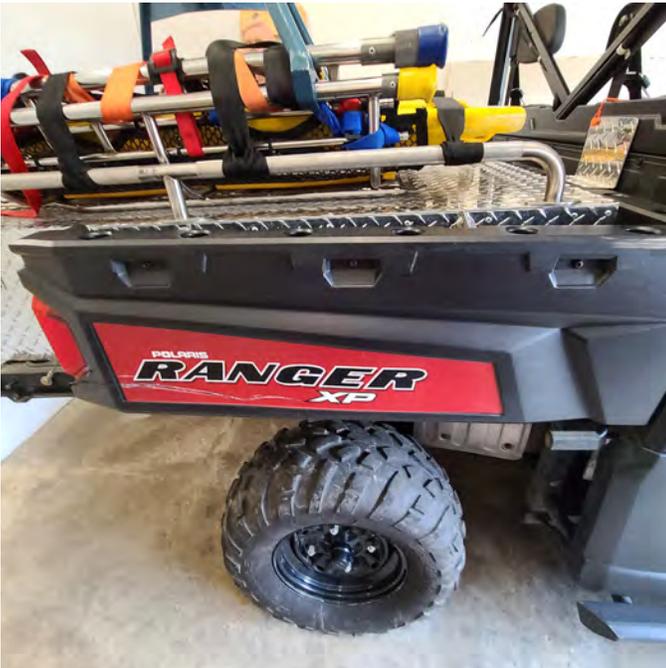
The photo above shows rescue equipment and storage area.

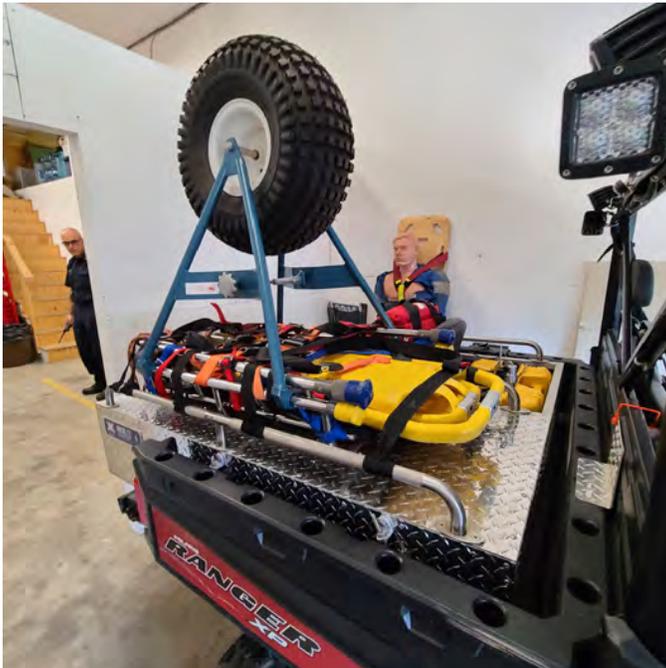
The photo above shows rescue equipment and storage area. The rescue storage bays are separated from the gear room with a simple partition wall. No exhaust cleaning system is observed in these areas.

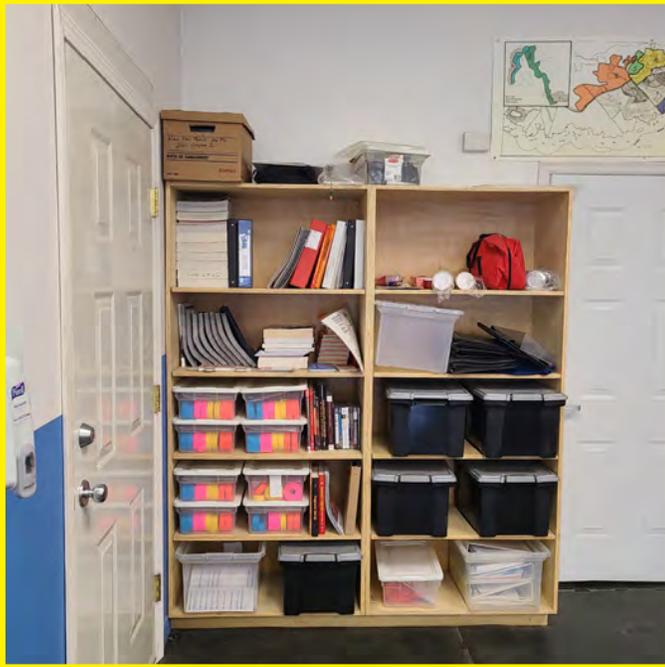
The photo above shows one section of the main floor 'administration area' which has been combined with the fitness room (gym). There is no room for proper separation. There is no room for properly organized shelves and archives.

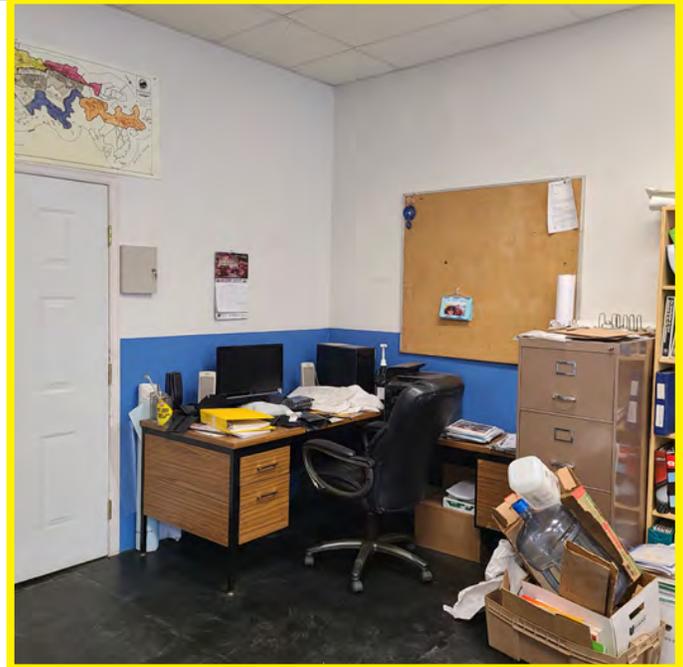
The photo above shows a desk space that is used for various administrative purposes. The area is cluttered and there isn't room for proper organization.

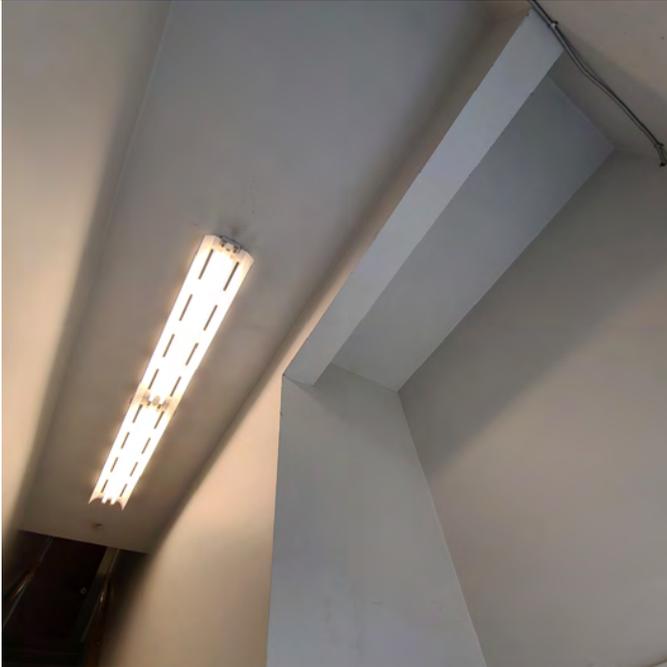
The photo above shows a look at the main entry ceiling and stairwell. One surface mounted light is observed and a supporting beam. The fire rating or structural elements cannot be confirmed.

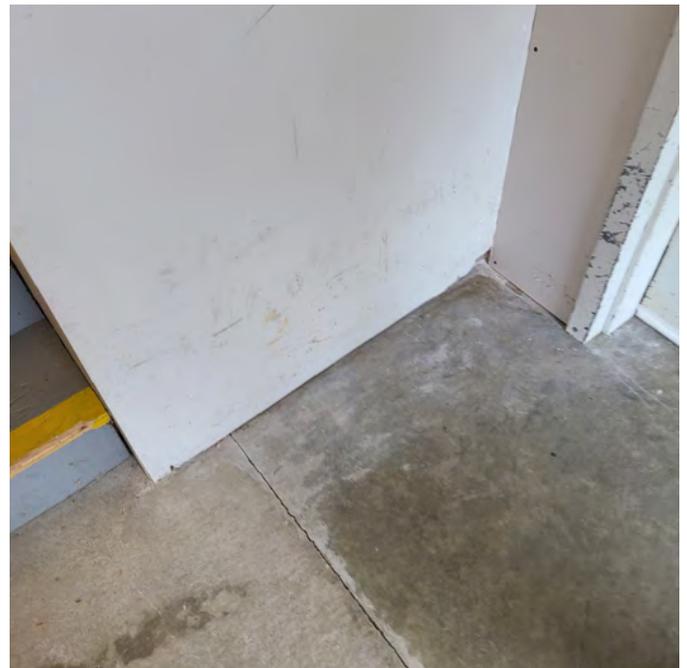
The photo above shows the condition of the main entry concrete slab, walls, and door frames. Maintenance is needed. This photo provides a closer look at the plywood stairs and nosing.

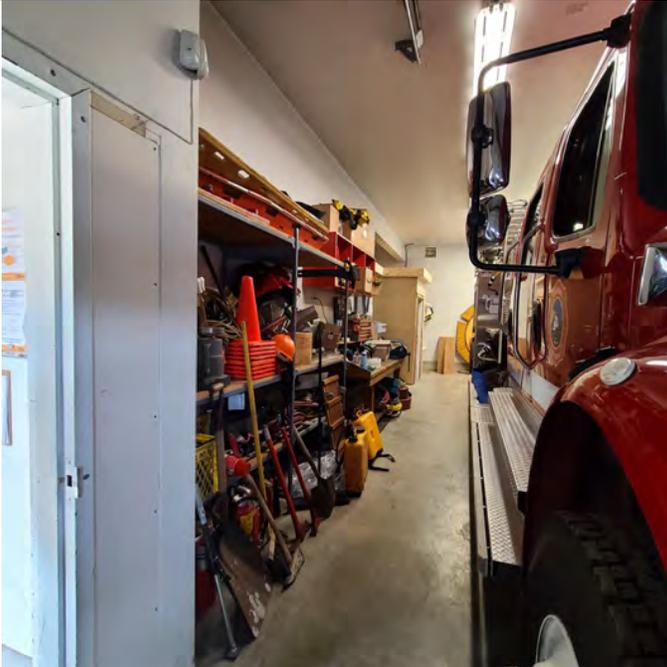
The photo above shows a look at the 'work shop' area located in the 3rd apparatus bay (left side of bay). There is not enough room for proper tool, equipment, and fuel storage.

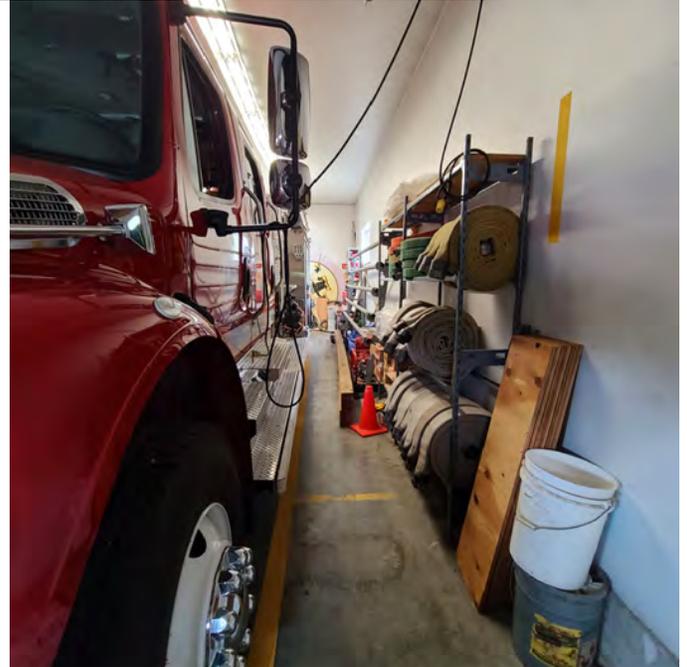
The photo above shows a look at the 'hose storage' area located in the 3rd apparatus bay (right side of bay). There is not enough room for proper hose drying and storage on racking.

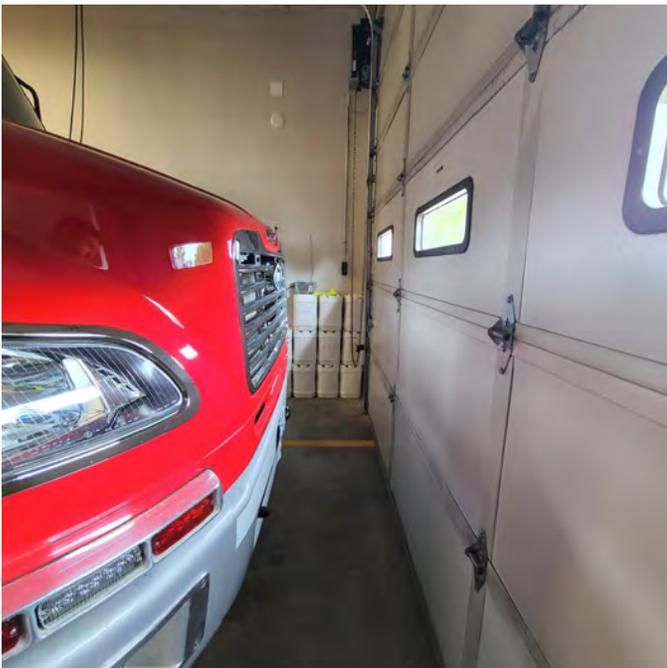
The photo above shows the limited apparatus bay space. There is very limited movement space in this bay.

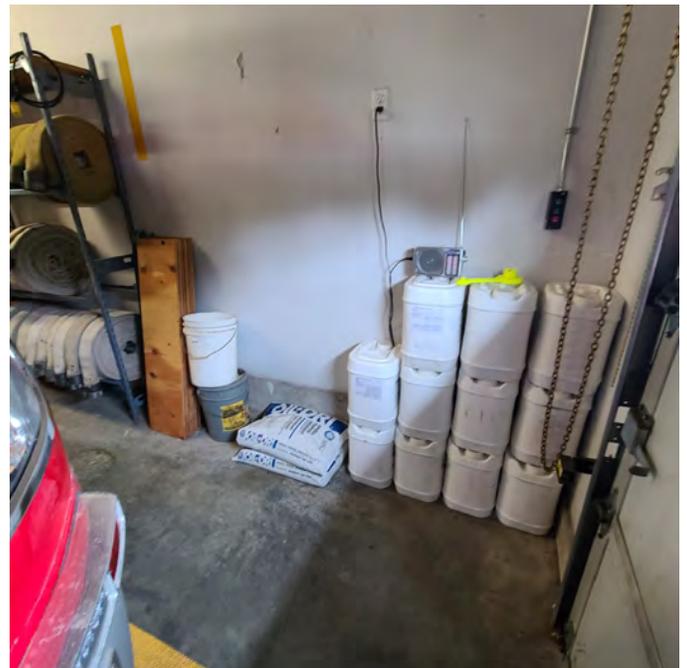
The photo above for storage in the apparatus bays that needs designated secure space.

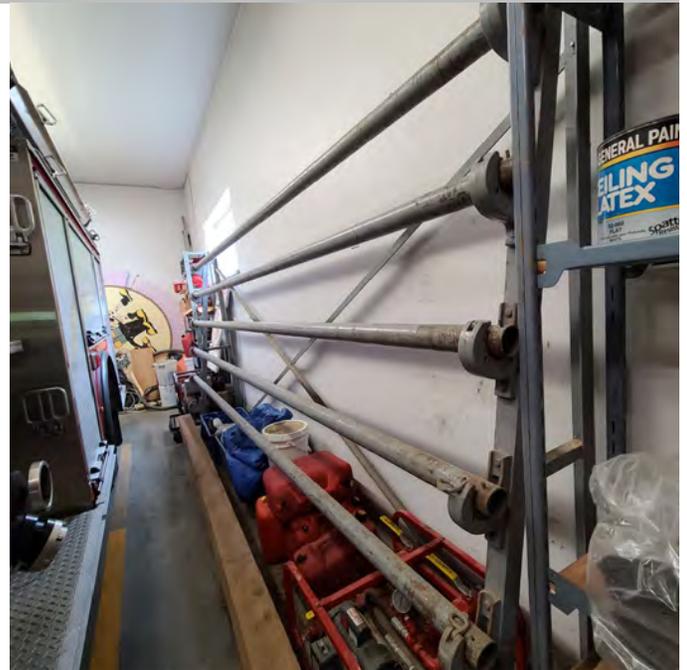
The photo above shows the storage in the apparatus bays that is creating problems due to the limited space available.

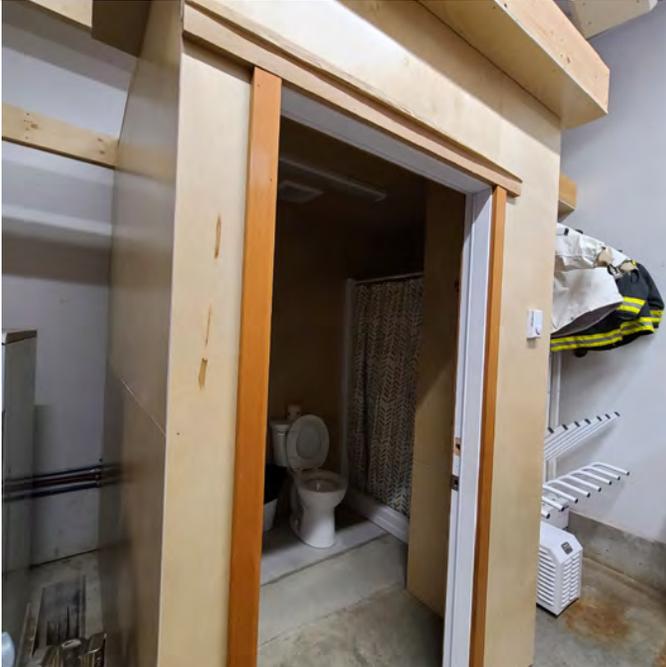
The photo above shows the only available washroom on the main floor. This washroom/ shower room combo is not sufficient for a decontamination room which should be available in the apparatus bays.

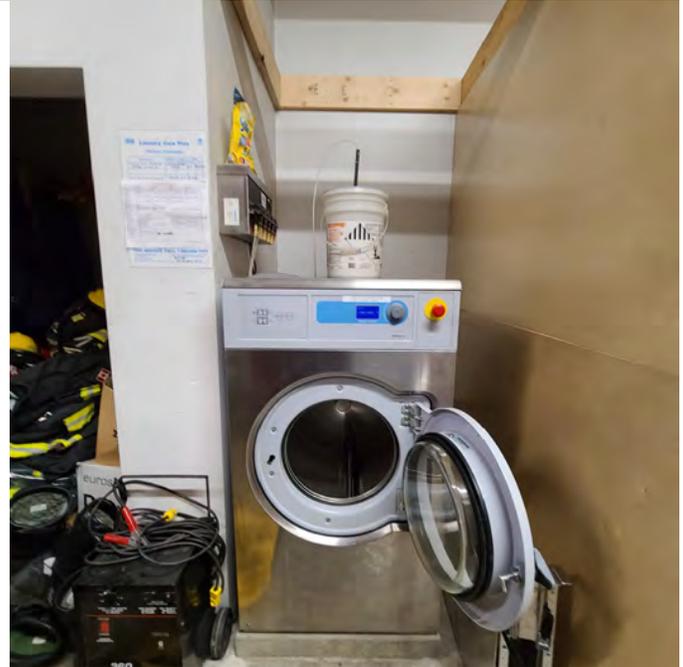
The photo above shows the gear washing machine. No organization or cleaning storage room is available in this area. The workshop storage to the left makes for a non-functional space.

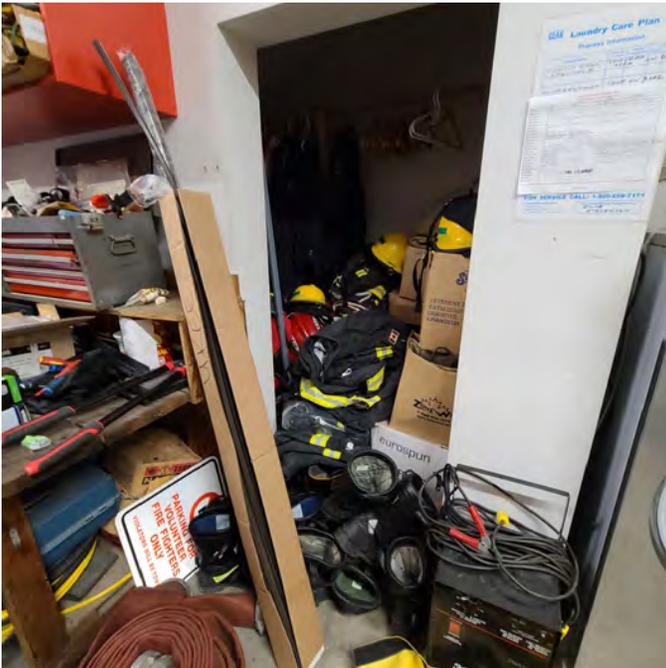
The photo above shows the 'work shop' and bench area with a small storage room.

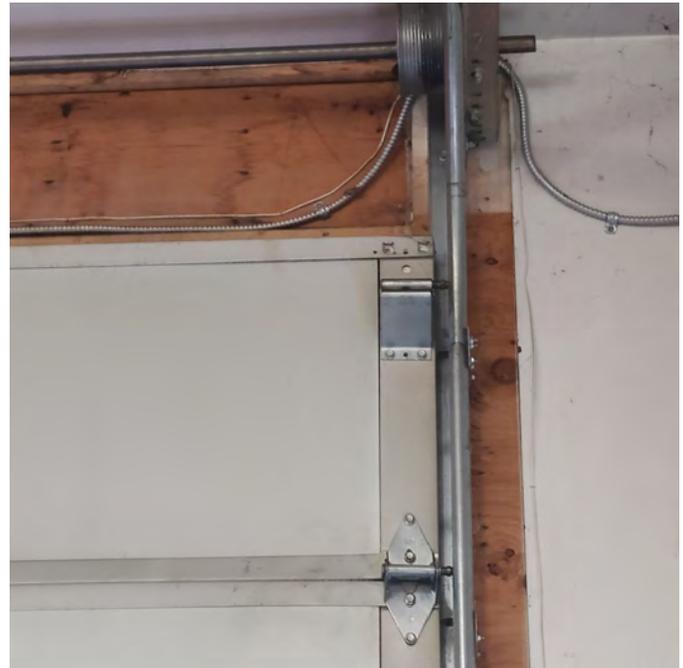
The photo above shows the bay addition overhead door mounting.

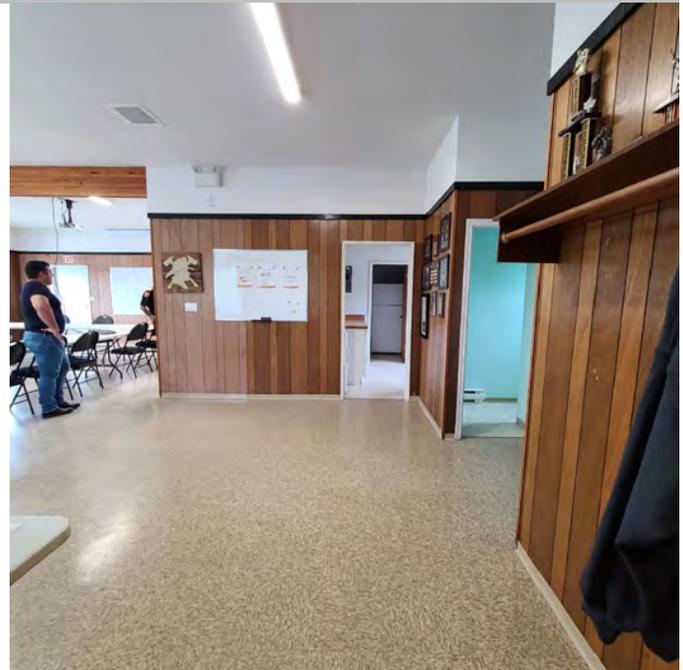
The photo above shows a view of the washrooms, kitchen, and training/ multi-use areas. The flooring and interior aesthetic is outdated.

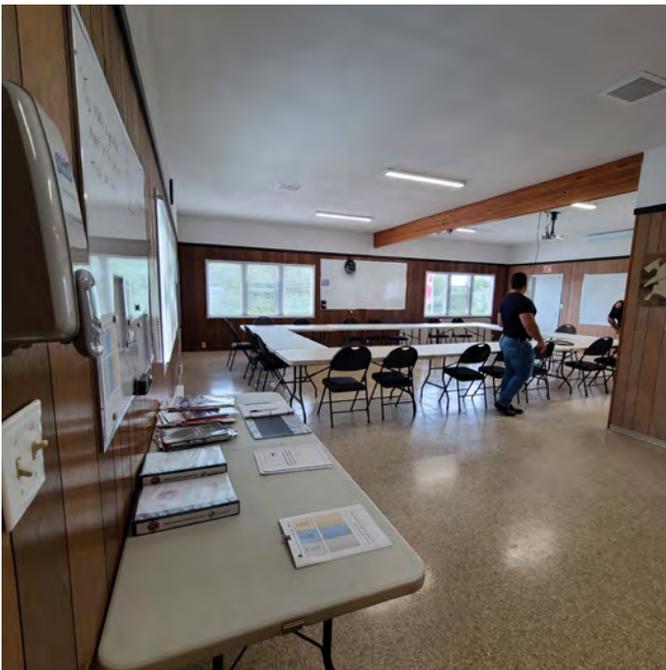
The photo above shows the multi-use area where most in-classroom training sessions are completed. Space is limited.

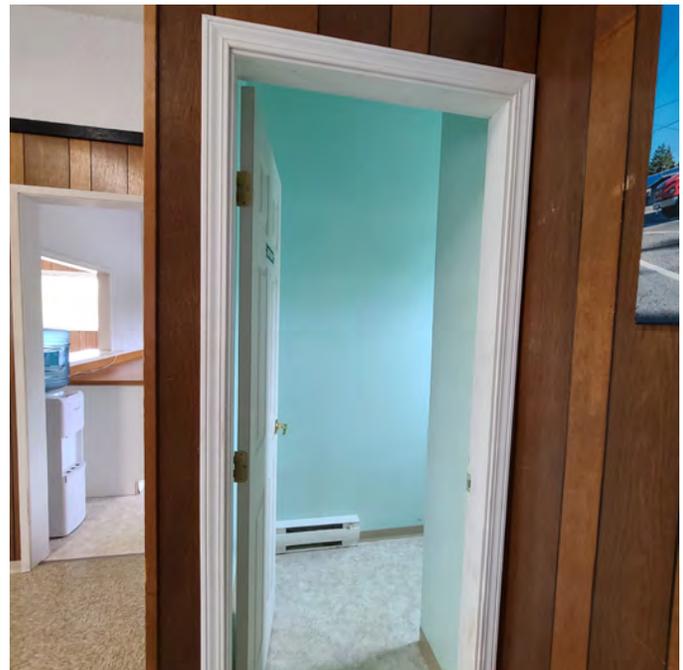
The photo above shows one washroom with electric baseboard heating.

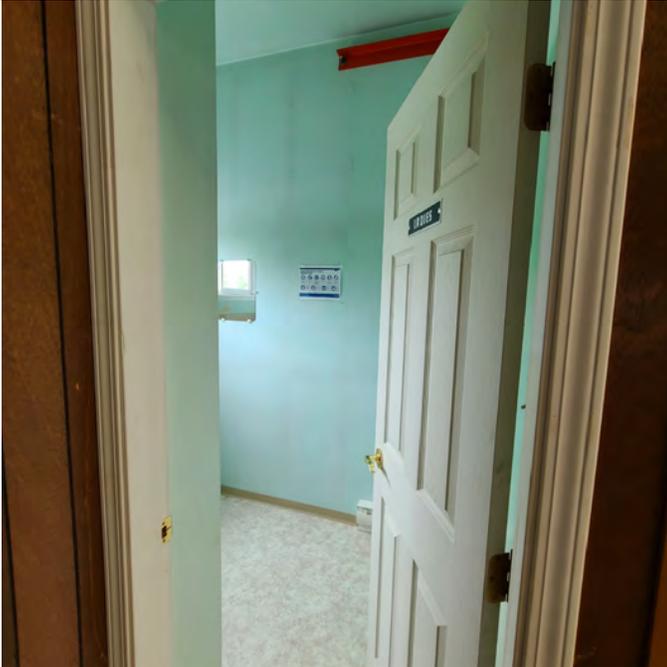
The photo above shows a secondary washroom.

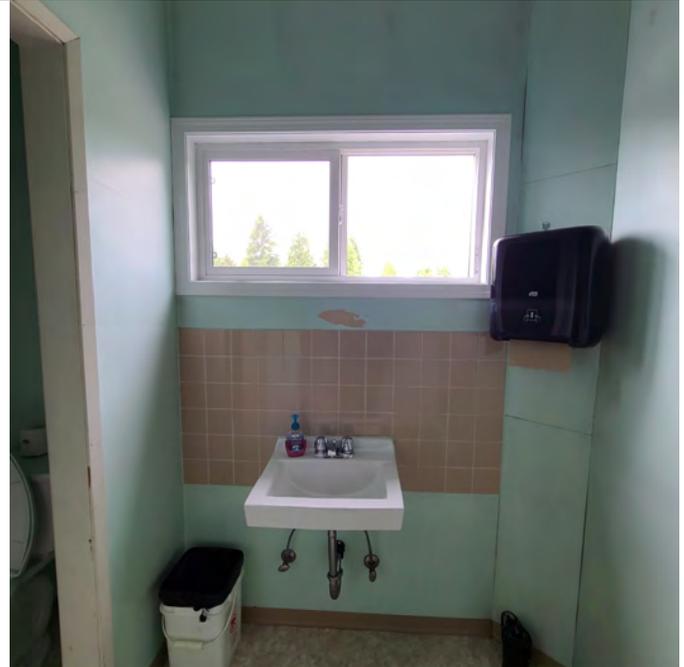
The photo above shows outdated washroom accessories and awkward washroom layouts.

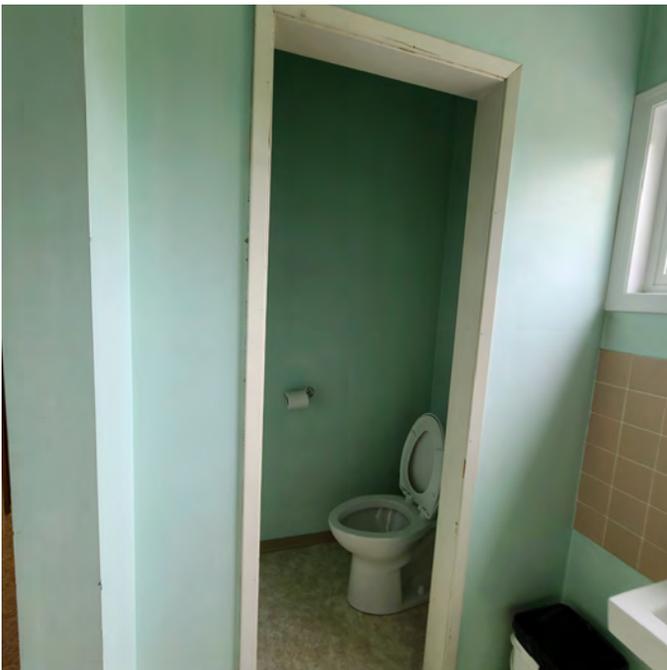
The washrooms are inadequate for the facility uses.

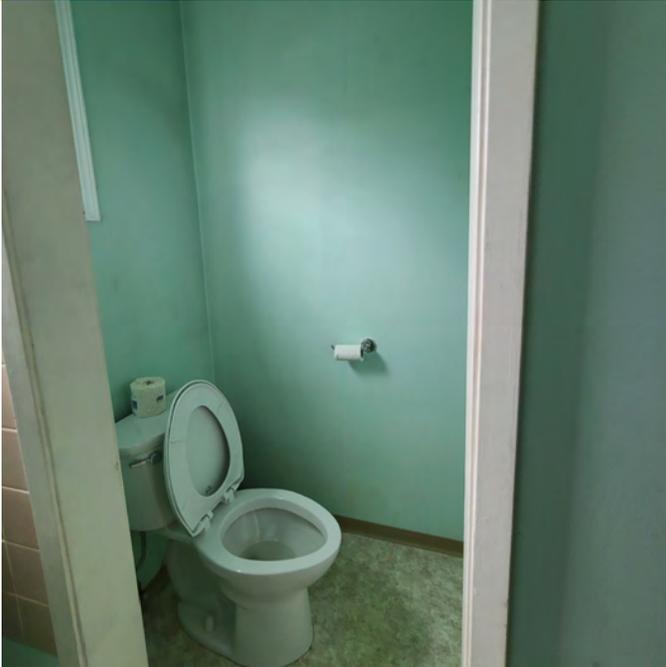
The photo above shows a residential style water closet. The toilets should be replaced with commercial grade units including open front seats.

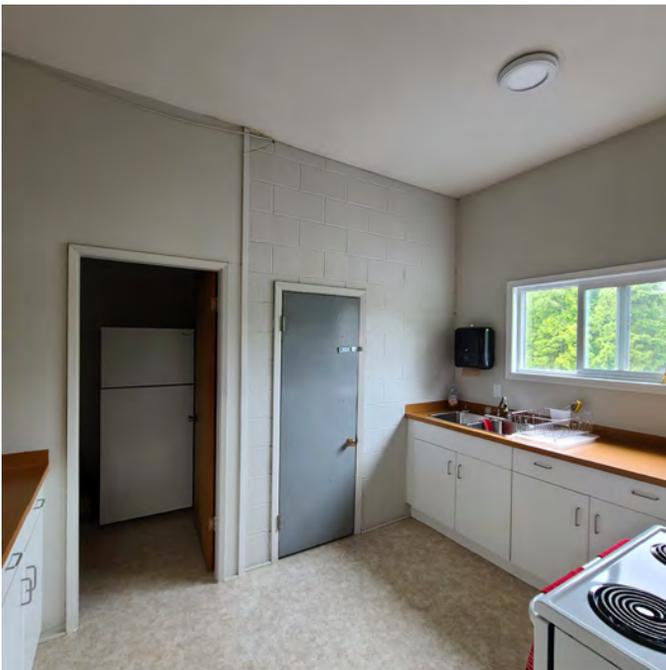
The photo above shows a view of the general kitchen layout. There is no room for the fridge to be placed within the required space.

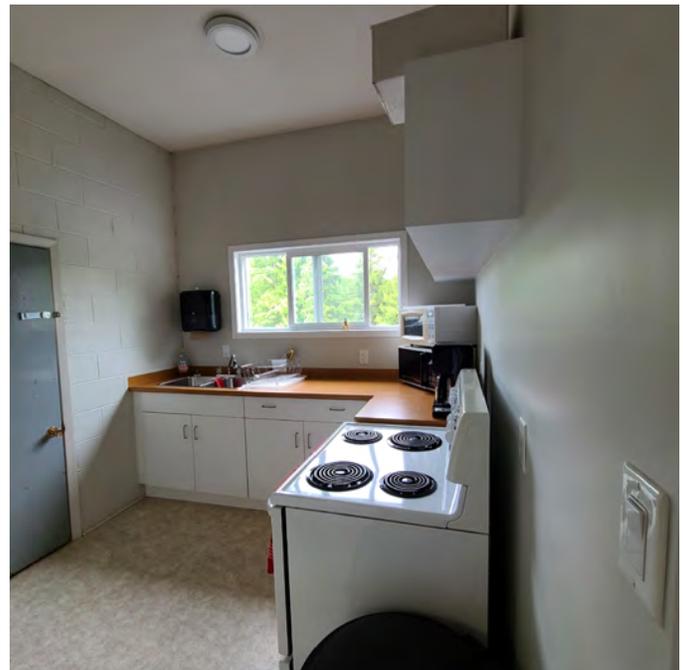
The photo above shows an overall outdated kitchen that needs redesign. More counter space and prep. area is required.

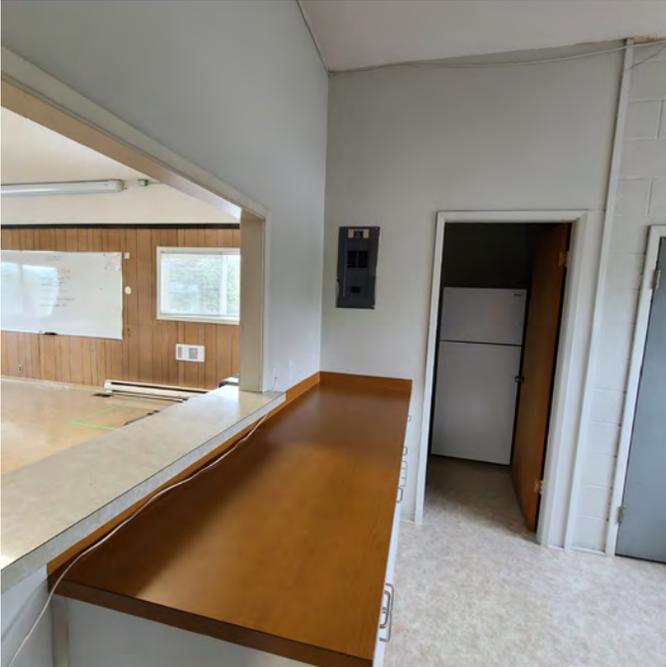
The photo above shows a pass-through style counter top and prep. area. The layout is disconnected and doesn't make for a functional use of space. The fridge and pantry room are seen in the background of this photo. The layout is not ideal.

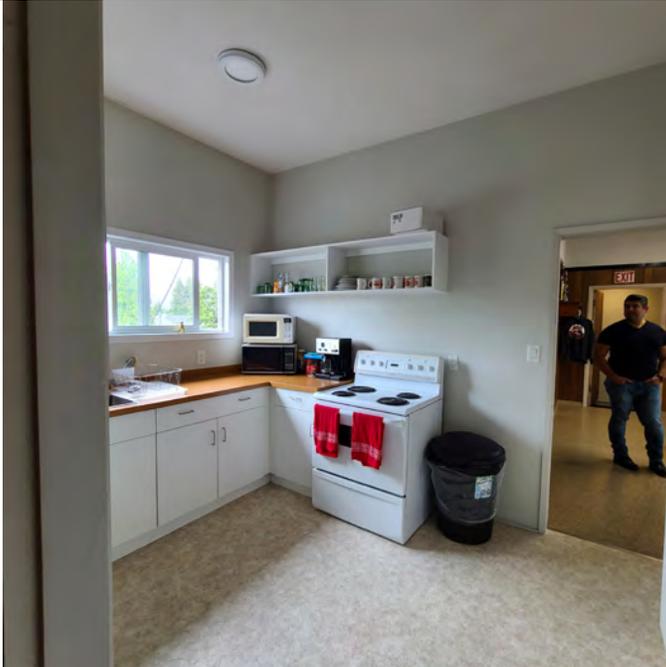
The photo above shows the kitchen appliances: stove, two microwaves, sink, no dishwasher.
