REGULAR MEETING OF COUNCIL
Monday, October 23, 2023 @ 4:00 PM
Ucluelet Community Centre
500 Matterson Drive, Ucluelet

| 7.3 | <p>Fire Hall Replacement

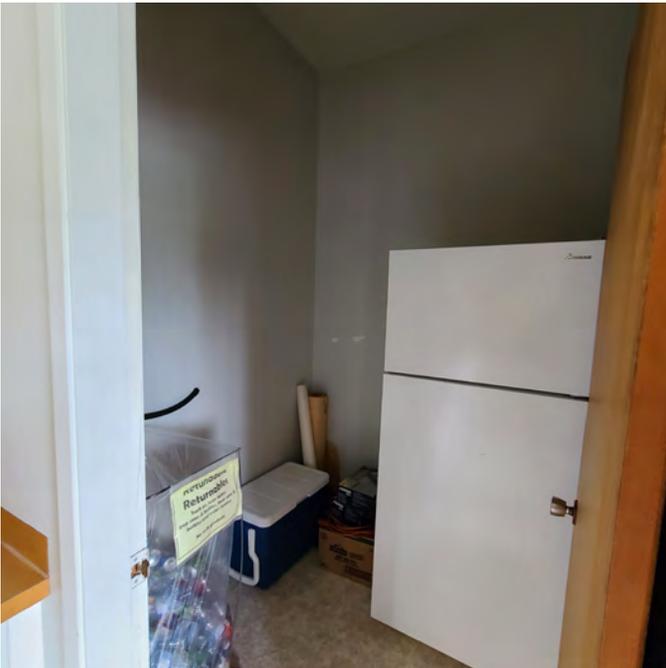
The photo above shows the fridge and 'pantry' storage/ recycling room. This room could be configured for better storage and use of space.

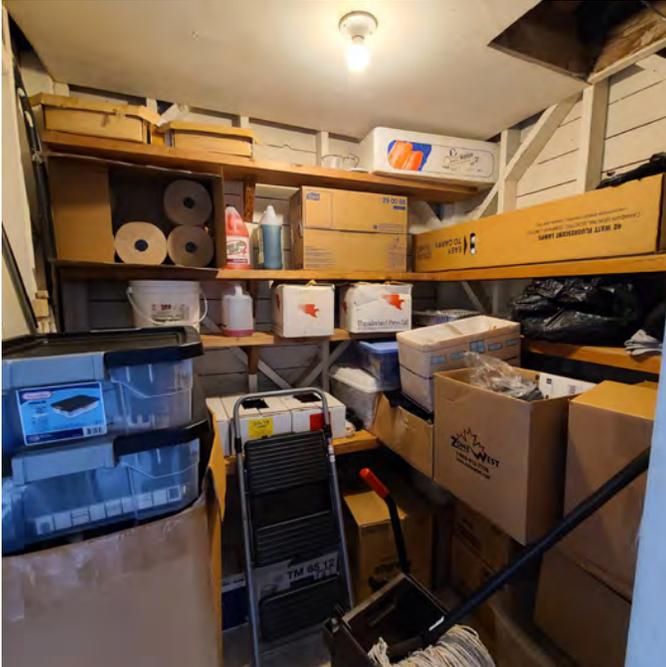
The photo above shows the storage/ janitorial supply room. The room is overstocked and relatively inaccessible due to inadequate shelving and storage space. There is no mop sink for proper cleaning uses.

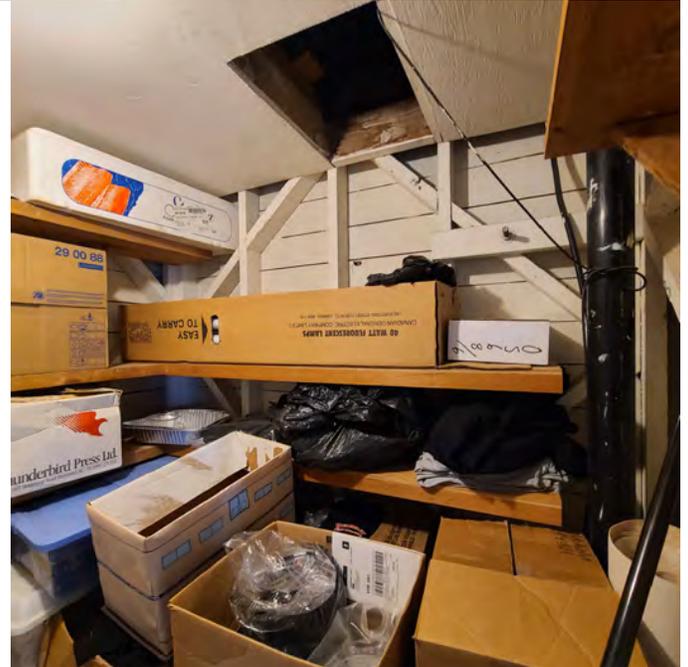
The photo above shows the storage/ janitorial supply room which is accessible in the kitchen area only. The room is unfinished inside with an inaccessible 'attic' access opening in the ceiling.

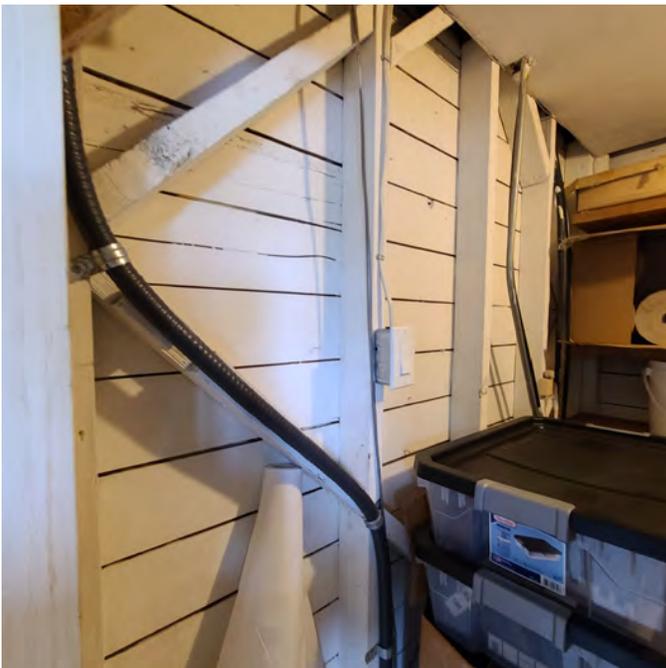
The photo above shows the storage/ janitorial supply room which is accessible in the kitchen area only. Exposed electrical and interior wall structure can be observed.

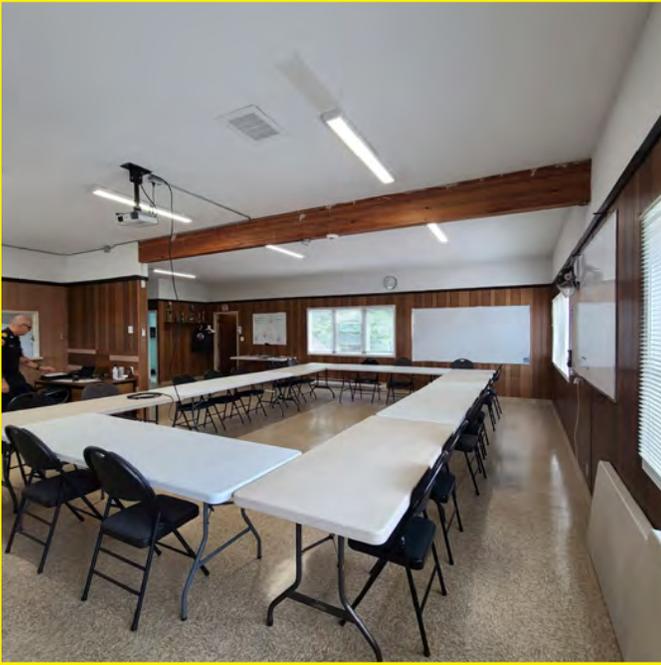
The photo above shows an overall view of the second floor administration area where all in-class training sessions are held. The table grouping allows for approximately 18 seats plus an instructor. The FD requires space for 24 training/ 30 occupants EOC.

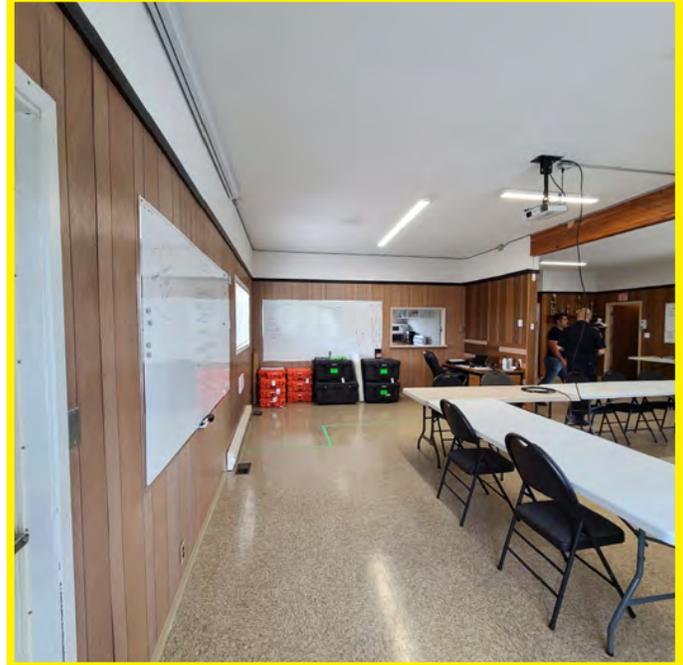
The photo above shows white boards mounted to the walls for training teaching sessions. Storage and a desk space is seen in the background of this photo (now this is the Fire Chief's office). There is no open space for rope or first aid training or practice.

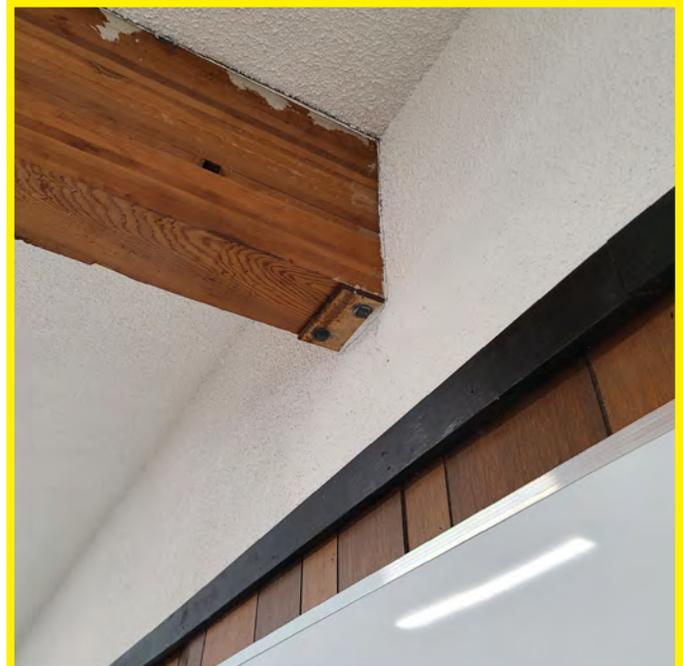
The following photos show elements of the supporting roof structure. A single exposed glulam beam is observed. The bearing and support column is hidden in the wall and cannot be confirmed adequate.

The photo above shows the glulam beam support at the front exterior wall. The beam is fastened to a metal bracket. The integrity and adequacy of this connection cannot be confirmed. It does not appear seismically sound.

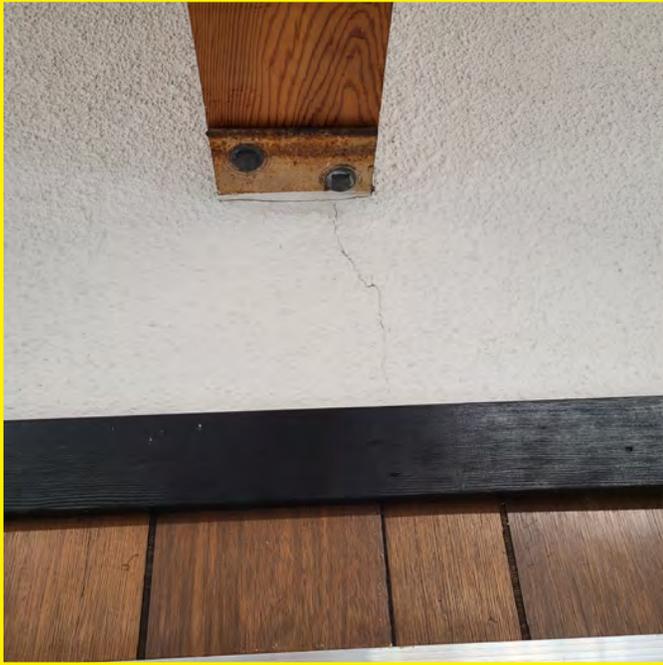
The photo above shows drywall cracking below the glulam beam which indicates building movement and/ or settlement.

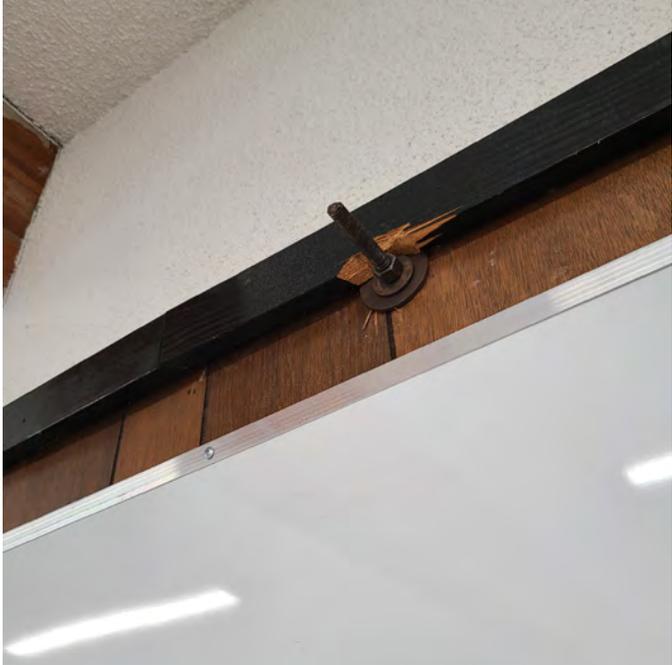
The photo above shows a through-wall bolt connection (purpose unknown).

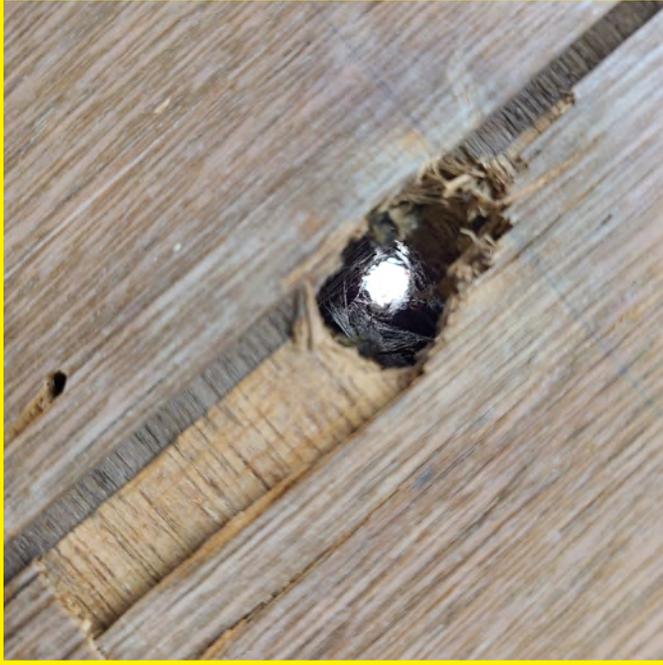
The photo above shows a hole through the complete building envelope. Daylight can be seen from the interior. The building wall assembly does not appear to be acceptable.

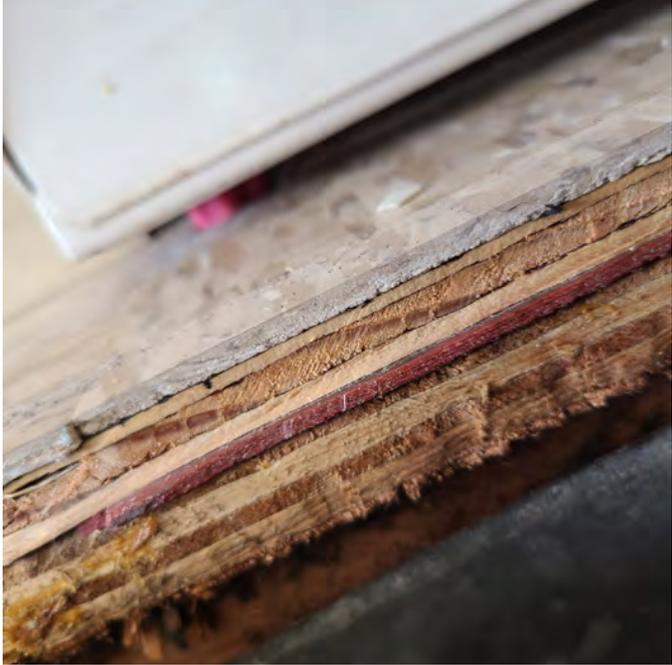
The photo above shows multiple flooring layers.

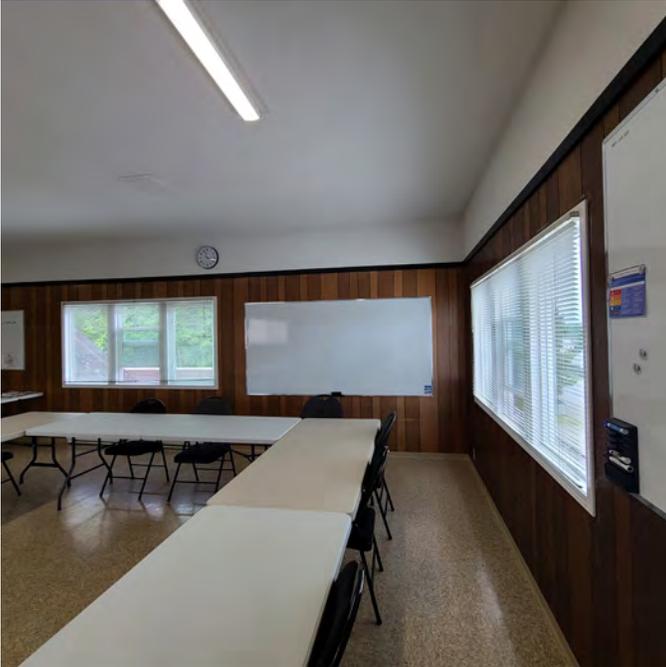
The photo above shows a further look at the training area. The room has good natural lighting. The windows need to be replaced with new. The lighting should be upgraded.

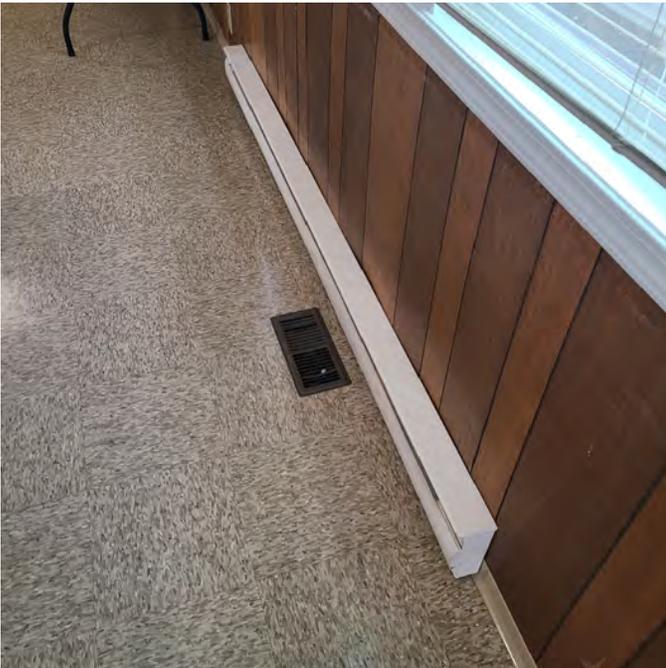
The photo above shows the building heating components.

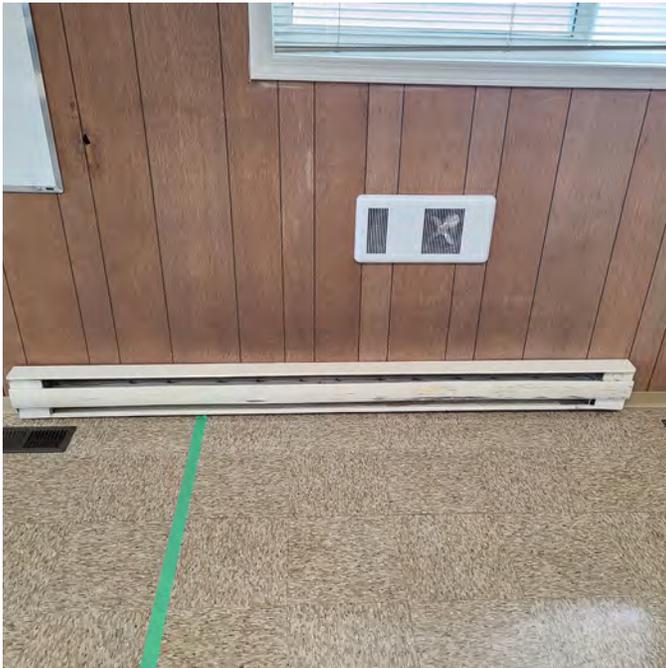
The photo above shows electric baseboard heating and wall register. The photo also shows a closer look at the outdated VCT tile and wall finish.

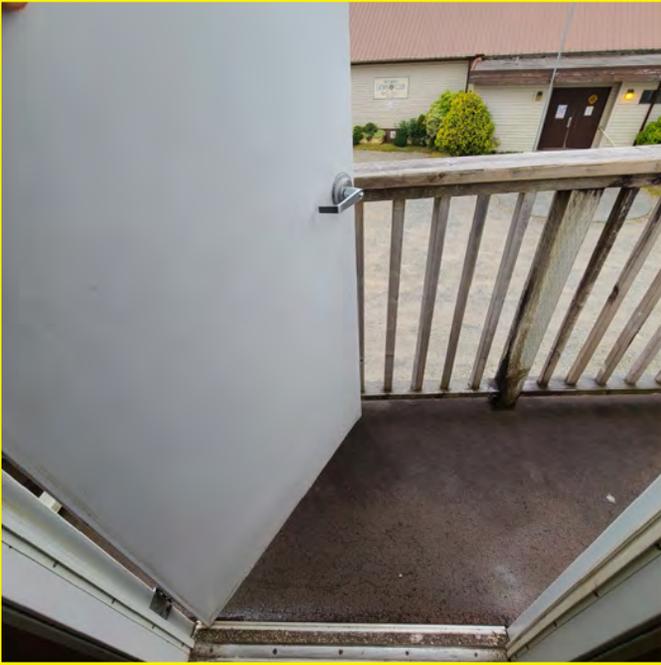
The photo above shows the second floor emergency exit stairs. The door does not have any emergency panic hardware and the door can only open approximately 75 degrees. The railing wood railing is weak and shows signs of significant weathering.

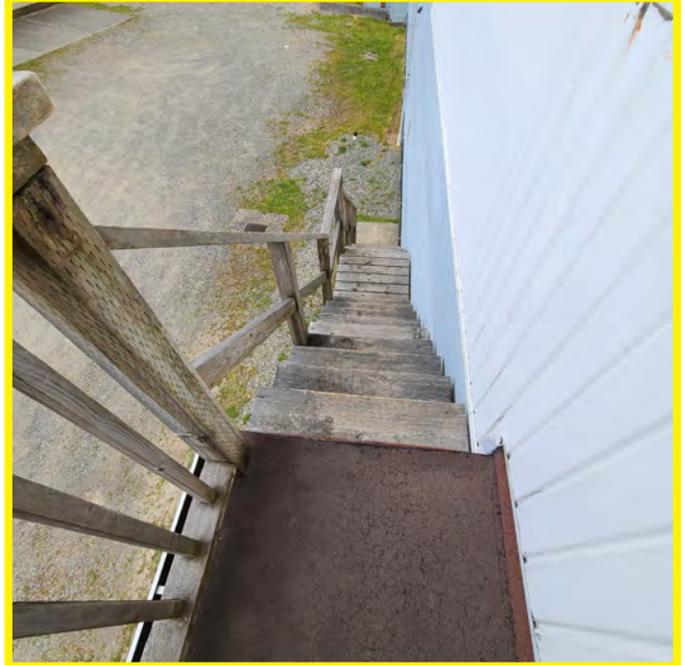
The photo above shows a view from the exterior exit stair landing to the ground. The landing surface is deteriorating and narrow. The hand rail is not of an acceptable design. NOT TO CODE/ unsafe for use.
